State Highway 9 Wildlife Crossings Mitigation Monitoring

1. Report No. CDOT-2021-XX		2. Government Accession No.		3. Recipient's Catalog No.	
4. Title and Subtitle State Highway 9 Wildlife Mitigation Monitoring				5. Report Date March 2021

16. Abstract This research monitored the effectiveness of a wildlife mitigation project on State Highway 9 in Grand County, Colorado. The purpose of the mitigation was to reduce wildlife-vehicle collisions (WVC) while providing permeability for wildlife across the highway. This five-year study used motion activated cameras and analyses of WVC crash and carcass data to evaluate mitigation effectiveness. The research documented 112,678 mule deer successful passages and a success rate of 96% across the seven structures. In addition to mule deer, sixteen other wildlife species successfully used the crossing structures. The wildlife crossings and fencing mitigation helped decrease WVC crashes by 92% and carcasses by 90% relative to preconstruction levels. Implementation Initial findings of the study were used to inform mitigation designs in the second construction phase, resulting in the addition of new escape ramp and wildlife guard designs. The fi

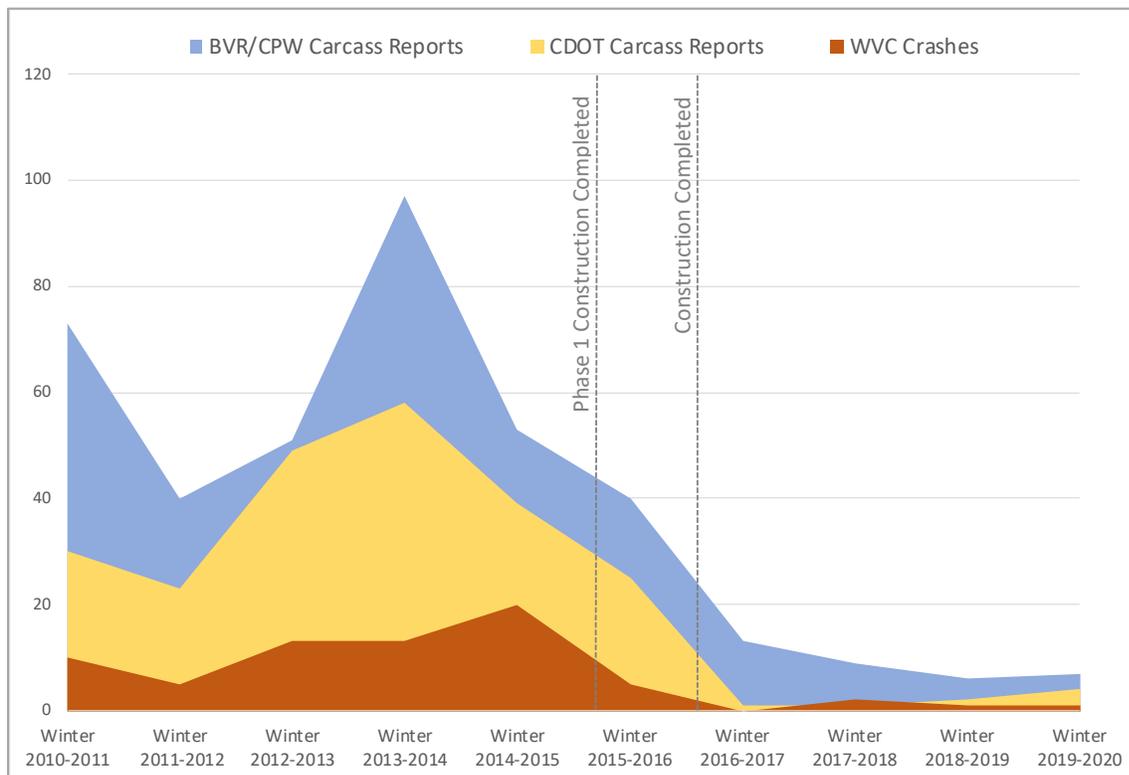
Figure E-1. Pre- and post construction WVC carcasses and crashes reported each winter as documented by BVR/CPW carcass reports, CDOT carcass reports, and CDOT crash reports. Mule deer activity and, correspondingly, WVC are highest during the winter months (November – April), which were the focus of the BVR/CPW carcass reporting effort.

Altogether, the wildlife crossings, continuous fencing, and associated mitigation features achieved major safety benefits, helping to decrease WVC crashes reported to law enforcement by 92% and supplementary carcass counts by 90% relative to preconstruction levels (Fig. E-1). As a result of this mitigation, an average of 13 crashes and 56 WVC mule deer mortalities were prevented each year since the construction was completed. Statistical analyses confirmed that the crossing structures and fencing were effective in producing this dramatic reduction in WVC within the mitigated segment relative to control segments. WVC continued to occur beyond the project area, south of the fence end where ongoing ungulate activity occurred, indicating that the project may not fully mitigate wildlife movements across SH 9.

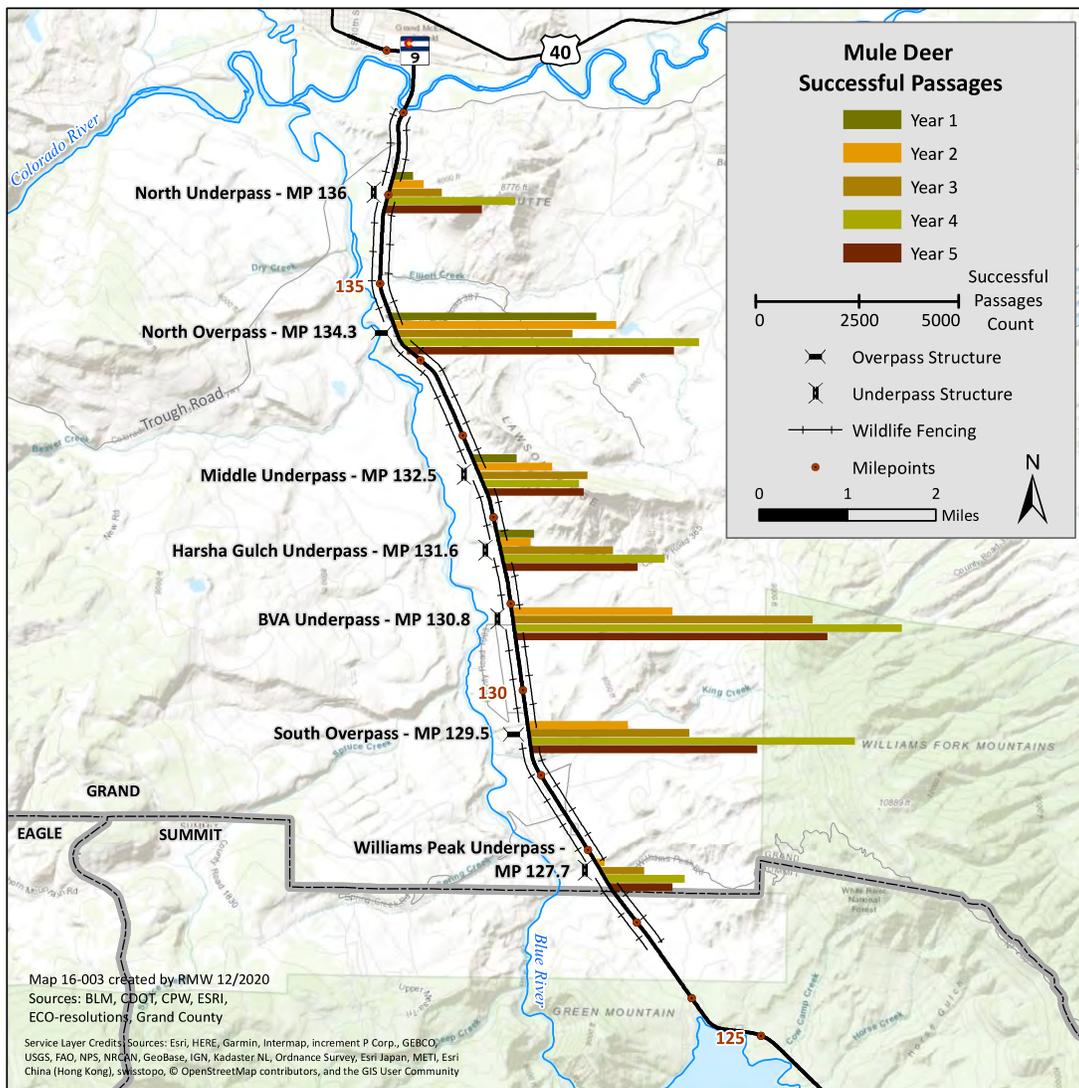
Figure E-2. Mule deer successful passages by study year at each crossing structure location. In total, the study documented 112,678 successful passages by mule deer.

The number of mule deer successful passages generally increased each year post construction, and both the overpasses and the underpasses functioned extremely well for mule deer passage (Fig. E-2). While the total number of successful passages was higher at the five underpass structures than at the two overpass structures, statistical analyses found no discernable preference for one structure type over the other, suggesting that both the overpass and underpass designs used on SH 9 were effective for mule deer. Differential use of the crossing structures across the study area likely reflected variations in mule deer winter range habitat use – that is, structures located in portions of the winter range with the greatest density of mule deer received the most use, regardless of structure type.

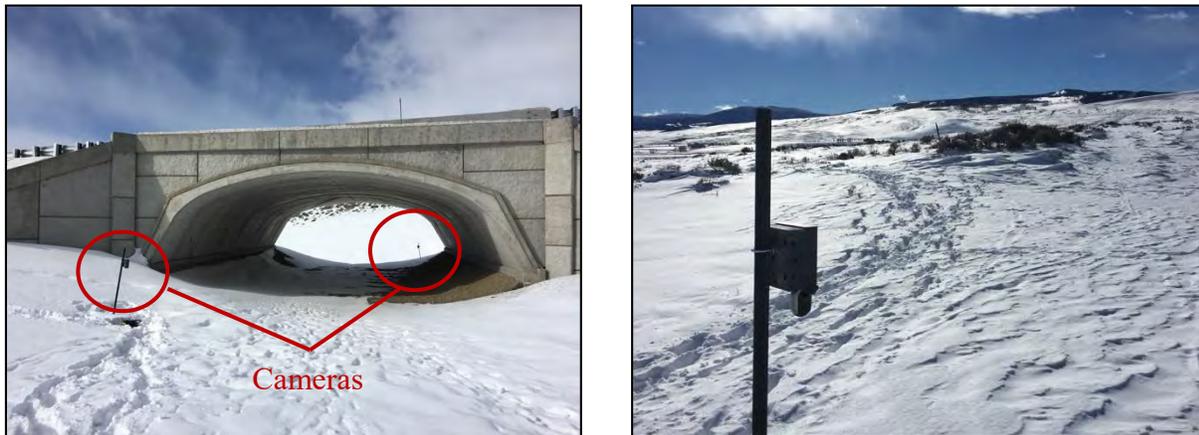
Figure 2-1. Two cameras were positioned at each underpass at opposite corners (left). Habitat camera placed 50-100 feet away from a structure, facing out into the adjacent habitat (right).

structure entrance, facing away from the road toward the adjacent habitat. The objective of these habitat cameras was to document species present in the landscape adjacent to the crossing structures and to determine whether these species also approached the structures.

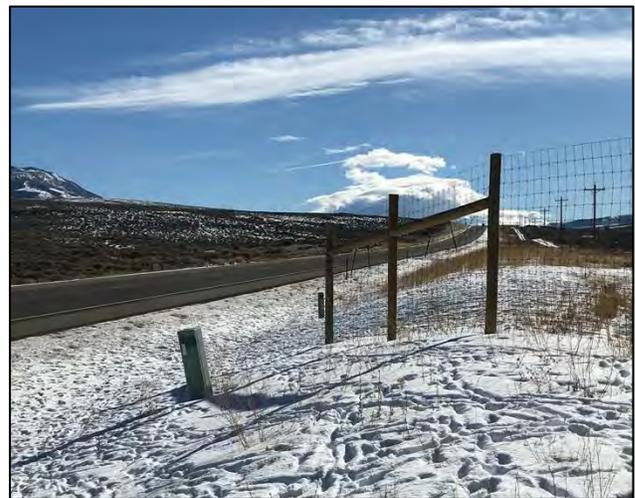
Figure 2-3. Cameras encased in utility boxes at the south fence end.

Wildlife exclusion fence runs along the right-of-way line throughout the project area. The northern terminus ties into the Colorado River Bridge south of Kremmling. The southern terminus is at MP 126.7. At this fence end, the fence line angled in towards the highway, ending 20' from the pavement edge so that it was not inside the clear zone. At the south fence end (Fig. 2-3), cameras were positioned to capture wildlife movements into and out of the fenced right-of way, as well as movements that occurred beyond the fence end.

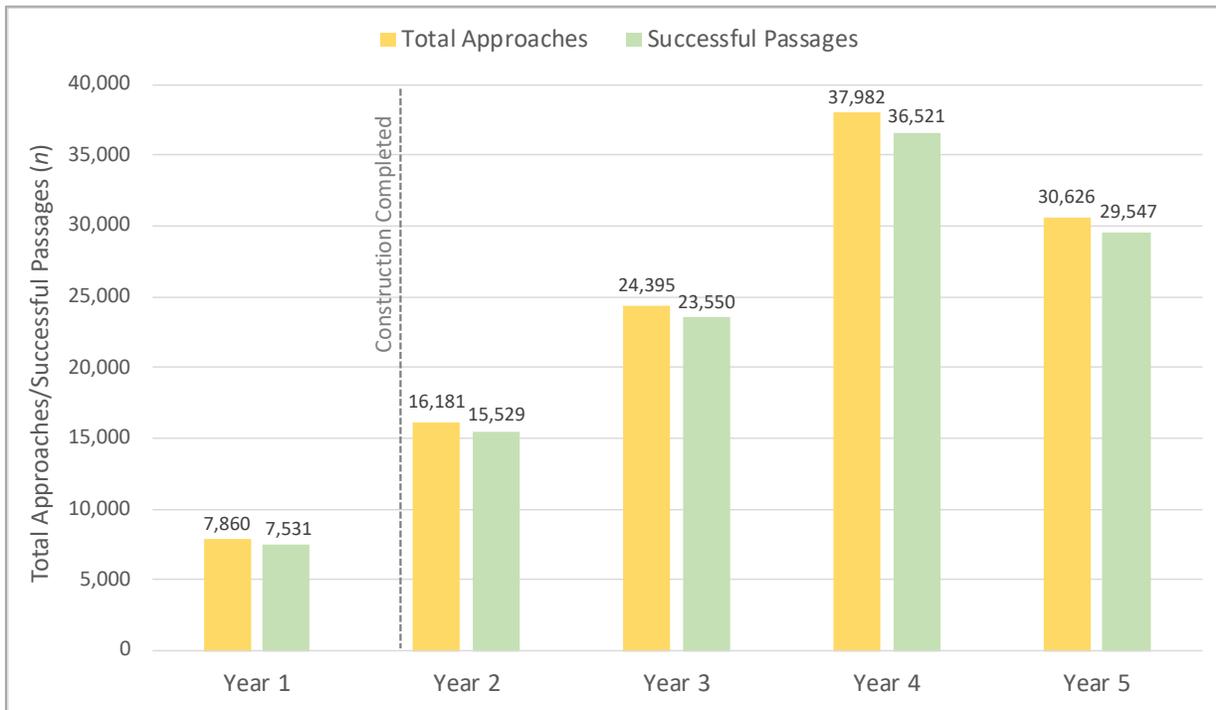
Figure 3-1. Total number of mule deer approaches and successful passages at the seven wildlife crossing structures each year of the study. For each year, the closer the yellow and green bars are in height, the higher the success rate. Four crossing structures were monitored in Year 1. Construction was completed at the end of Summer of Year 2, marking the onset of post construction monitoring at all seven crossing locations.

Year 2 data primarily reflect winter movements. Ongoing construction during the summer months resulted in a temporary cessation of monitoring activities at several locations in the Phase 1 portion of the project area and crossing structures in the Phase 2 portion of the project area were still under construction. While the total number of mule deer approaches and successful passages was lowest during the Construction Phase (Winter of Year 1 through Summer of Year 2), mule deer made 9,173 successful passages during this timeframe (7,531 in Year 1 and 1,642 in Summer of Year 2) with a success rate of 96%.

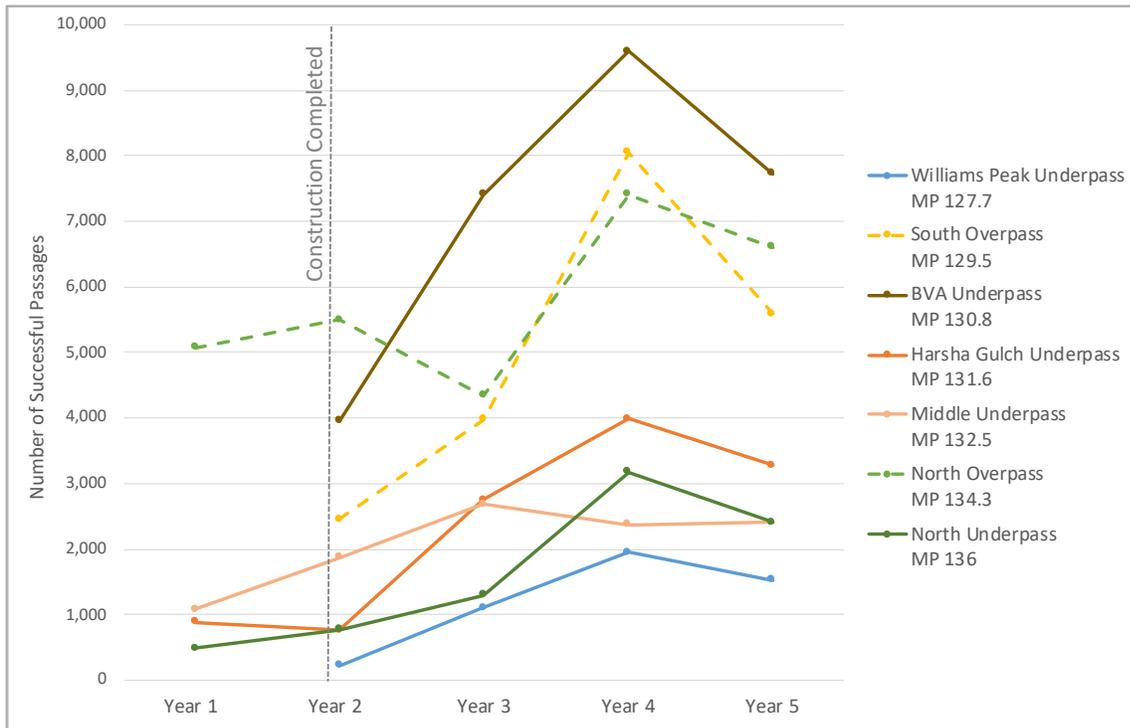
Figure 3-2. Annual number of mule deer successful passages at each crossing structure each year of the five-year study.

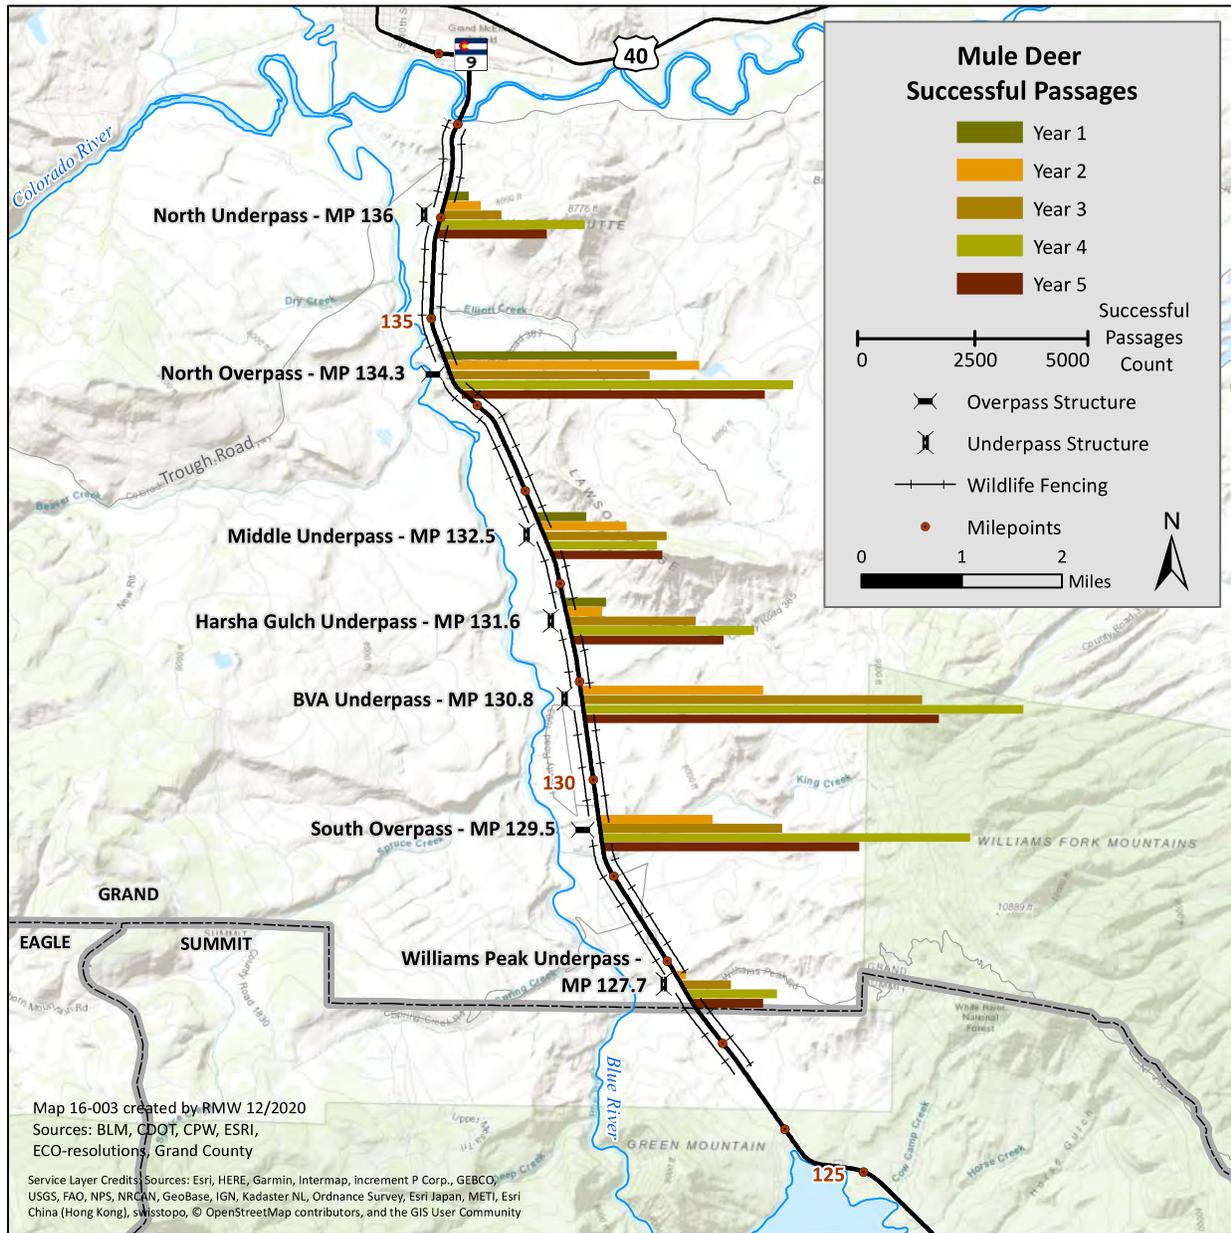
Figure 3-3. Mule deer successful passages by study year at each crossing structure location.

successful passages. Figure 3-3 plots the annual number of successful passages by location to demonstrate the spatial distribution of mule deer activity at the crossing structures. Detailed results from each crossing structure location are presented in Appendix D.

followed by the North Overpass (27.8) and the South Overpass (26). Each of the other four underpass structures saw 11 or fewer successful passages a day in winter. On average, there were 11.4 success movements per crossing structures each day of the study (adjusted for the number of monitoring days at each location) and 17.5 success movements each winter day.

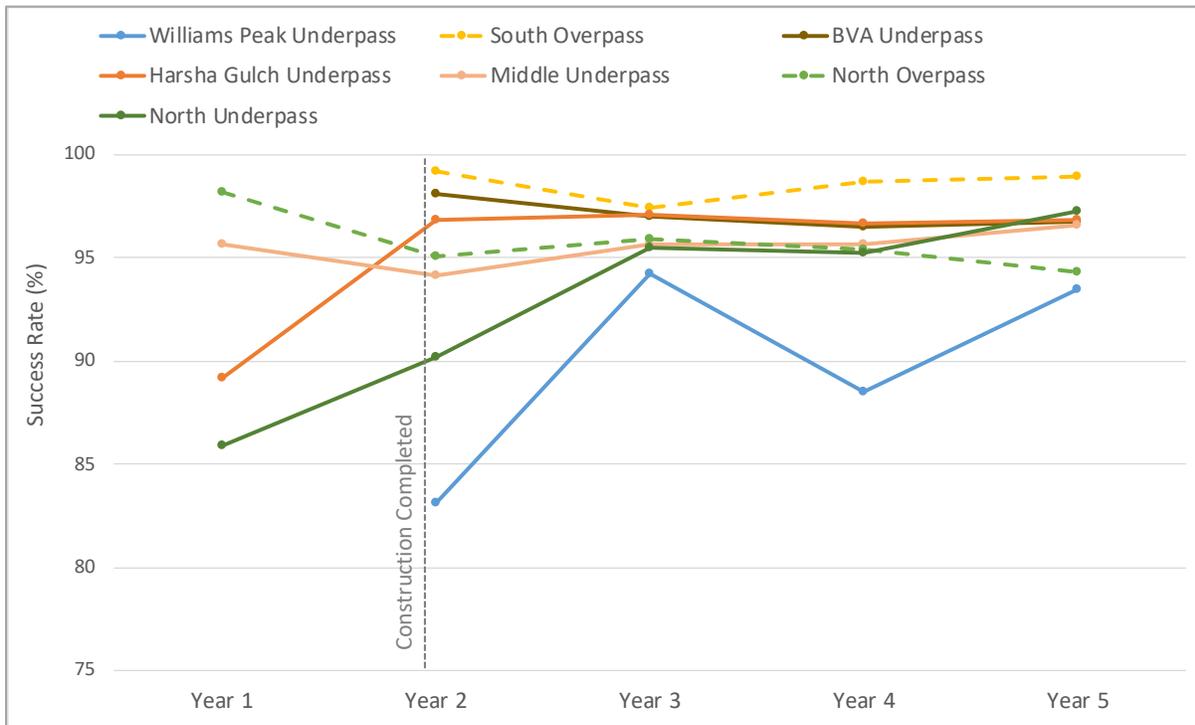
Figure 3-4. Mule Deer success rates at each of the crossing structures each year of the study.

The overall success rate for mule deer across all of the crossing structures was 96%. Success rates ranged from 83% (Williams Peak Underpass, Year 1) to 99% (South Overpass, Years 2, 4 & 5), and tended to increase over time at each crossing location (Fig. 3-4). In the final year of the study mule deer success rates ranged from 94% to 99%. While a small decrease in success rate was observed at the North Overpass in Year 5, this decrease was not significant, and across all years of the study the success rate at this location was 94% or greater. Both overpasses, the BVA Underpass, and the Middle Underpass had success rates around 95% or higher throughout the time that they were monitored. At the remaining underpass structures, success rates were lowest in the first year of monitoring and increased in the second year. The greatest variability in success rate was observed at the Williams Peak Underpass, which had the highest repel rate (7.5%). The number of parallel movements relative to the total number of approaches was greatest at the North Underpass, the Middle Underpass, and the BVA Underpass. In general, parallel movements represented a small proportion of the overall activity at the crossing structures.

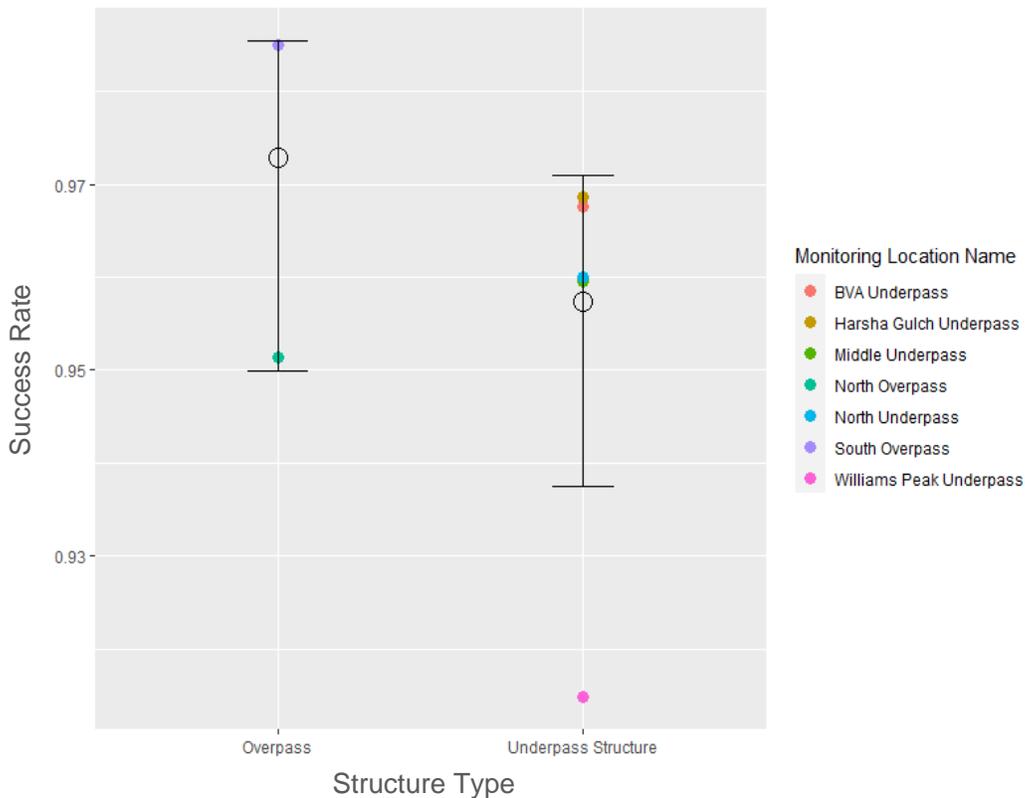
Figure 3-6. Mean mule deer success rate (open circle) and standard deviation by crossing structure type.

Statistical investigations into the differences in success rates between overpasses and underpasses were conducted. An analysis of deviance (Type II Wald chi square tests) of the overall post construction mean success rate for overpasses (97%) was not shown to be different from the mean success rate of underpasses (96%; $p=0.233$; Fig. 3-6). A gender-based preference for overpasses or underpasses based on buck and doe success rates could not be determined, but in the final three years of the study, bucks and does used overpasses (55% and 65%, respectively) more than underpasses.

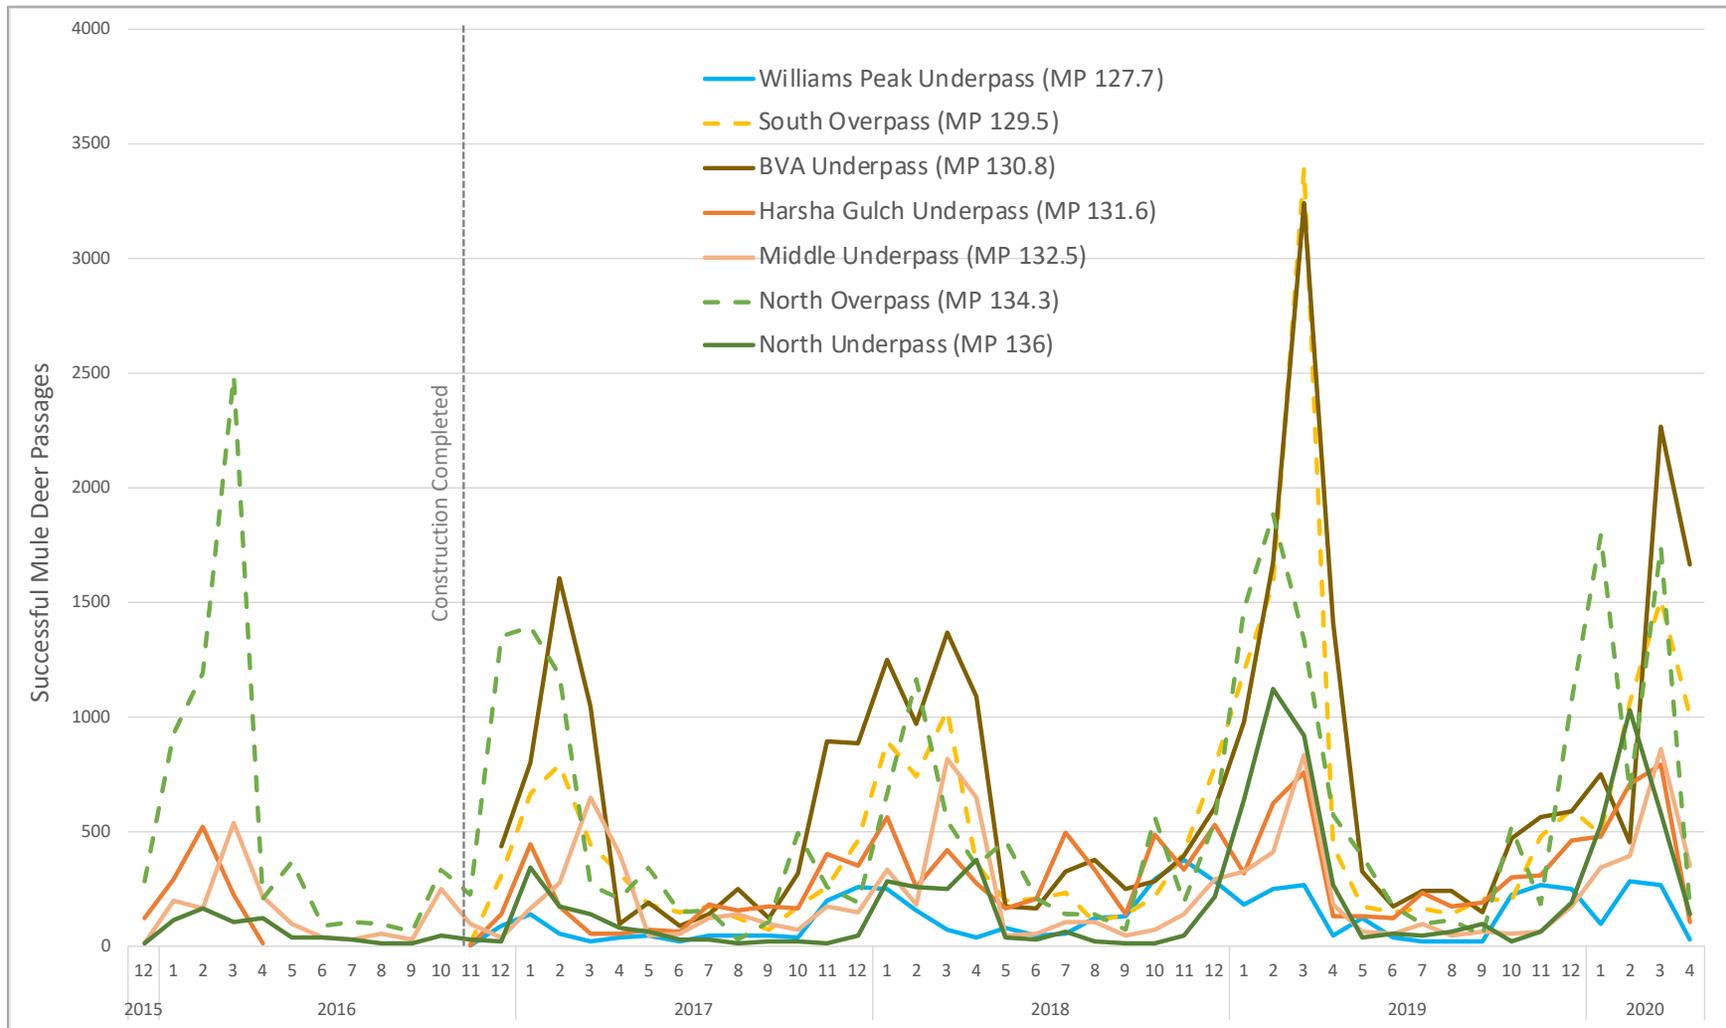
Figure 3-7. Mule deer successful passages by month and year at each of the wildlife crossing structures over the five-year study period.

Successful passages by mule deer at the wildlife crossing structures were plotted for each month from the onset of the camera monitoring in December 2015 through April 2020 (Fig. 3-7). Periods of peak mule deer use differed at each crossing structure location and varied from one year to the next. In general, mule deer numbers began increasing in October as migratory herds arrived on winter range and decreased in April as these herds moved out of the study area onto summer range. Mule deer activity generally peaked in February or March at all crossing structures, although the timing of these peaks varied from year to year and by location. Winter 2018-19 saw the greatest number of successful passages at all of the crossing structures except the Middle Underpass where the number of successful passages decreased slightly (-7%).

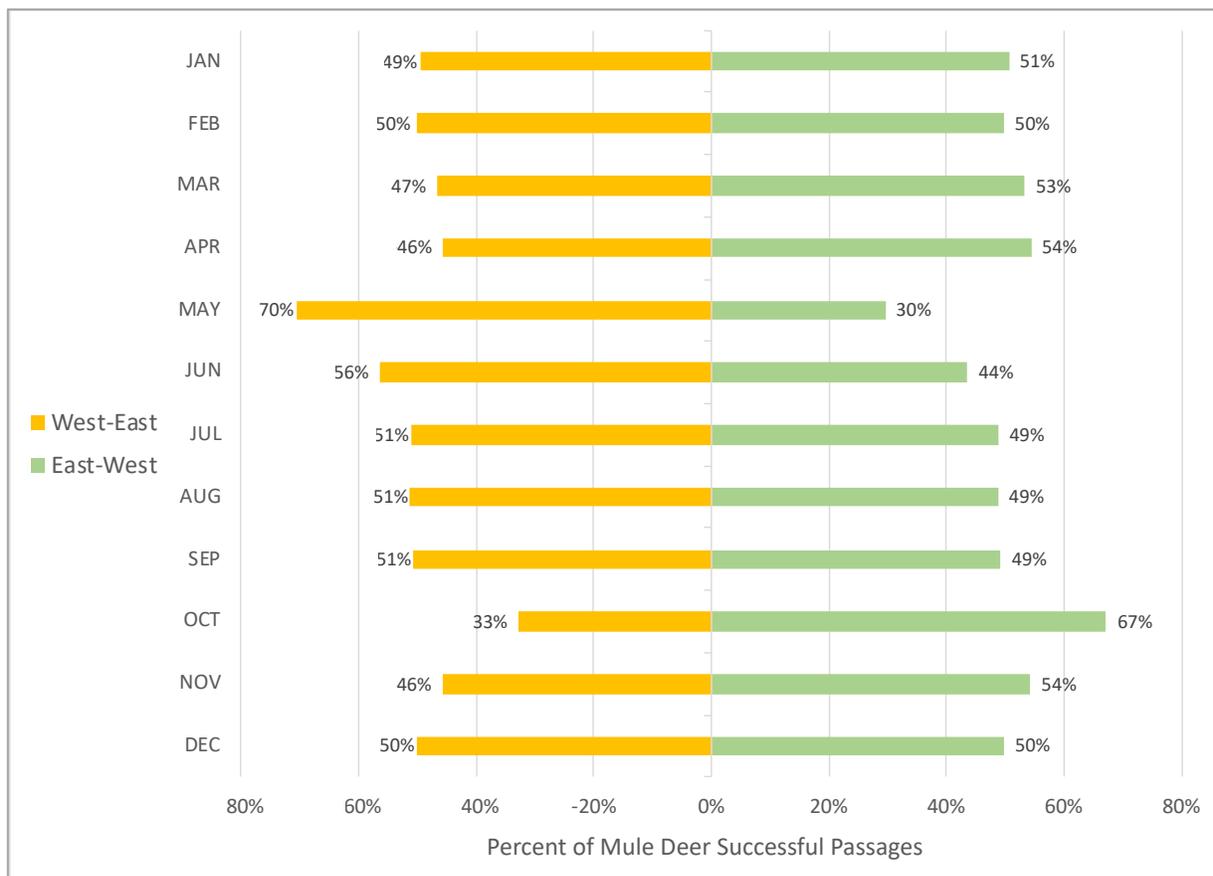
Figure 3-8. Direction of origin of mule deer successful passages by month of the year (Years 1-5).

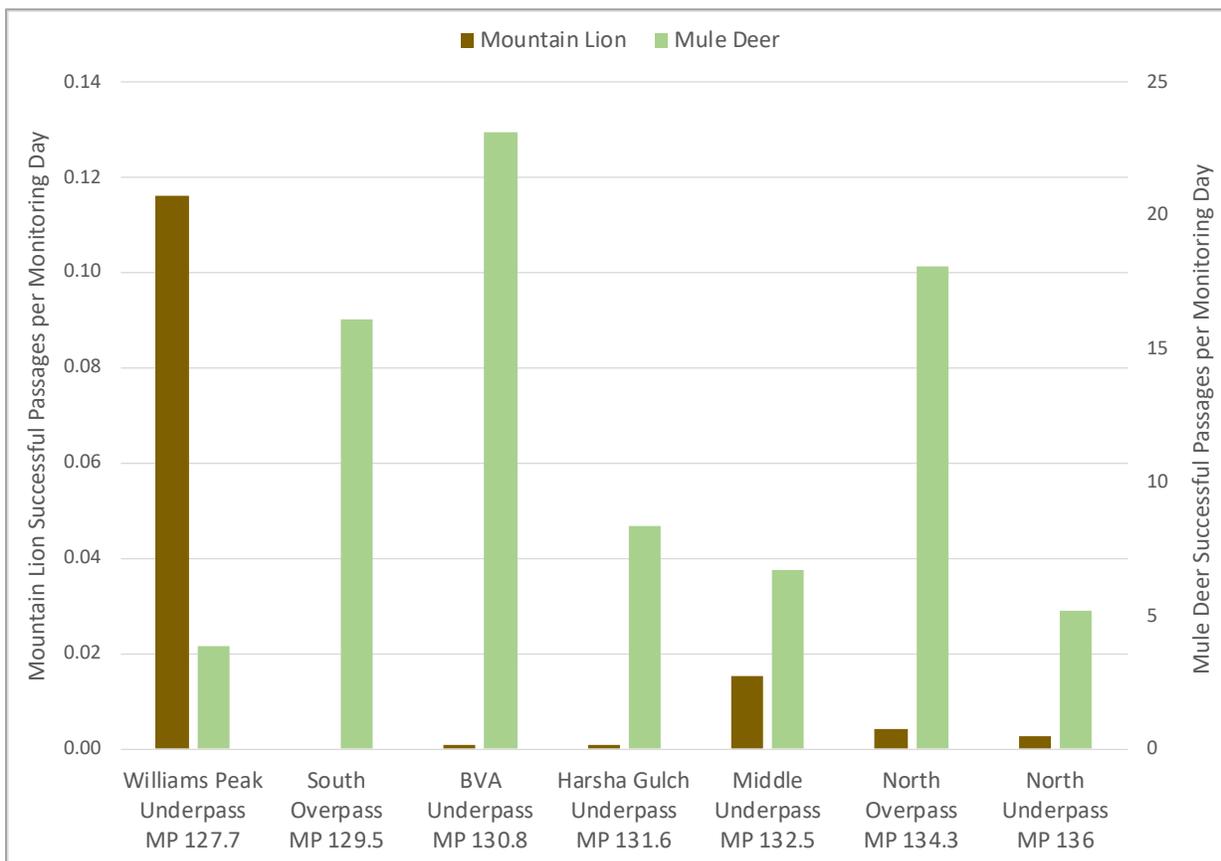
Figure 3-12. Mountain lion and mule deer successful passages per monitoring day at each crossing structure.

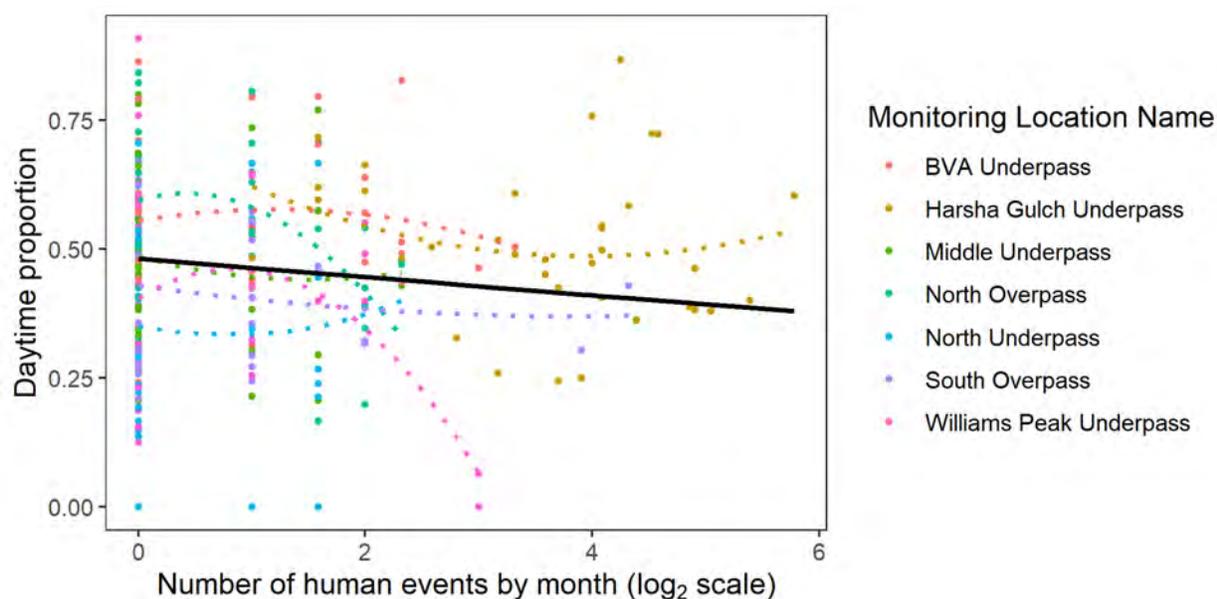
Figure 3-13. Proportion of mule deer successful passages occurring during the daytime relative to the number of human events at crossing structures. Each observation represents one month in the 3 post construction years (36 observations for each location). The dotted lines are smoothed curves fit to the data for each location, demonstrating location-specific relationships. The black line depicts the statistical regression of the number of successful passages during the day relative to the total number of successful passages on the number of human events.

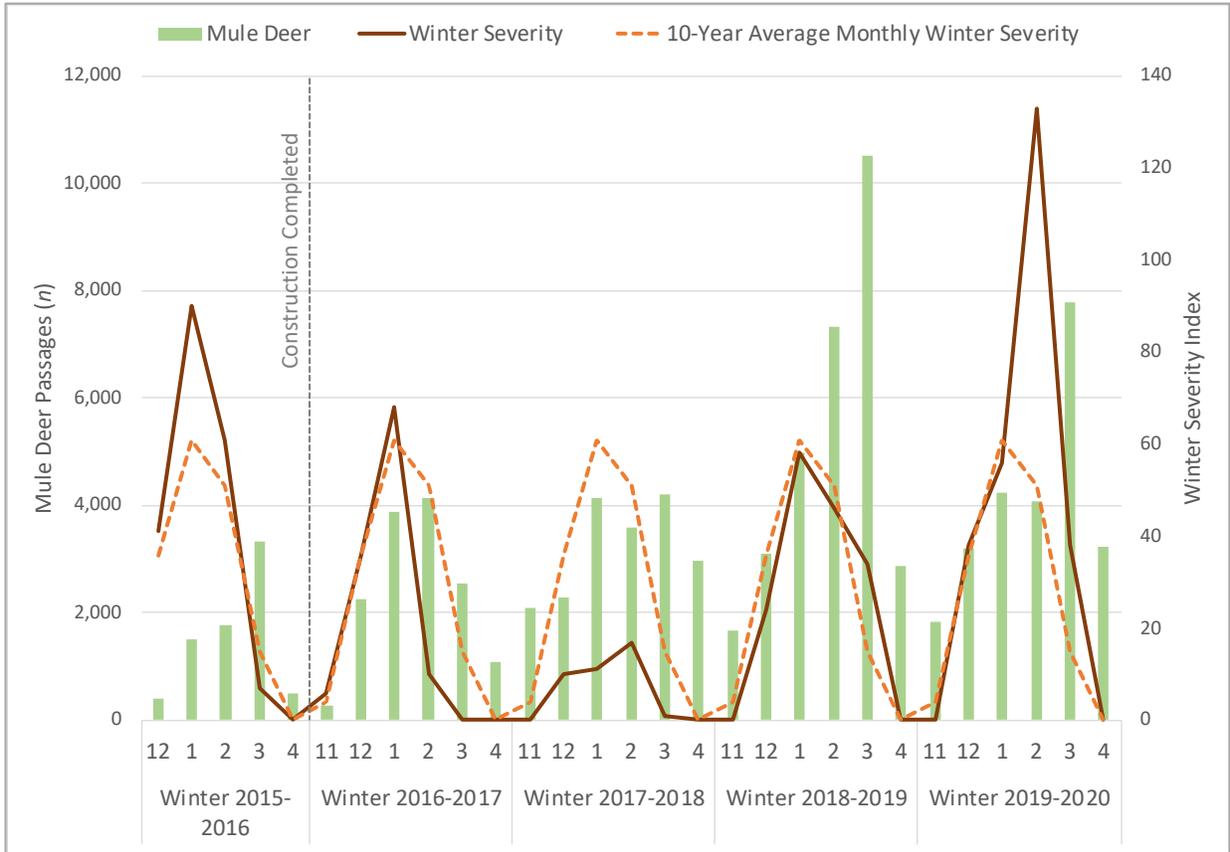
Figure 3-14. Comparison of mule deer successful passages, annual winter severity, and the ten-year average winter severity by winter month (November through April). Winter severity is an index based on weekly temperatures and snow depth.

The number of mule deer successful passages per winter month was analyzed with respect to monthly winter severity to help illuminate if there was a relationship between mule deer successful passages and snow depth and temperatures. CPW’s winter severity index was based on weekly measurements of temperature and snow depth at established transects (Birch 2020). The weekly indices were averaged by month for comparison to monthly winter mule deer passages at crossing structure (Fig. 3-14). A range of winter conditions were observed following the completion of construction activities, including two average winters (Winters 2016-2017 and 2018-2019), one mild winter (Winter 2017-2018), and one severe winter (Winter 2019-2020). In general, the month with the most severe winter conditions (January/February) was followed by the month with the highest number of mule deer passages. The number of mule deer passages (Fig. 3-15) peaked in Winter 2018-2019, while winter severity peaked in Winter 2019-2020, during which there was a relative decrease in the number of mule deer movements.

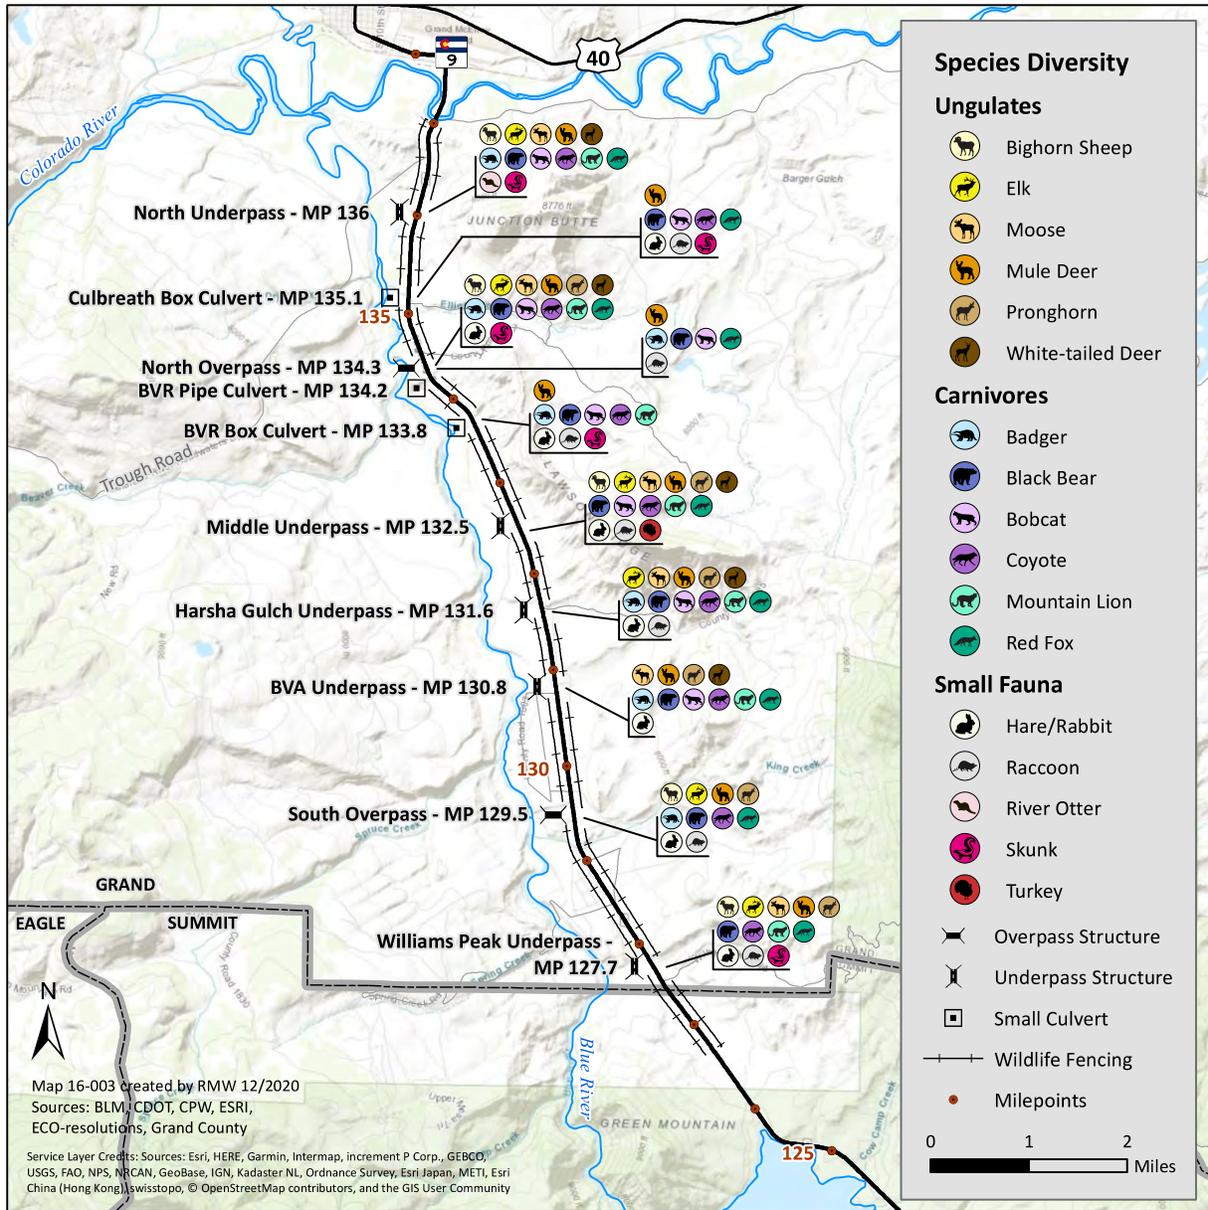
Figure 4-1. Diversity of species that made successful passages at each wildlife crossing structure and small culvert over the five-year study period.

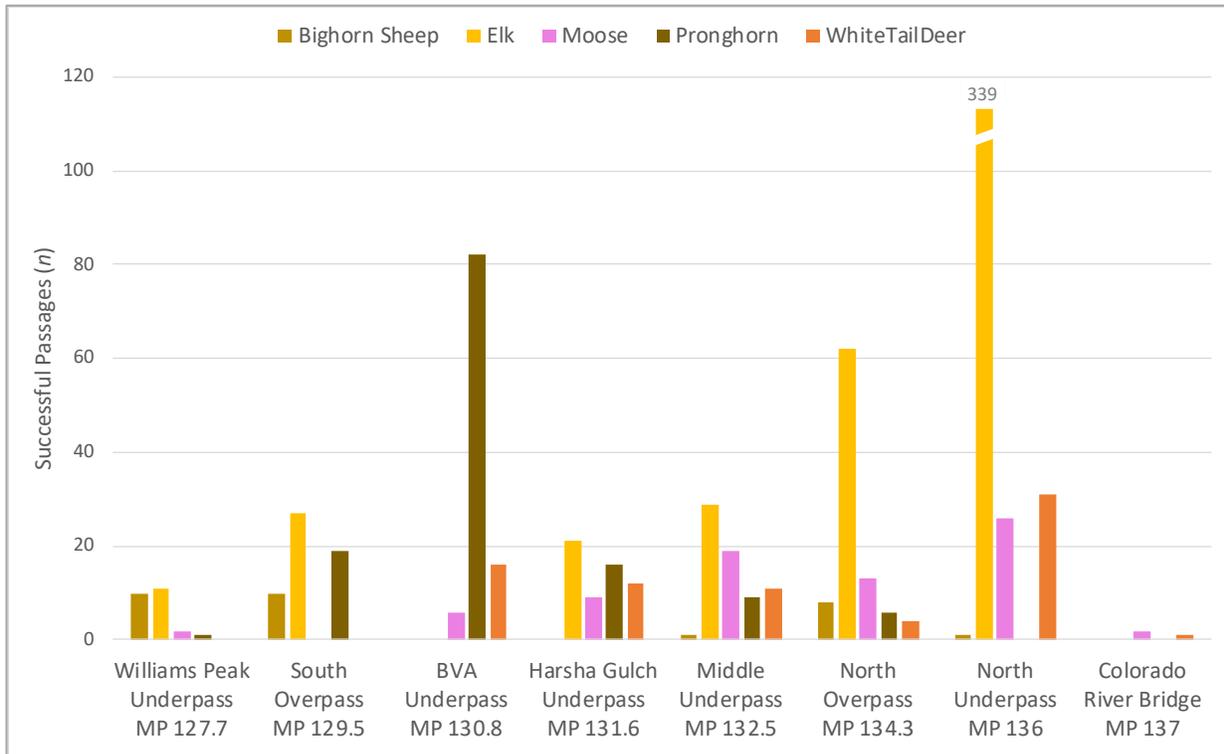
Figure 4-2. Successful passages at each wildlife crossing structure location and existing bridge for bighorn sheep, elk, moose, pronghorn, and white-tailed deer during the five-year study. The number of monitoring days at the Colorado River Bridge was one-fourth that of the other locations.

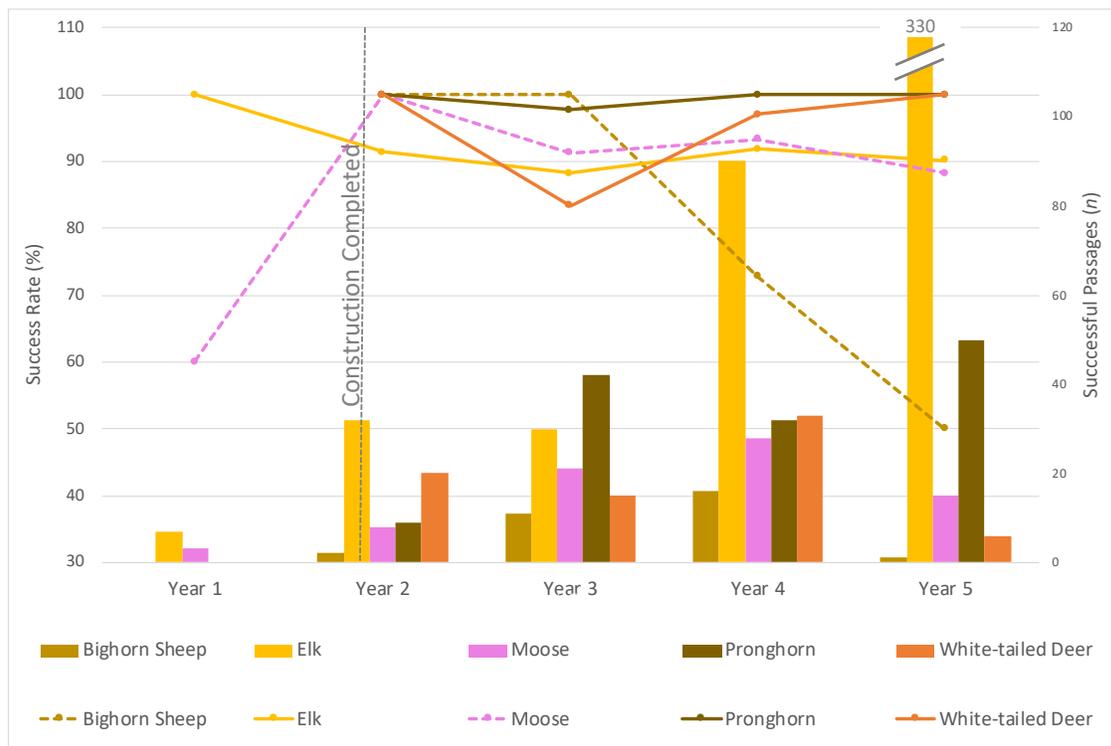
Figure 4-3. Number of successful passages by ungulate species other than mule deer and species success rates at the combined crossing structures each year of the study. Monitoring Year 1 only included the winter season (November – April). Monitoring during the summer months of Year 2 was limited due to ongoing construction at crossing locations in both Phase 1 and Phase 2.

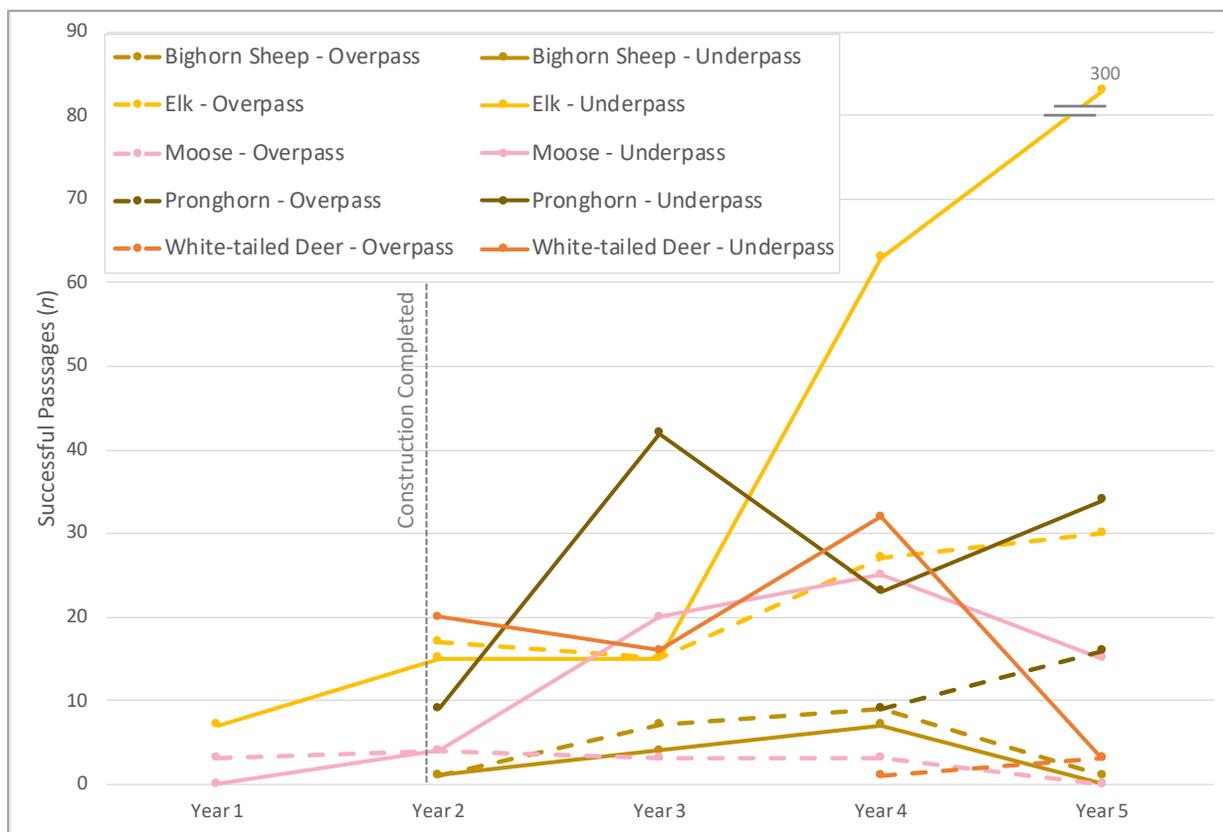
Figure 4-4. Ungulate use of overpasses and underpasses each year of the study.

Each ungulate species used both overpasses and underpasses over the course of the study in varying proportions (Fig. 4-4). Elk and moose were the only ungulate species other than mule deer to use the crossing structures in Year 1, which did not include a summer season. In Year 2, following the completion of construction, each ungulate species was observed at both underpasses and overpasses, except pronghorn and white-tailed deer, which were not documented at an overpass until Year 4. Many of these movements by the different ungulate species were by individual animals, pairs, or small family groups. The exception to this was elk in Years 4 and 5, which were increasingly documented in small herds at the North Underpass.

Elk passages at underpasses was greater than at overpasses but this was driven exclusively by movements at the North Underpass by what was presumed to be the same herd making more regular passages. Moose were also more commonly observed at underpasses but movements at both underpasses and overpasses were documented each year of the study, including during the construction phase (Year 1). The majority of pronghorn passages were males (79%) making solo movements or in pairs at underpass structures. Bighorn sheep passages at overpasses were consistently higher than at underpasses, with a 100% success rate at overpasses versus 63% at underpasses, but the total number of sheep passages was small ($n=30$). White-tailed deer visited the underpasses more than the overpasses and were not observed at all at the two southernmost structures in the study area (Williams Peak Underpass and the South Overpass).

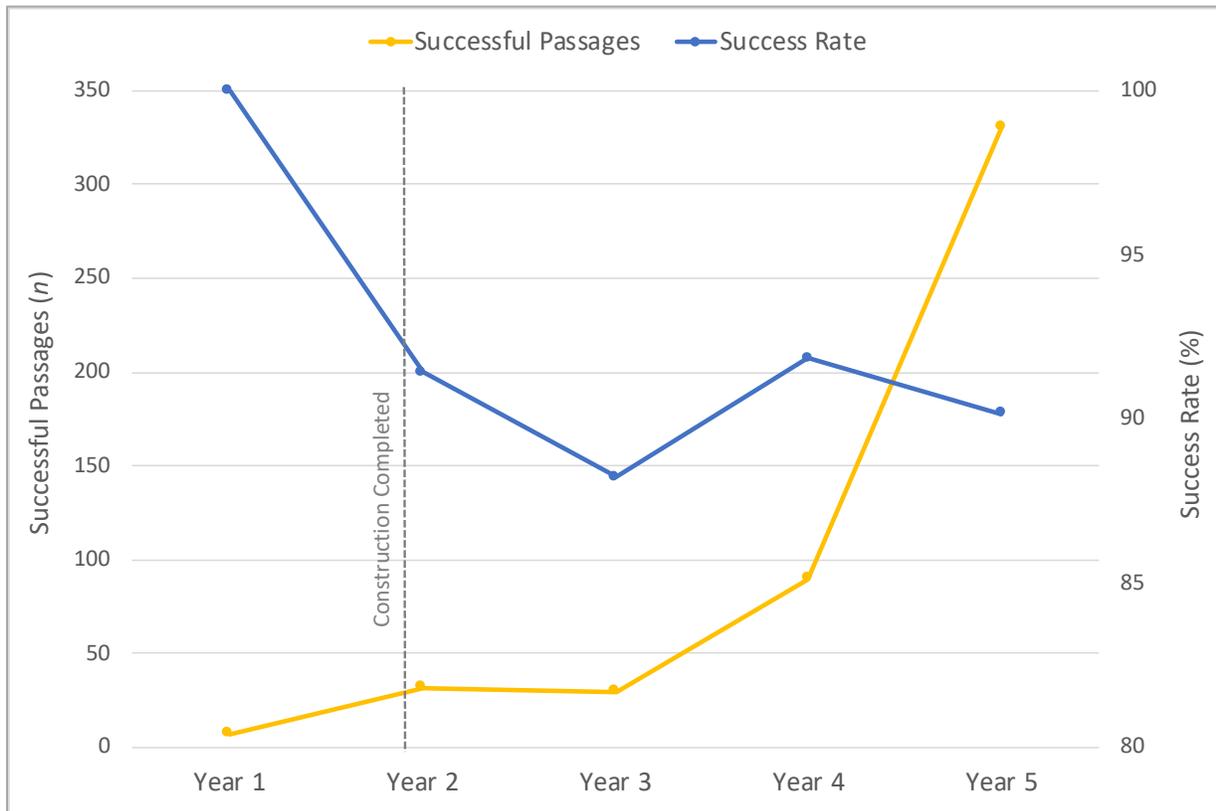
Figure 4-5. Number of successful elk passages and elk success rate at the combined crossing structures each year of the study. Monitoring Year 1 only included the winter season (November – April). Monitoring during the summer months of Year 2 was limited due to ongoing construction at crossing locations in both Phase 1 and Phase 2.
