State Highway 9 Wildlife Crossings Mitigation Monitoring

1. Report No. CDOT-2021-XX		2. Government Accession No.		3. Recipient's Catalog No.	
4. Title and Subtitle State Highway 9 Wildlife Mitigation Monitoring				5. Report Date March 2021

16. Abstract This research monitored the effectiveness of a wildlife mitigation project on State Highway 9 in Grand County, Colorado. The purpose of the mitigation was to reduce wildlife-vehicle collisions (WVC) while providing permeability for wildlife across the highway. This five-year study used motion activated cameras and analyses of WVC crash and carcass data to evaluate mitigation effectiveness. The research documented 112,678 mule deer successful passages and a success rate of 96% across the seven structures. In addition to mule deer, sixteen other wildlife species successfully used the crossing structures. The wildlife crossings and fencing mitigation helped decrease WVC crashes by 92% and carcasses by 90% relative to preconstruction levels. Implementation Initial findings of the study were used to inform mitigation designs in the second construction phase, resulting in the addition of new escape ramp and wildlife guard designs. The fi

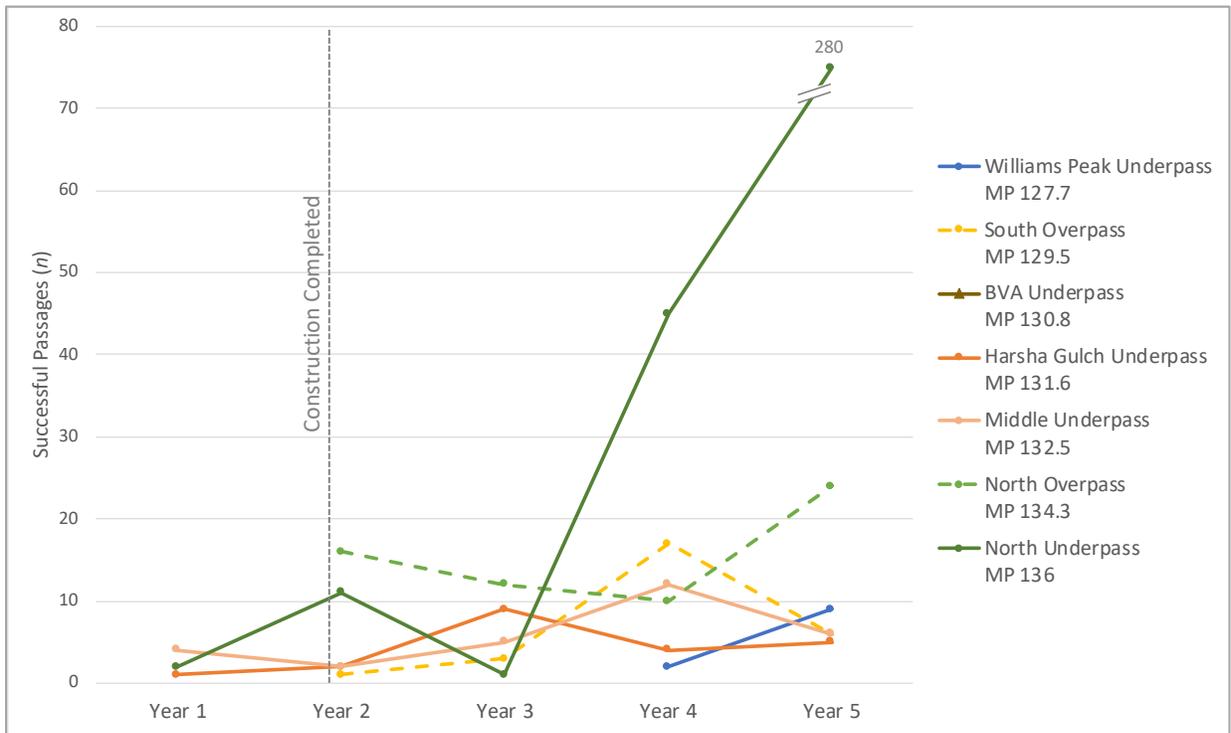
Figure 4-6. Number of successful passages by elk at each crossing structure location over the five-year study period.

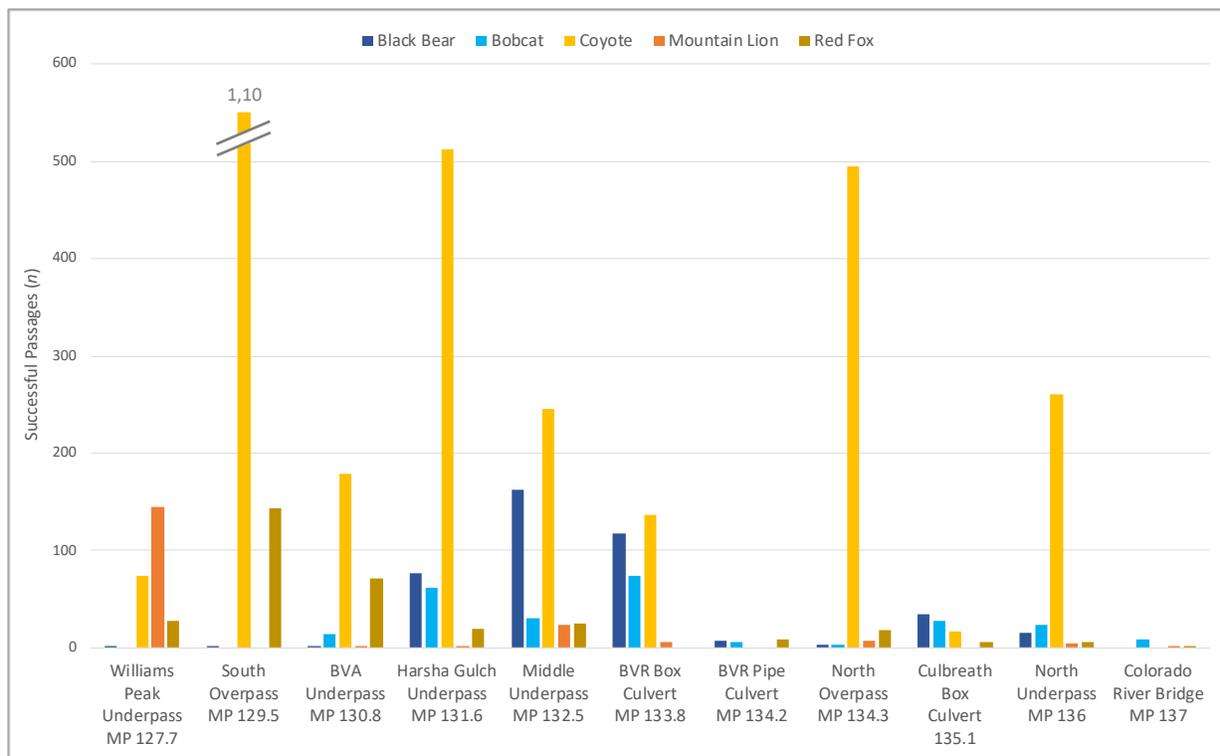
Figure 4-12. Successful passages by black bear, canids, and felids at wildlife crossing structures, small culverts, and the Colorado River Bridge.

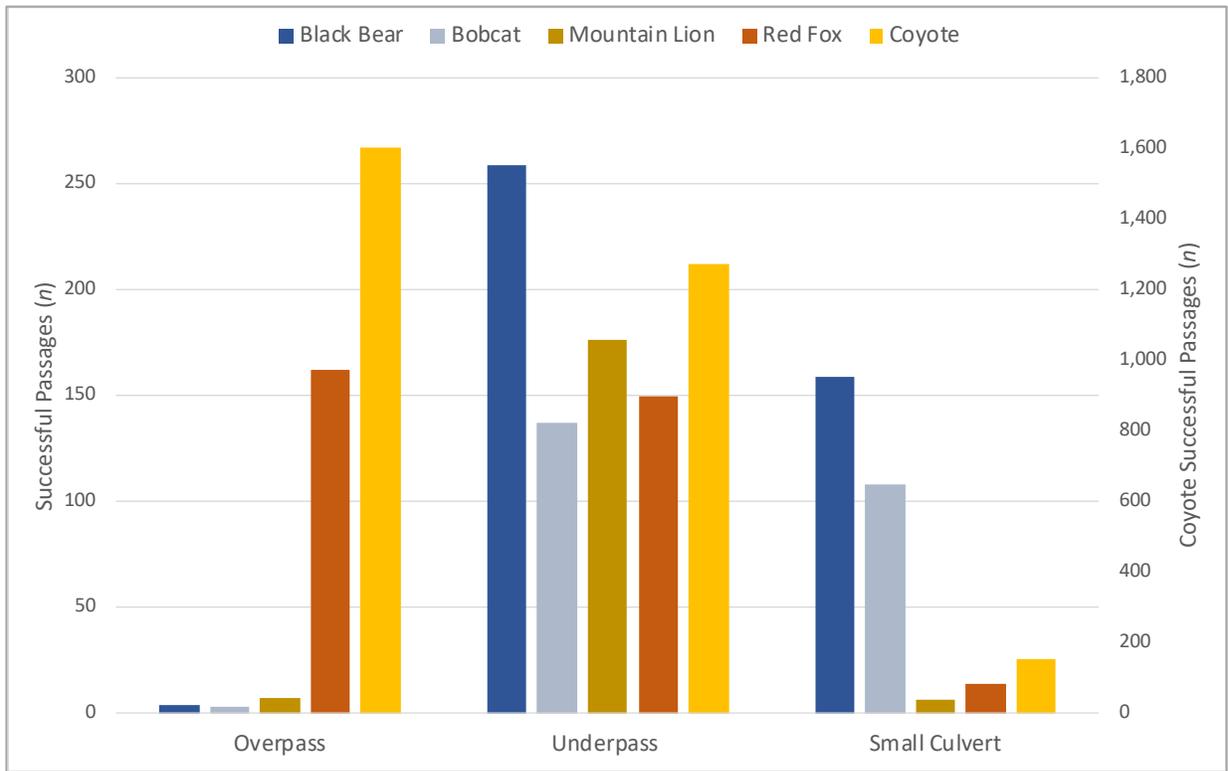
Figure 4-13. Total number of successful passages at overpasses, underpasses, and small culverts by black bear, bobcat, mountain lion, red fox, and coyote. Coyote was plotted on a secondary axis due to the large number of coyote passages.

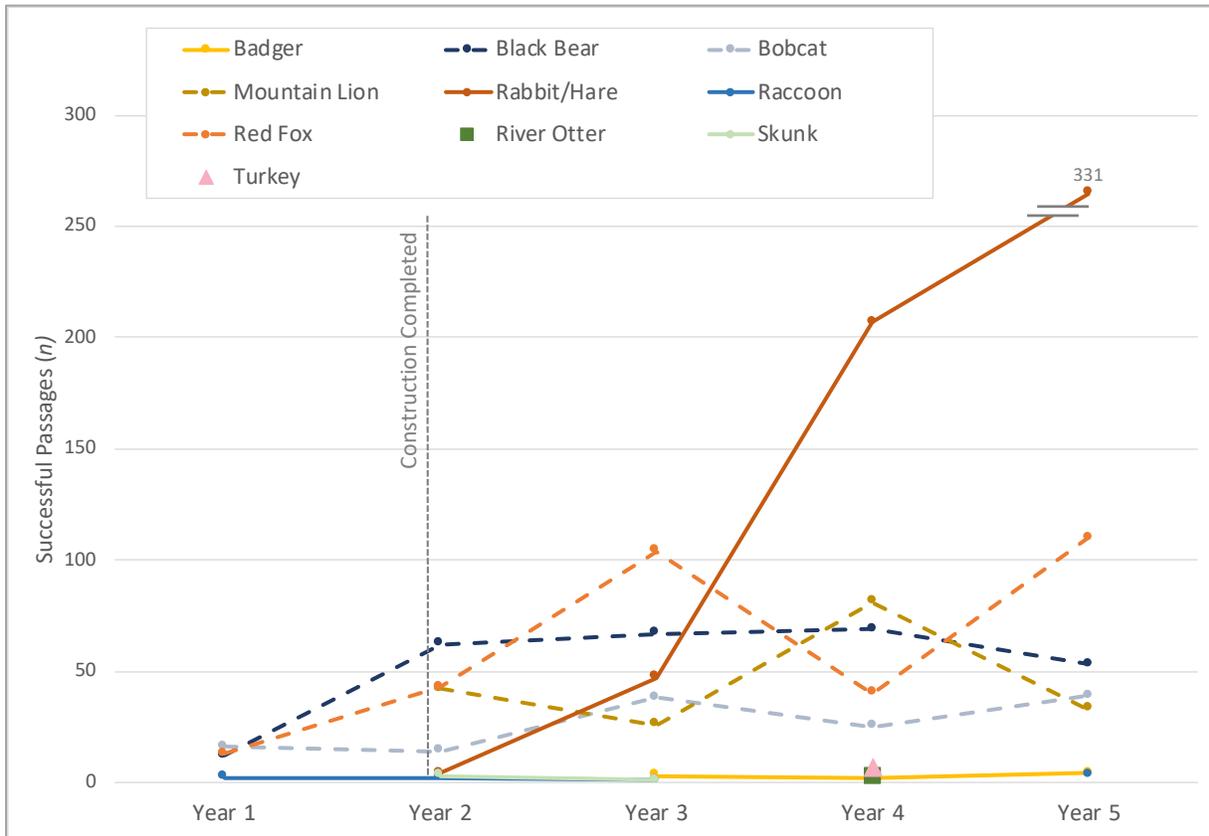
Figure 4-14. Number of successful passages by bears, canids, felids and small fauna at the combined crossing structures, small culverts and the Colorado River Bridge each year of the study. Coyote was excluded from the graph due to the large number of coyotes each year of the study. Monitoring Year 1 only included the winter season (November – April). Monitoring during the summer months of Year 2 was limited due to ongoing construction at crossing locations in both Phase 1 and Phase 2.

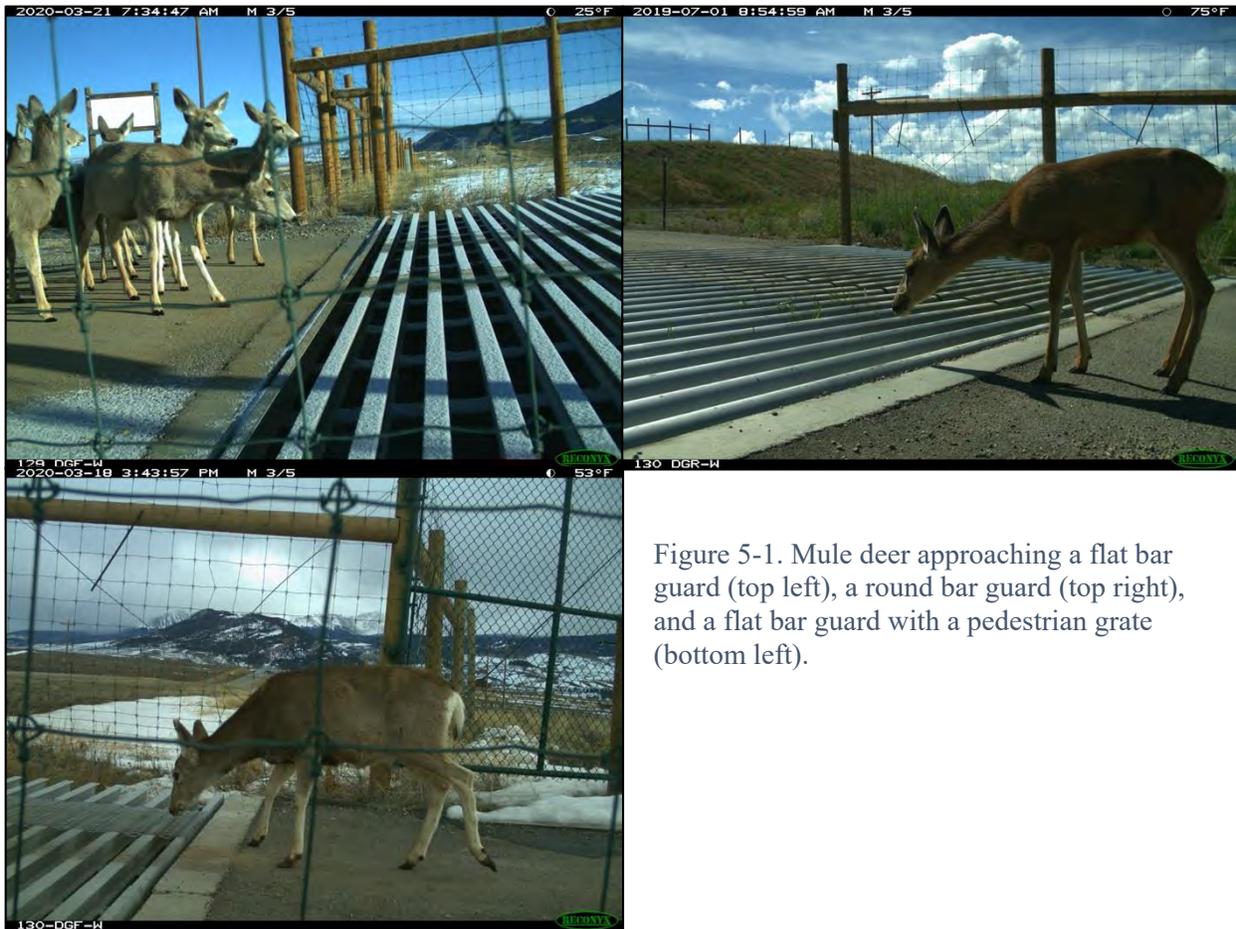
Figure 5-1. Mule deer approaching a flat bar guard (top left), a round bar guard (top right), and a flat bar guard with a pedestrian grate (bottom left).

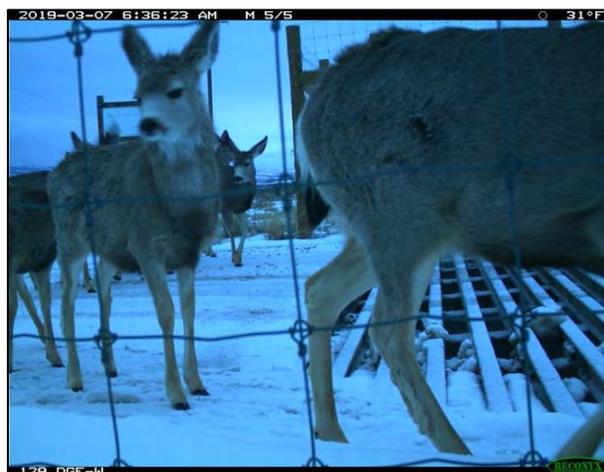
Figure 5-2. Mule deer breaching a wildlife guard by walking on snow packed in between the bars.

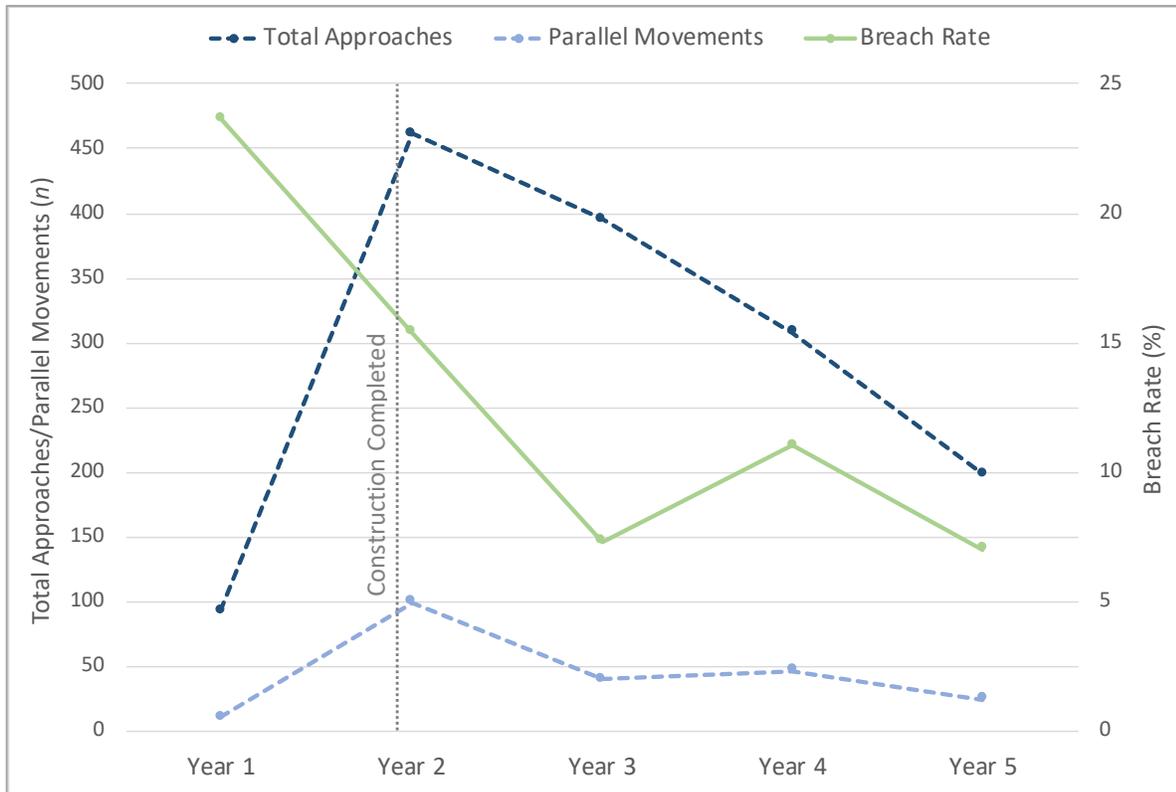
Figure 5-3. Total number of ungulate approaches, parallel movements and breach rate each year of the study.

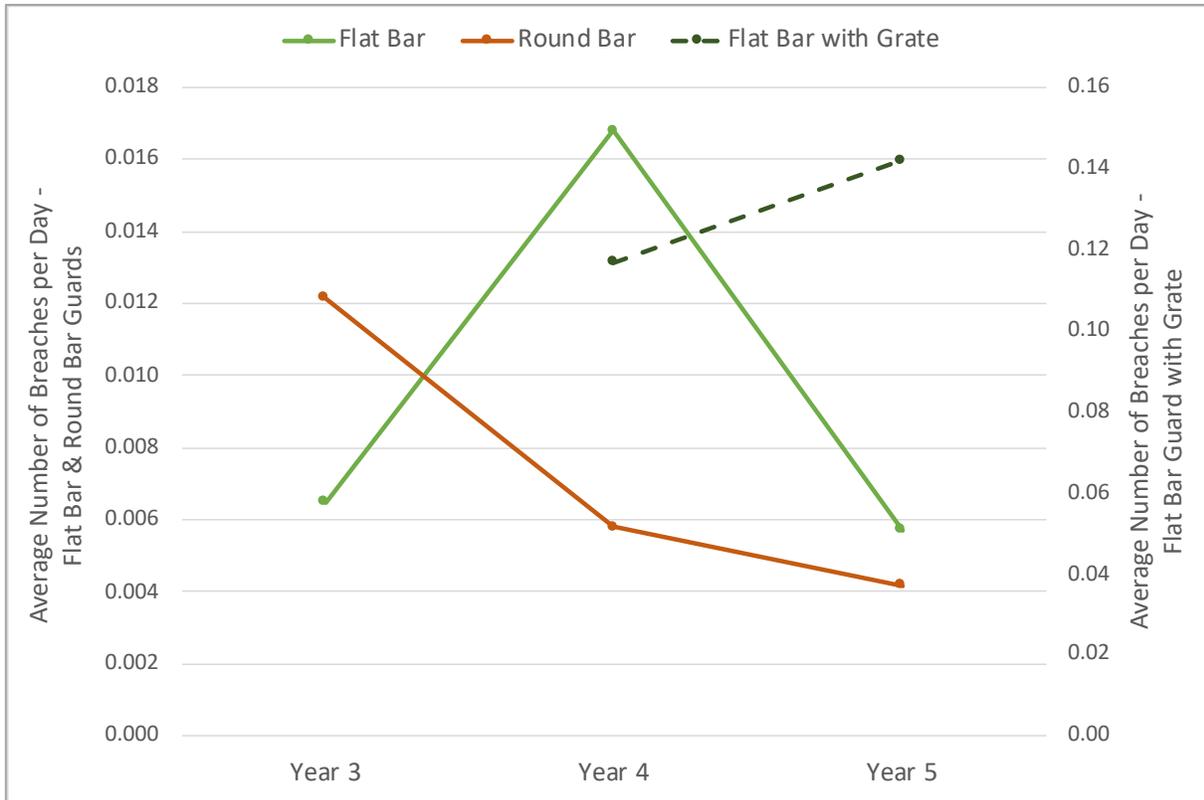
Figure 5-4. Average number of breaches per monitoring day by guard type Years 3-5. During this timeframe, six flat bar guards were monitored, five round bar guards, and one flat bar guard with a pedestrian grate.

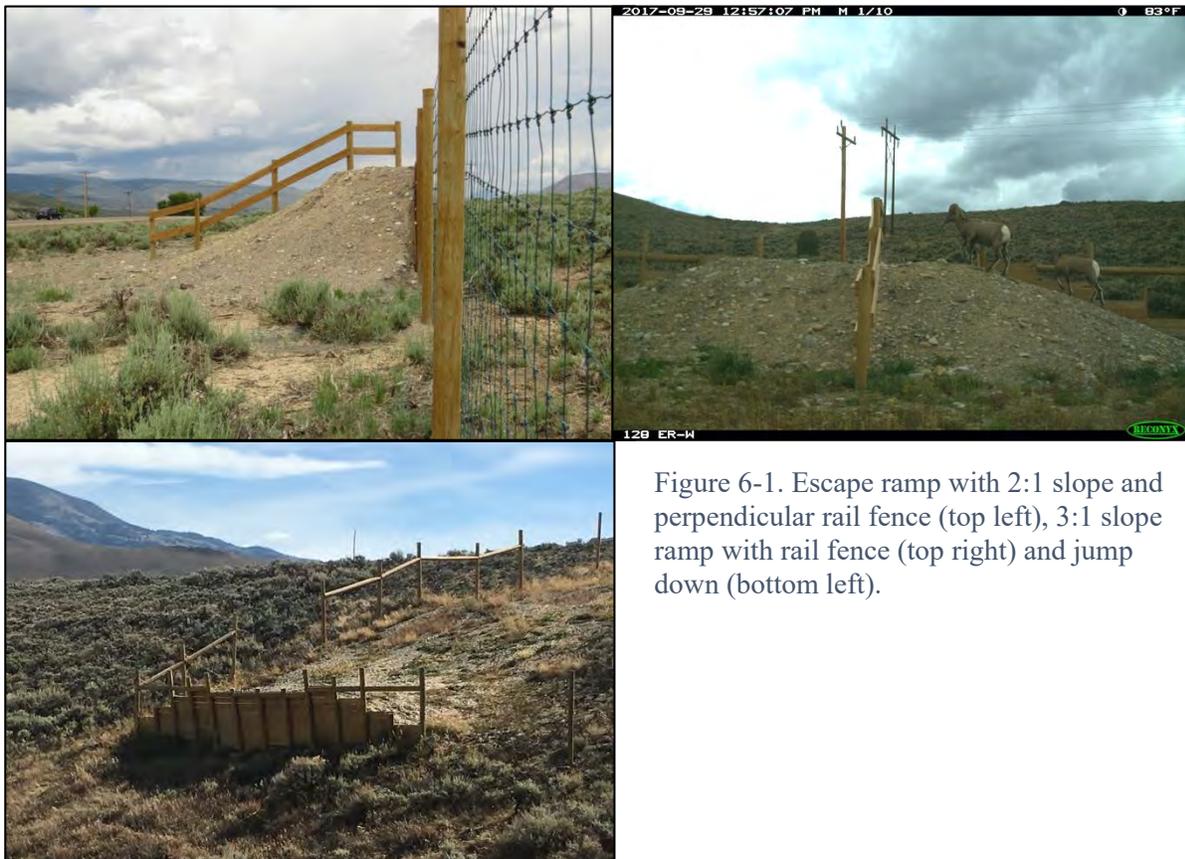
Figure 6-1. Escape ramp with 2:1 slope and perpendicular rail fence (top left), 3:1 slope ramp with rail fence (top right) and jump down (bottom left).

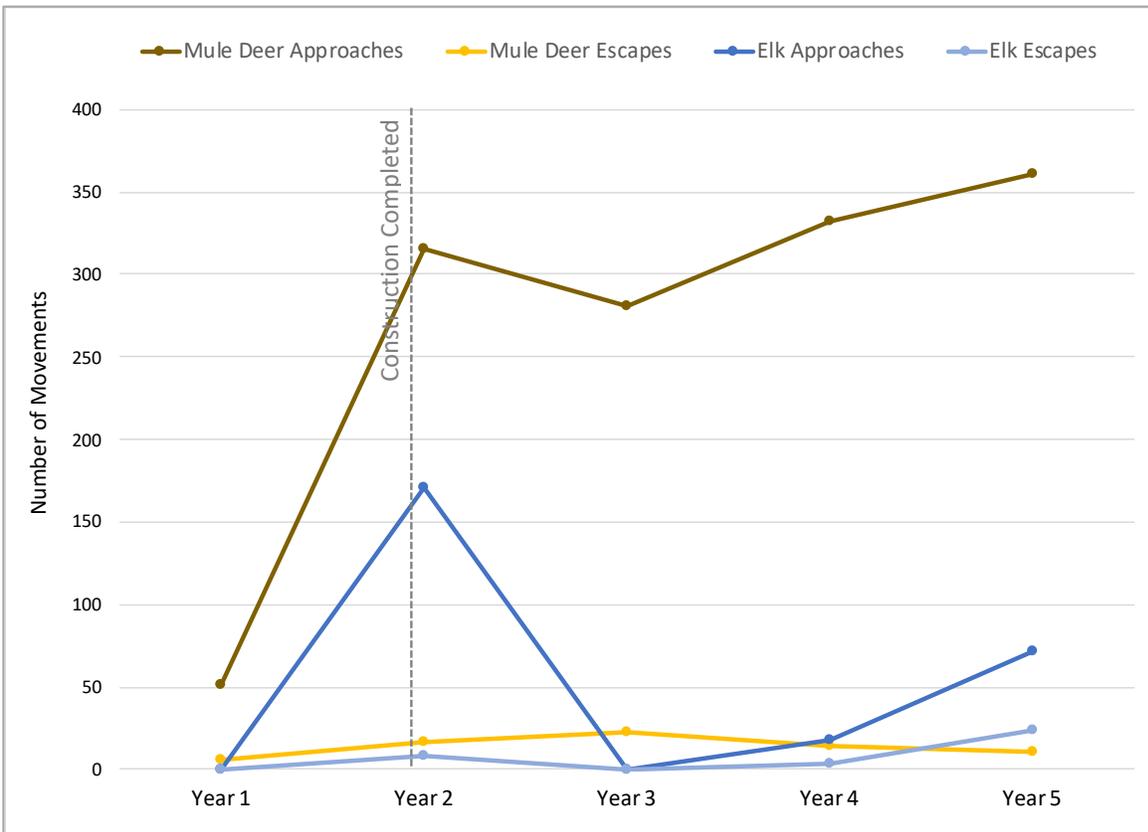
Figure 6-2. Elk and mule deer total approaches and successful escapes (jump downs) each year of the study.

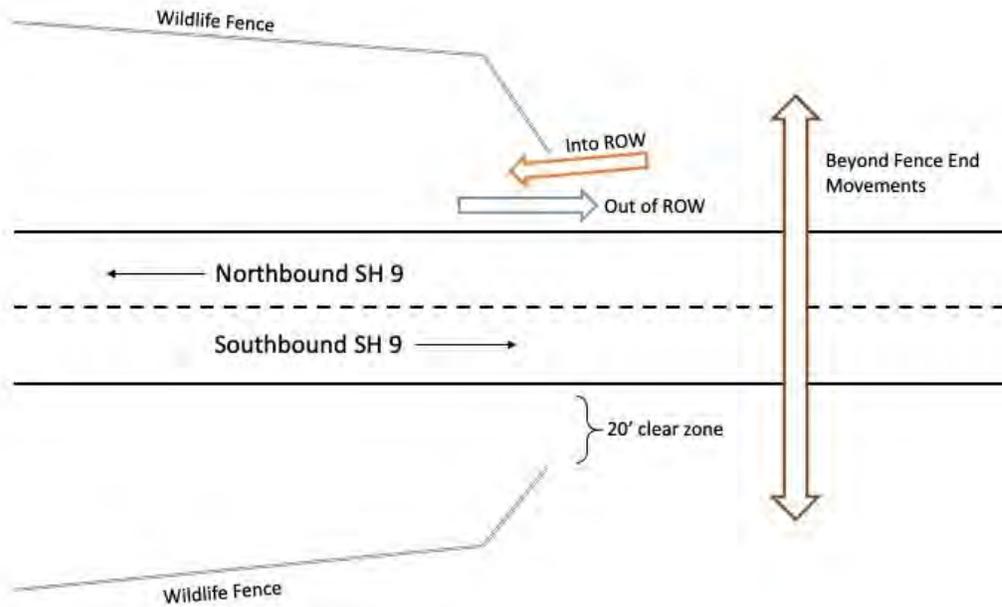
Figure 7-1. Diagram of types of the three types of wildlife movements at the south fence end.

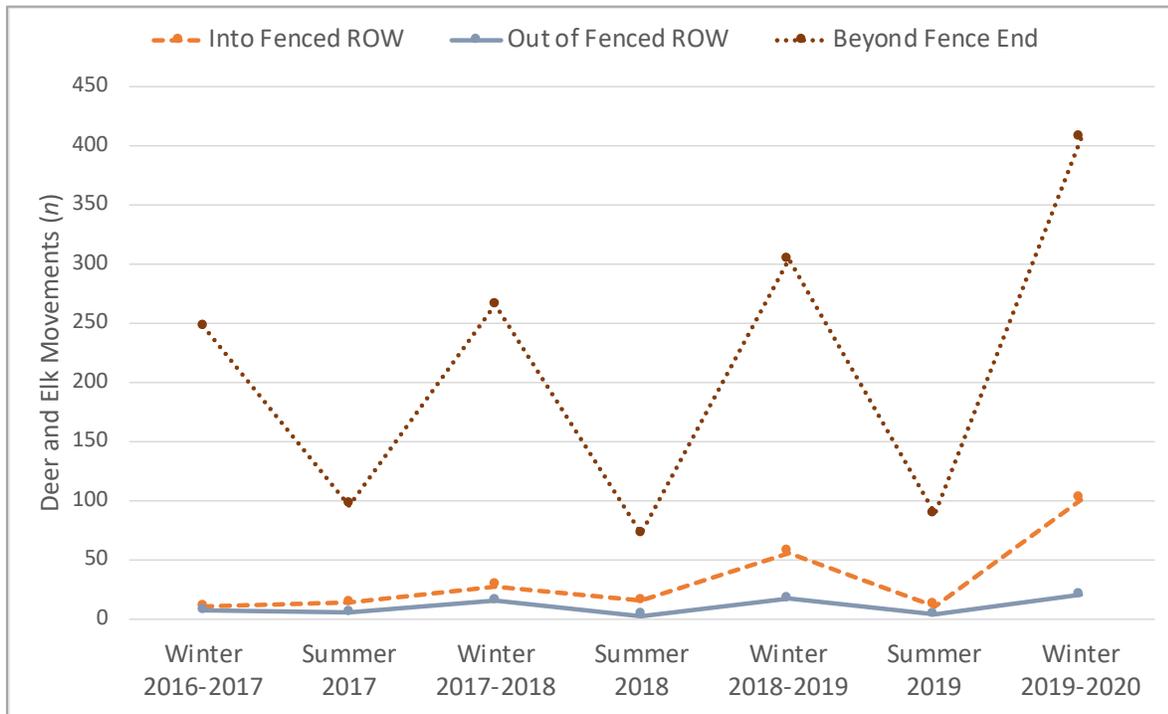
Figure 7-2. Three types of movements at the south fence end by deer and elk each season post construction.

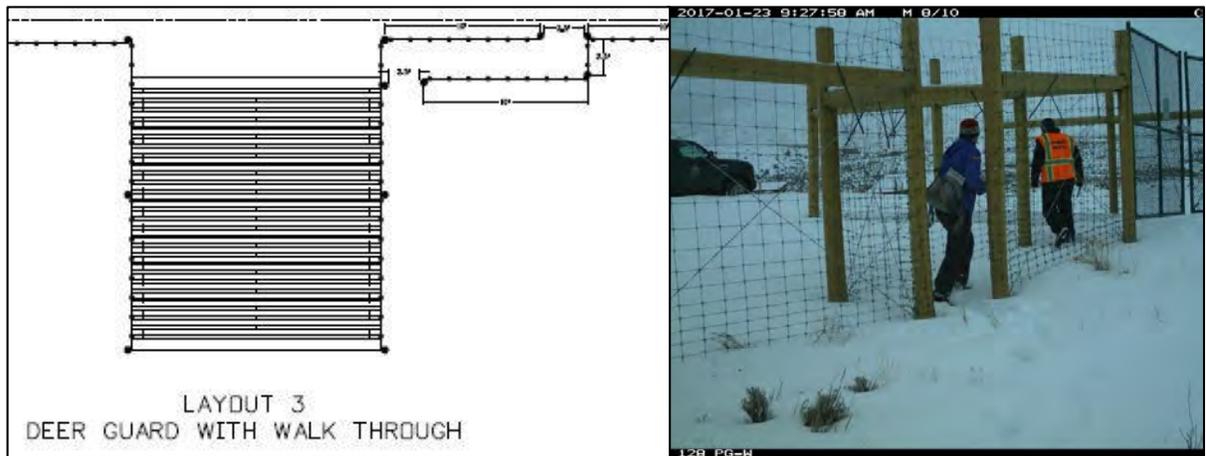
Figure 7-3. Left: CDOT design for pedestrian access point adjacent to a wildlife guard. Right: People walking through a pedestrian access point.

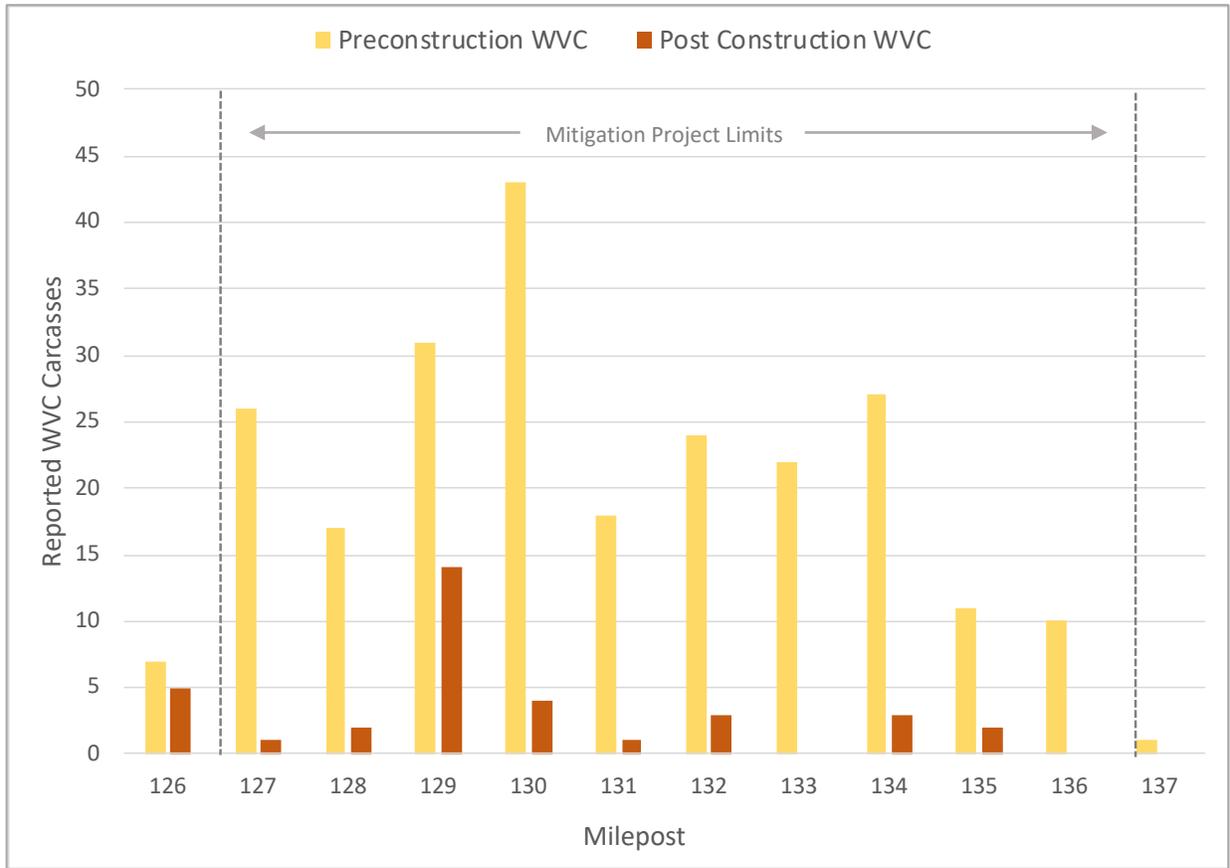
Figure 8-1. Distribution of BVR/CPW reported carcasses within the project area four years preconstruction (Winter 2011-2012 through Winter 2014-2015) and four years post construction (Winter 2016-2017 through Winter 2019-2020). Carcass data comparisons were curtailed to four years pre- and post construction due to the construction season from April 2015 through November 2016.

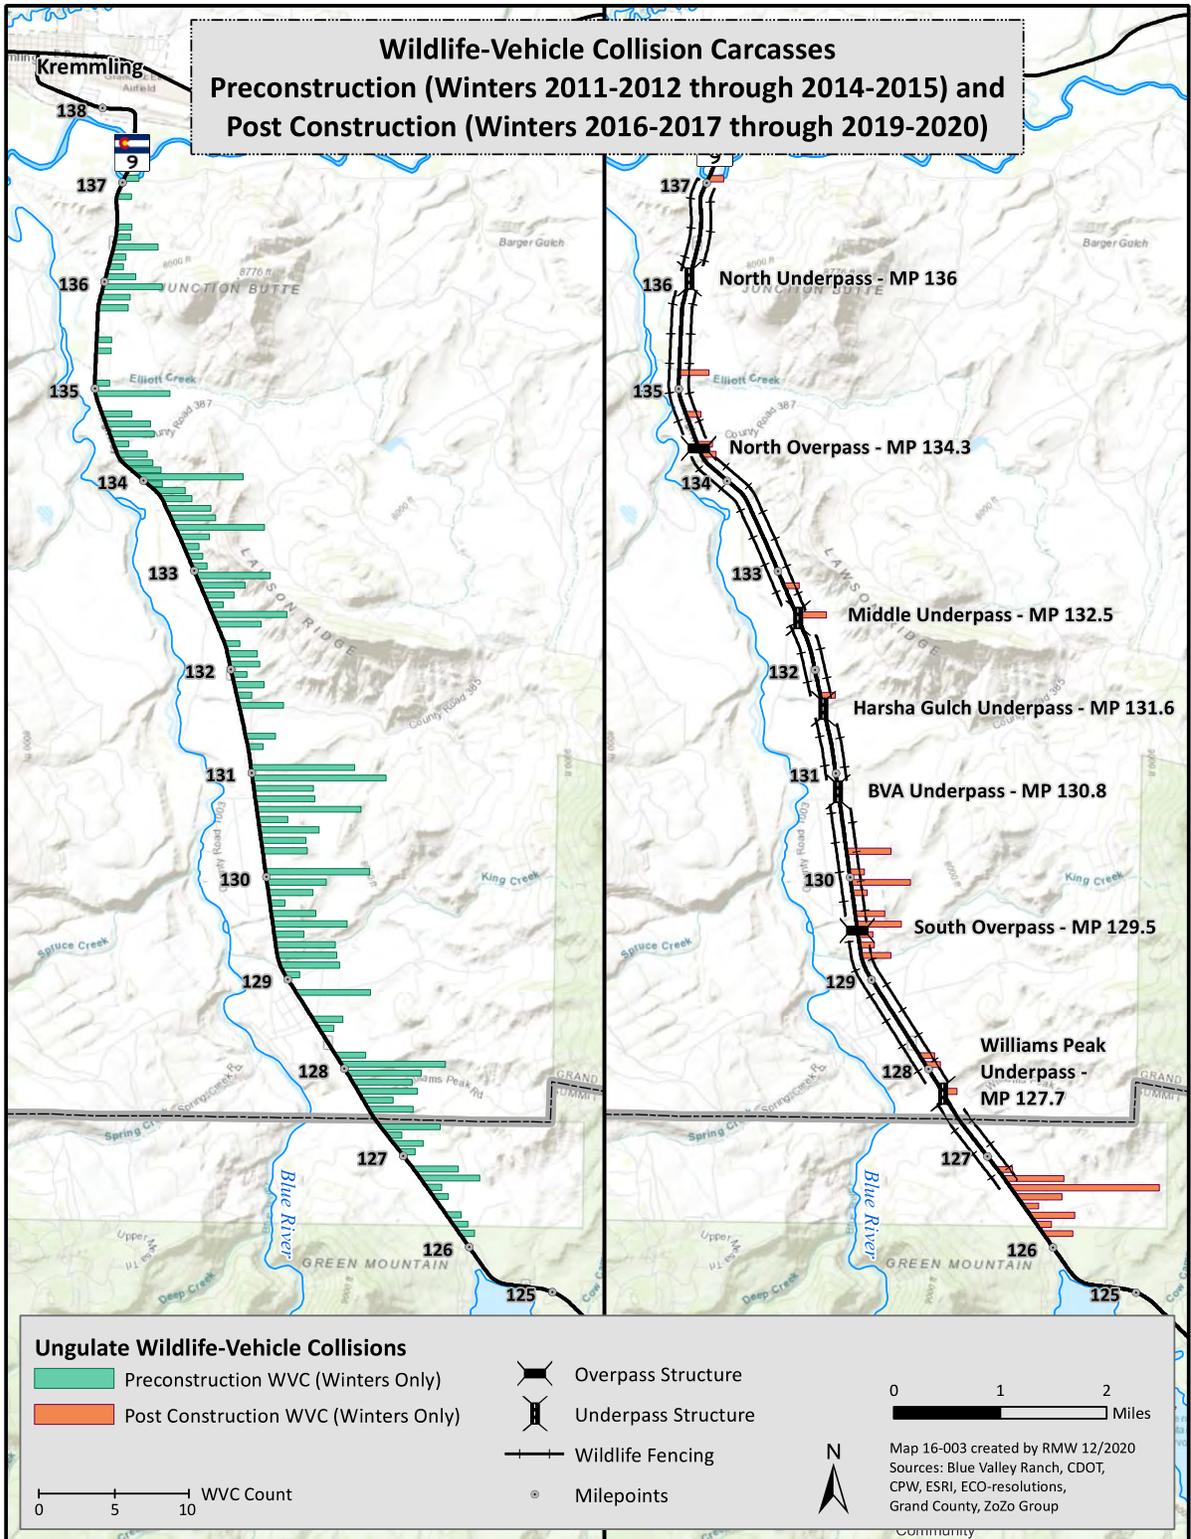
Figure 8-2. Map of the distribution of WVC carcasses reported by BVR/CPW four winters preconstruction (Winter 2011-2012 through Winter 2014-2015) and four years post construction (Winter 2016-2017 through Winter 2019-2020). Carcass data comparisons were curtailed to four years pre- and post construction due to the construction season from April 2015 through November 2016.

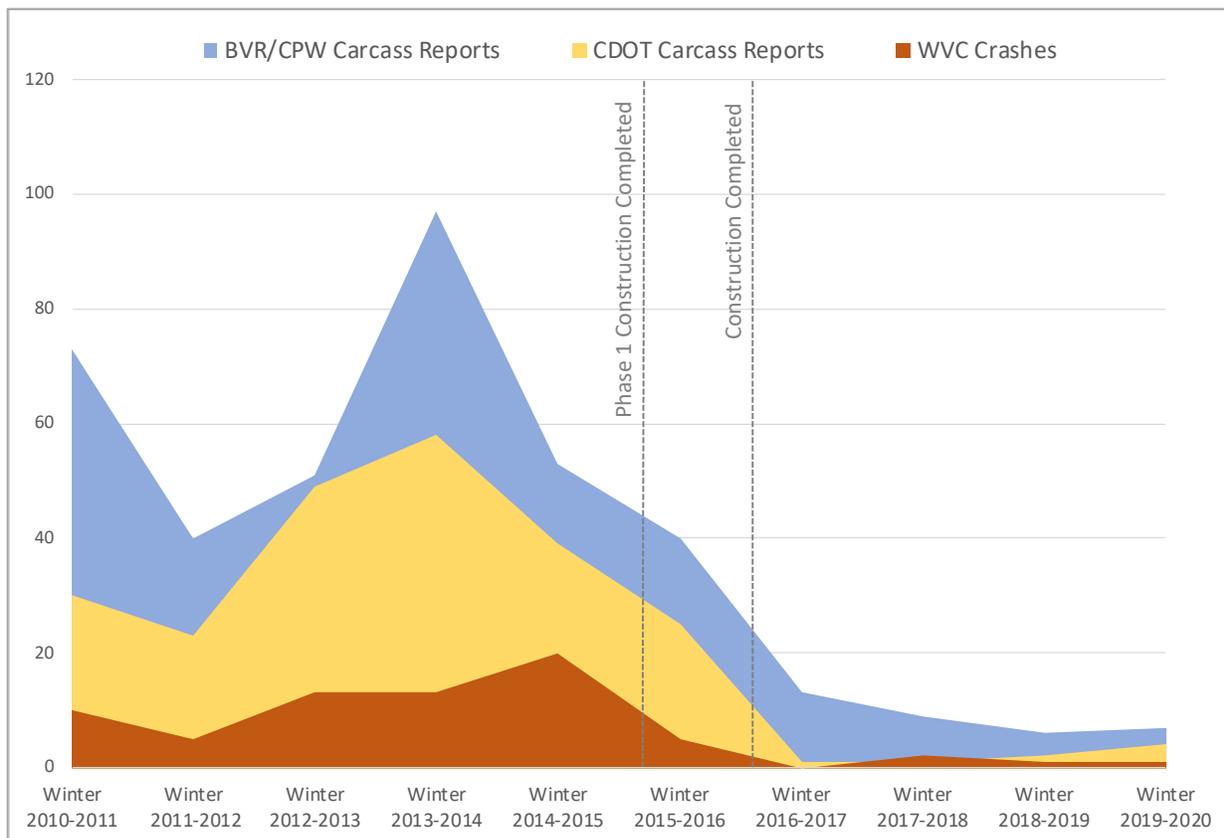
Figure 8-3. Pre- and post construction WVC carcasses and crashes reported each winter as documented by BVR/CPW carcass reports, CDOT carcass reports, and CDOT crash reports.

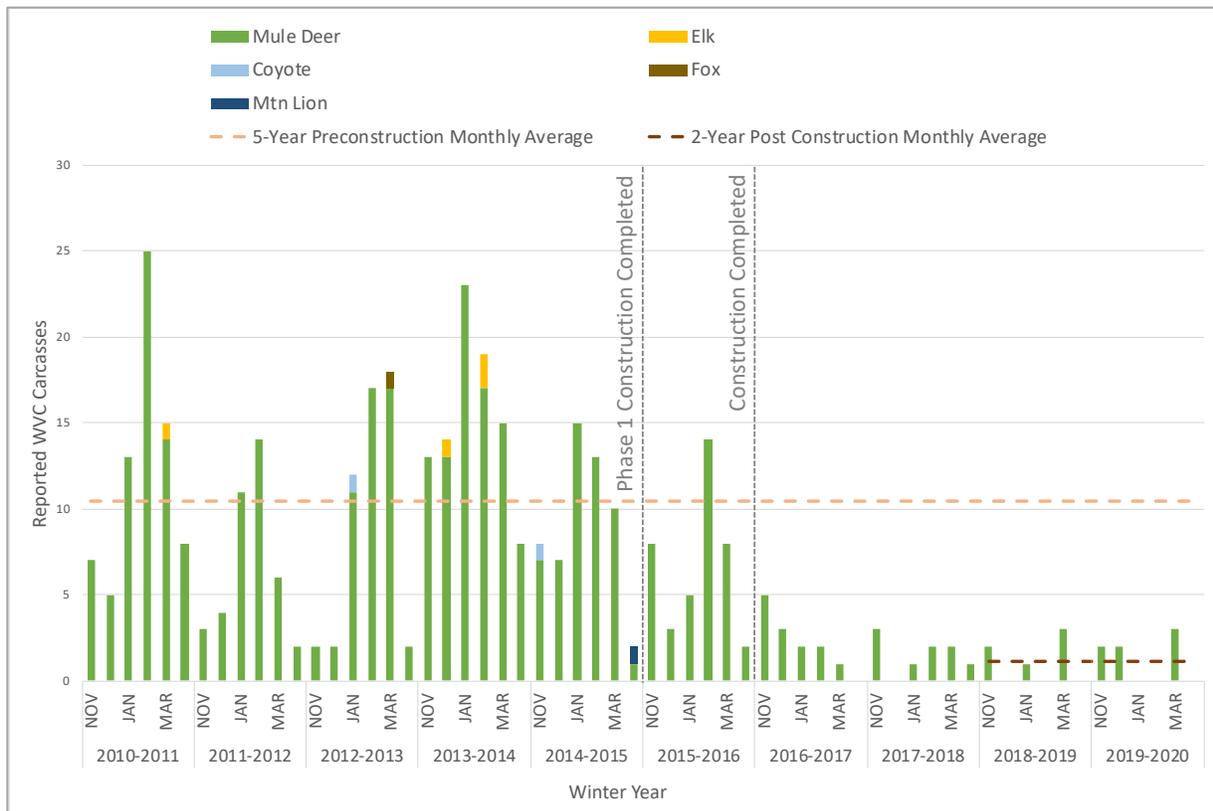
Figure 8-4. Monthly large mammal WVC carcass counts by species recorded by BVR/CPW during the winter months compared to the five-year preconstruction winter monthly average (10.4) and the final two-year post construction winter monthly average (1.1). Winter months include November through April.

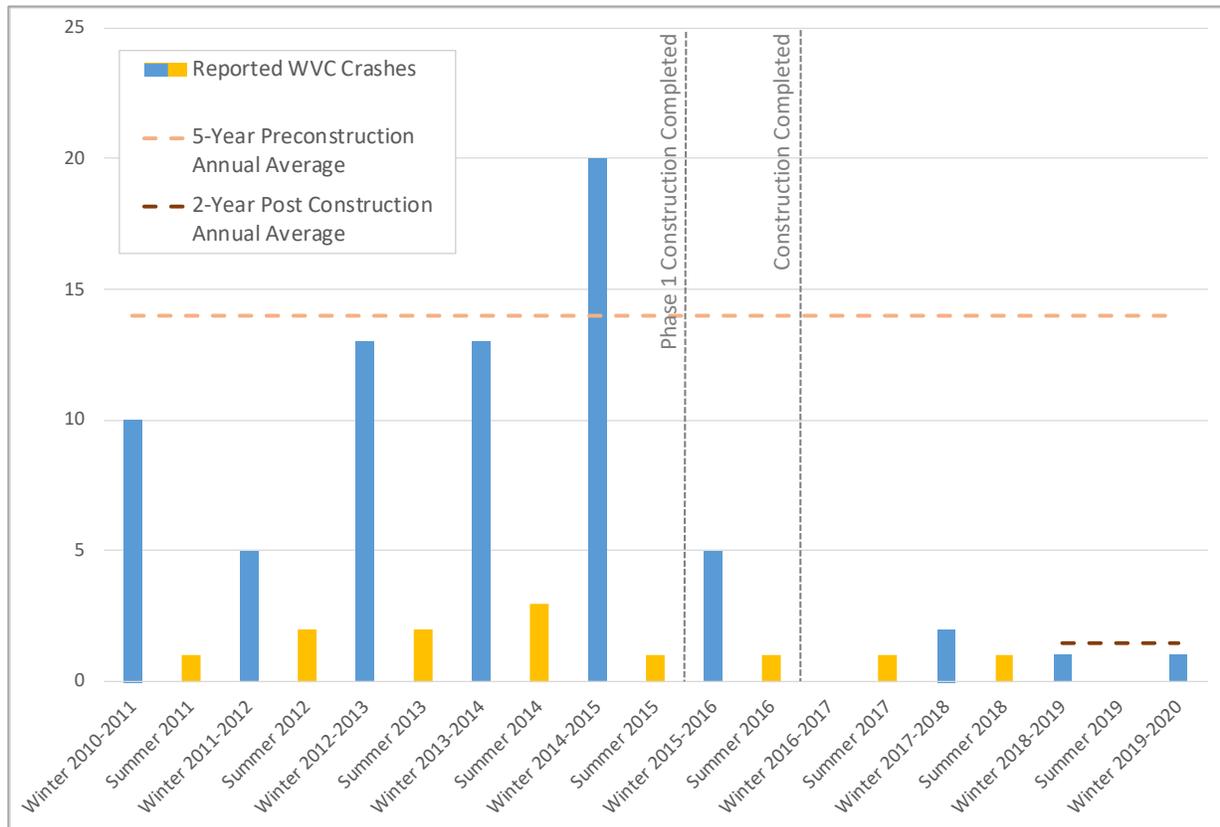
Figure 8-5. Wildlife-vehicle collision reported crashes by winter and summer seasons. The five-year preconstruction annual average was 14 crashes and the final two-year post construction annual average was 1.5 crashes.

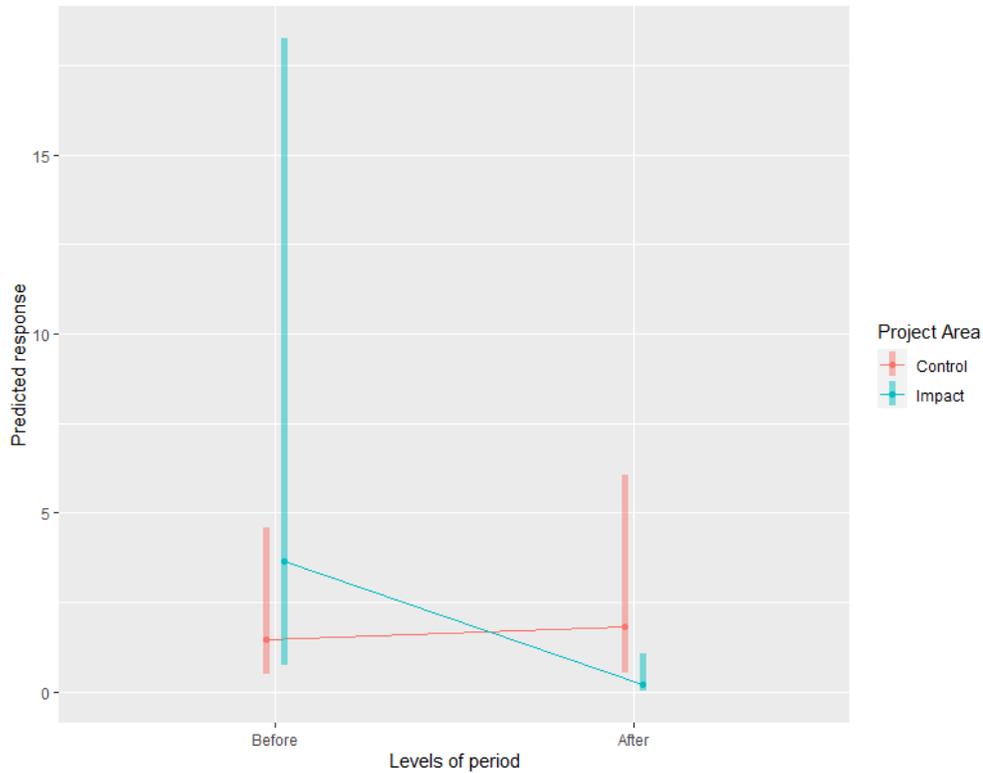
Figure 8-6. Estimated mean number of WVC carcasses per mile by project area and period, with 95% confidence interval.

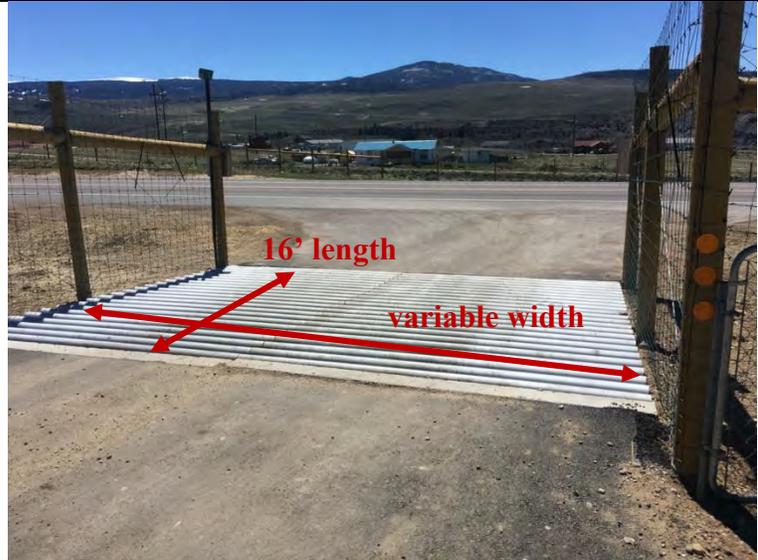
Wildlife Guard – round bar

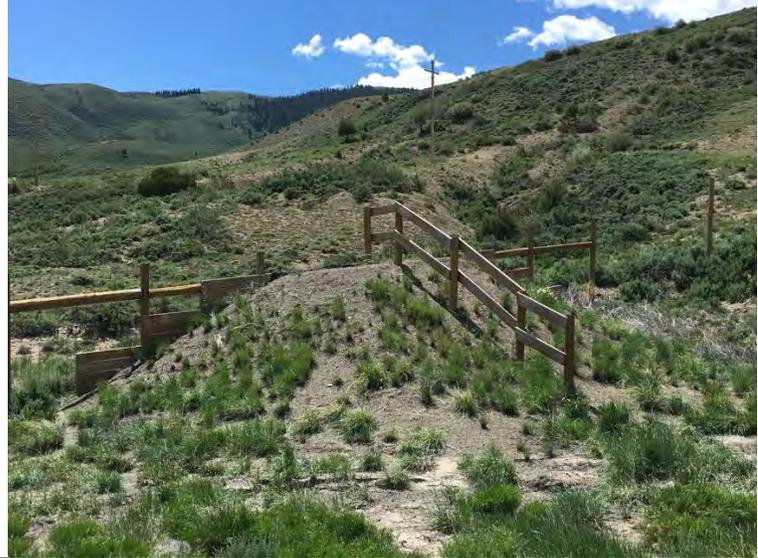
Escape Ramp – 2:1 slope with perpendicular rail fence

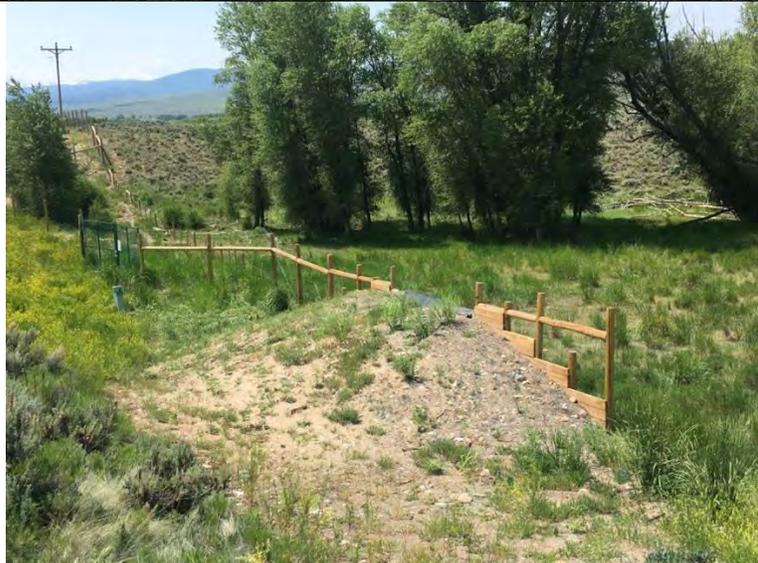
Escape Ramp – 3:1 slope without perpendicular rail fence

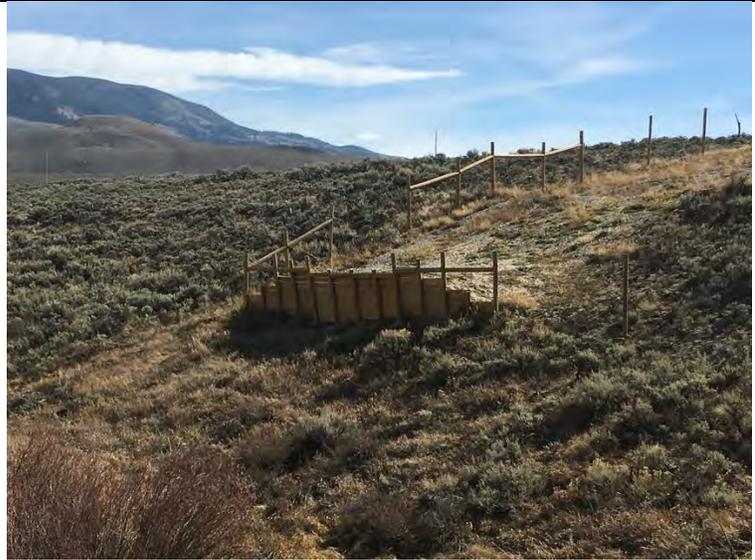
Escape Ramp – Jump Down
