# Stream Habitat Investigations and Assistance

Federal Aid Project F-161-R24

Performance Report

## PERFORMANCE REPORT

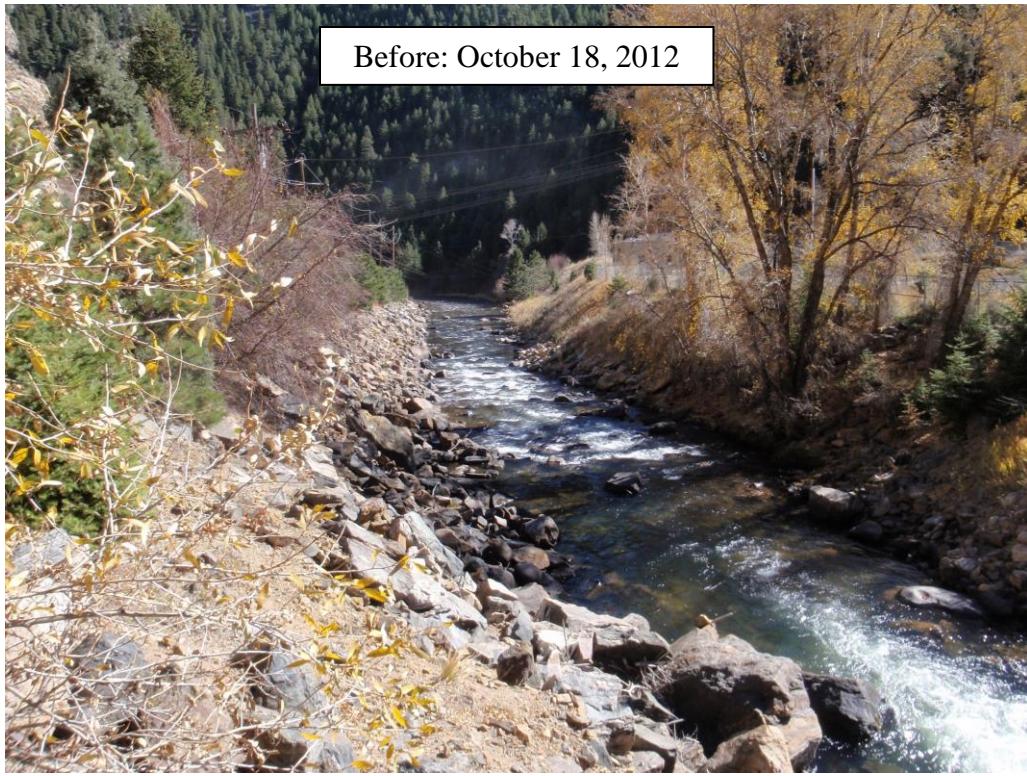
**Figure 1.1.** Pre-construction photo of the highly-confined “high-intensity” stream site as part of the Twin Tunnels project on Clear Creek.

The high-intensity treatment site is an approximately 1,300 foot long stream segment upstream of the Dog House Bridge. Primary treatments within this site consisted of riprap removal and removal of excess bank material to create a new flood plain and shape a new active channel that would align with the current channel-forming discharge (bankfull Q). This involved conversion of the existing highly-confined, channelized and riprapped, two-stage Rosgen F-stream type (confinement ratio <1.4; channel slope < 2%) to a moderately-confined, four-stage Rosgen Bc-stream type (confinement ratio 1.4-2.2; channel slope= 0.9%). Confinement was defined as the width of the valley at two times the average depth at bankfull (bkf) elevation divided by the bankfull (bkf) channel width. The pre-construction two-stage channel was converted to a post-construction four-stage channel with functional floodplain. The average confinement pre-construction within the high-intensity treatment reach was 1.2 (Figure 1.1; highly-confined channel). The average confinement post-construction was increased to nearly 2.0 (Figure 1.2; moderately-confined channel) due to the removal of riprap and expansion of floodplain area by removal of fill material. Other treatments within the high-intensity site included: addition of 153 habitat boulders (65% of total for the project or 153 of 234 total), installation of eight boulder structures (J-hooks, boulder half vanes, and cross vanes; 89% of total for the project or eight of nine total ), 2,458 linear feet (lf) of boulder toe (91% of total for the project or 2,458 lf of 2,708 lf total), 10 constructed pools (71% of total number of pools for the project or 10 out of 14 total), 5,420 square feet (sf) of point bar development (100% of total for the project), and 18,775 sf of riparian bench development (100% of total for the project).

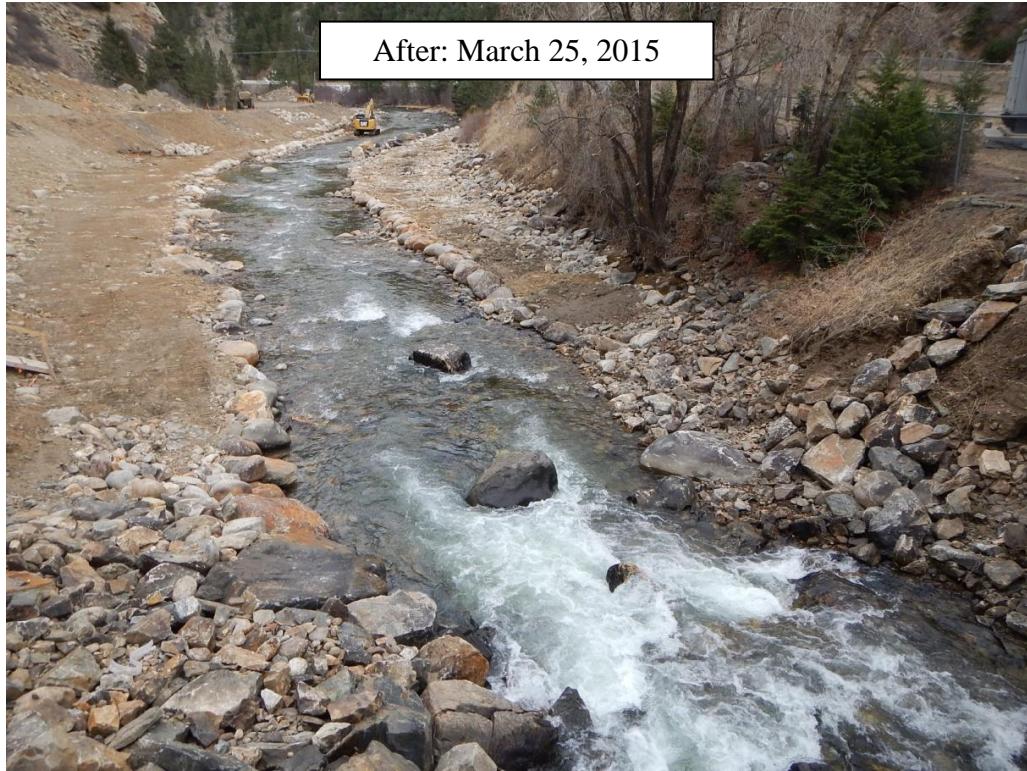
**Figure 1.2.** Post-construction photo of the moderately-confined “high-intensity” stream site as part of the Twin Tunnels project on Clear Creek.

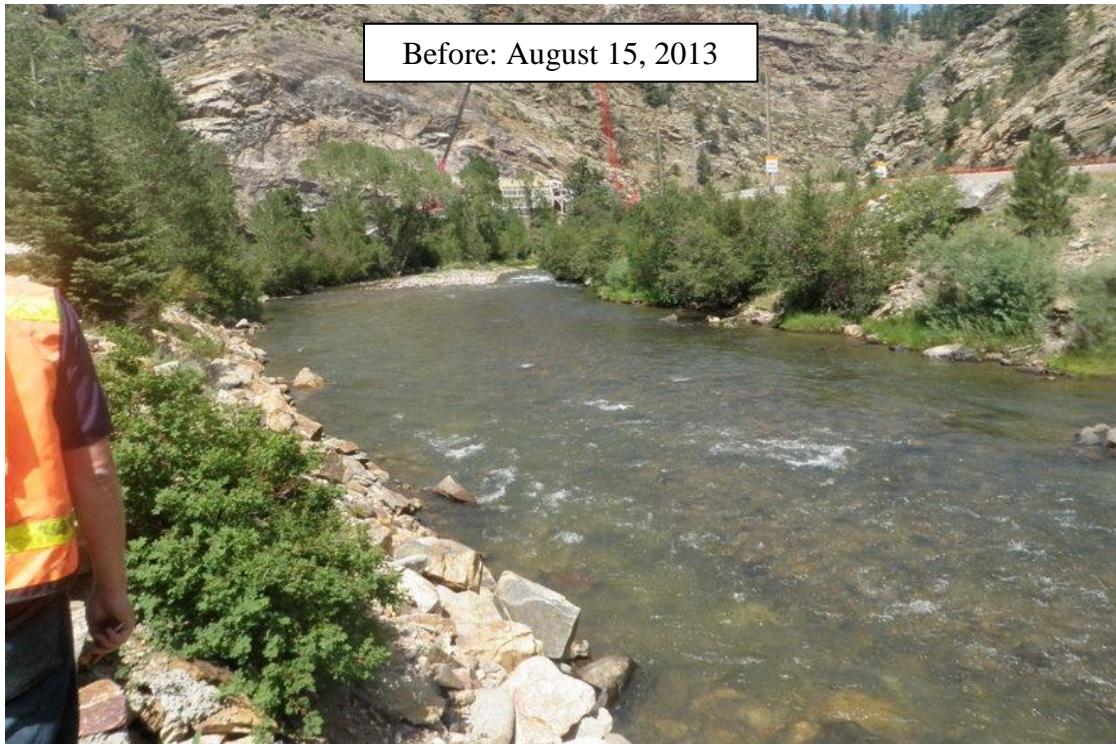
**Figure 1.3.** Pre-construction photo of the downstream “low-intensity” stream site as part of the Twin Tunnels project on Clear Creek.

The low-intensity treatment site consisted of an approximately 650 ft long stream segment located downstream of the Dog House Bridge. Unlike the high-intensity site, the channel geometry was not altered in this reach (no removal of riprap, conversion of two-stage to four-stage channel, point bar development, or riparian bench development). The average confinement for this reach before (Figure 1.3) compared with after (Figure 1.4) the project did not change (1.2). The low-intensity treatment site remained highly confined, riprapped, and constrained between two roadways. Treatments in the low-intensity segment included addition of habitat boulders (35% of total for the project or 81 of 234 total), installation of one boulder structure (cross-vane; 11% of total for the project or one of nine total), 250 lf of boulder toe (9% of total for the project or 250 lf of 2,708 lf total), and four constructed pools of which three were located off the main channel in a side-channel (Figures 1.5 and 1.6; 29% of total number of pools for the project or four out of 14 total). No point bar development or riparian benches were constructed within the low-intensity treatment segment.

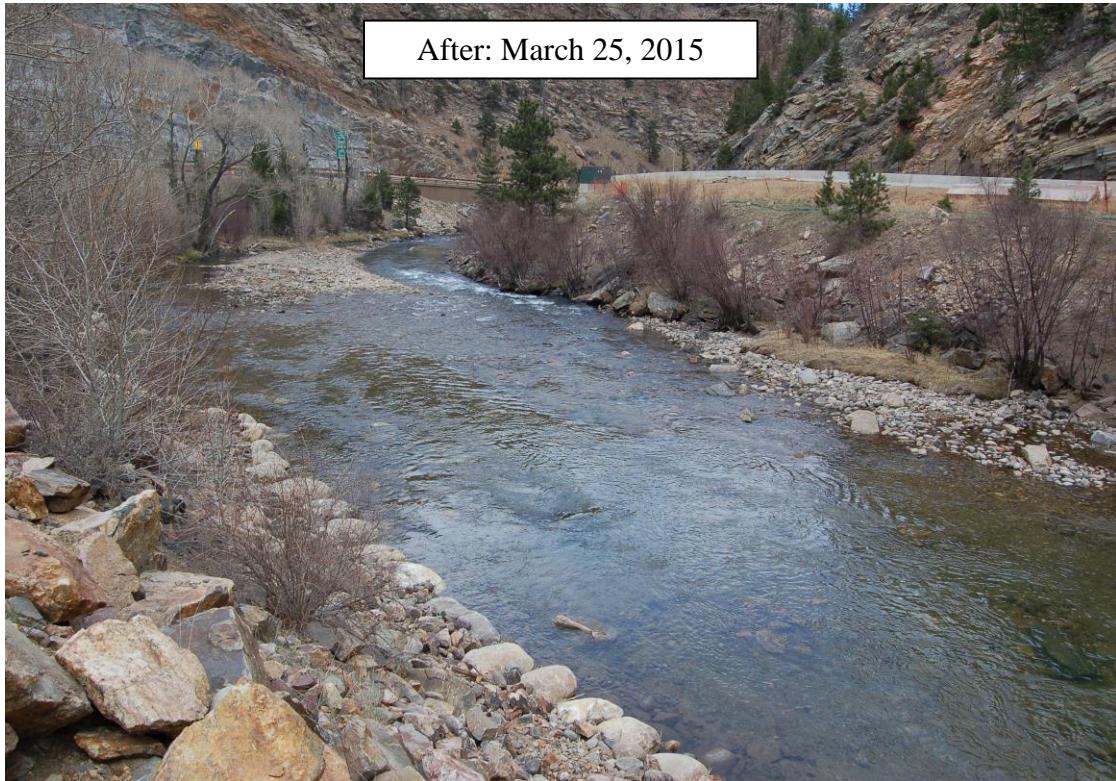
**Figure 1.4.** Post-construction photo of the downstream “low-intensity” stream site as part of the Twin Tunnels project on Clear Creek.

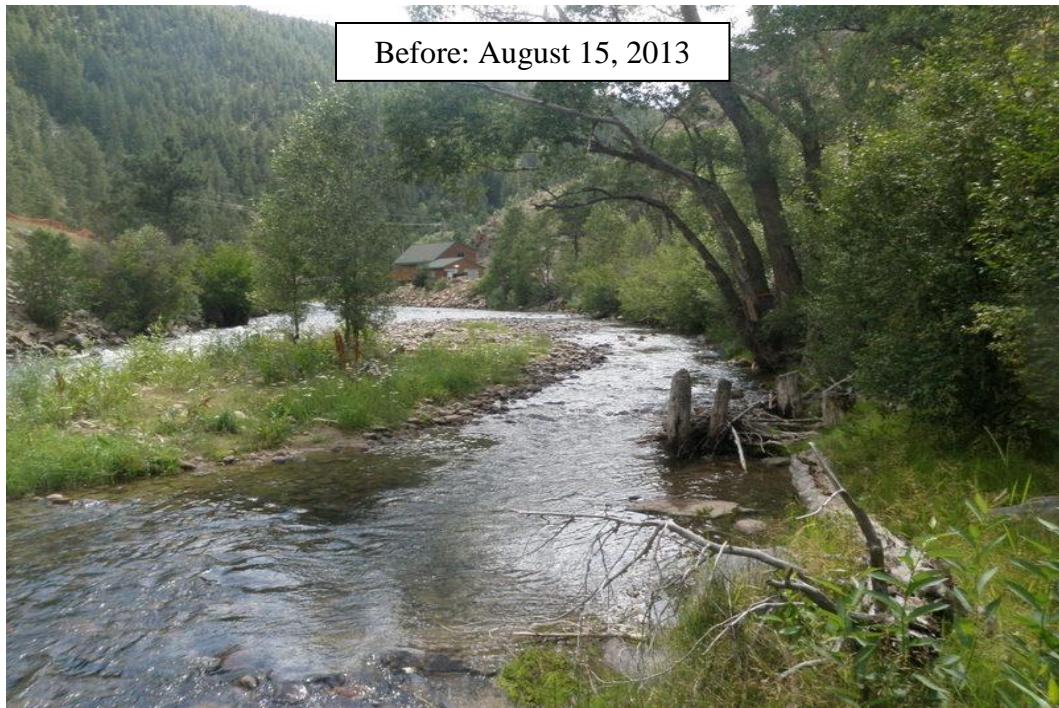
**Figure 1.5.** Pre-construction photo of the downstream “low-intensity” stream site (side-channel treatment) as part of the Twin Tunnels project on Clear Creek.

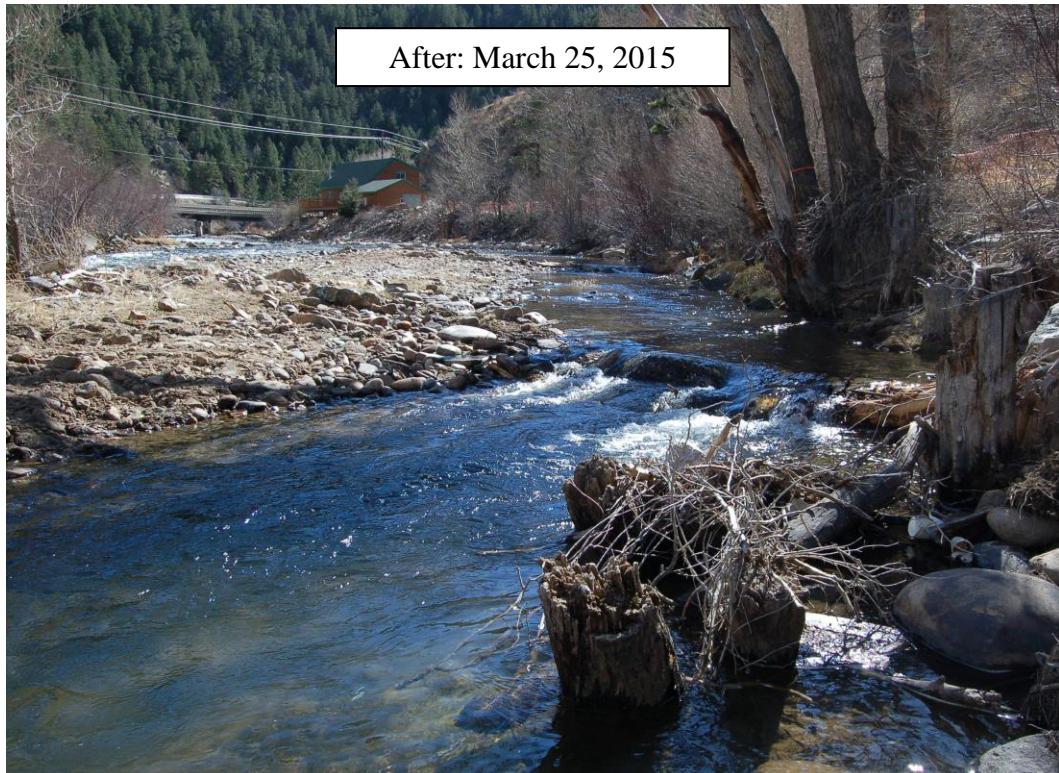
**Figure 1.6.** Post-construction photo of the downstream “low-intensity” stream site (side-channel treatment) as part of the Twin Tunnels project on Clear Creek.

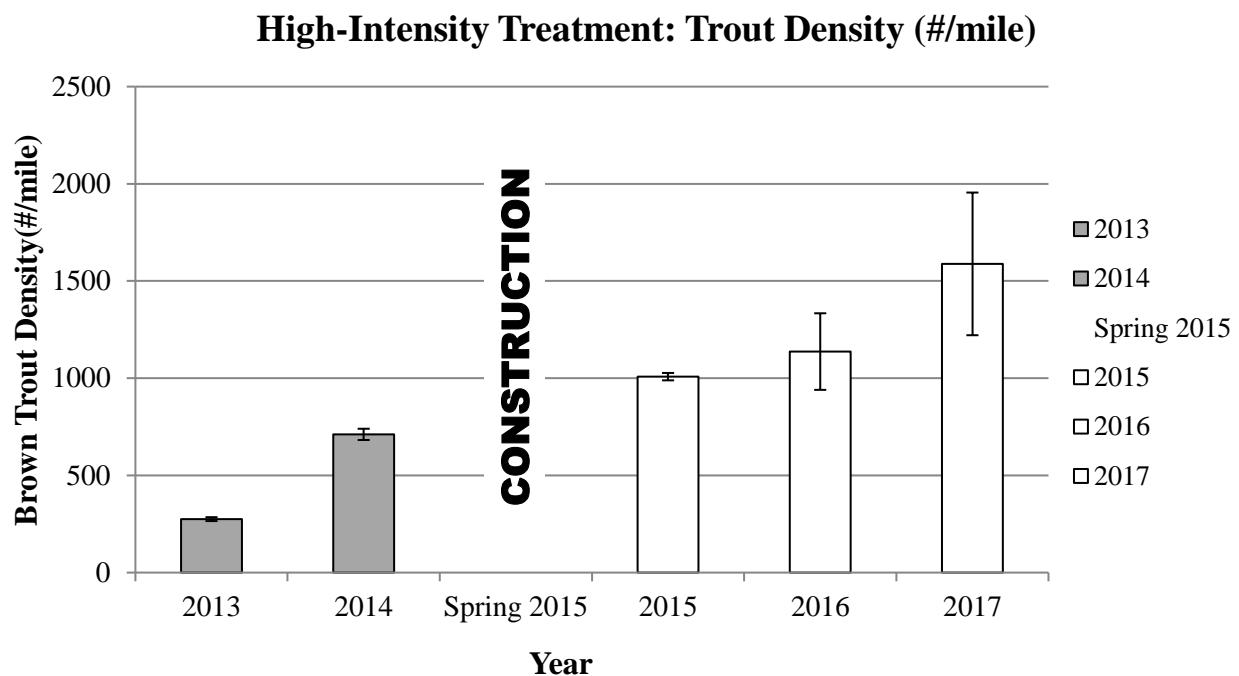
**Figure 1.7.** Brown Trout density (number/mile) within the “high-intensity” treatment site for pre- (shaded; 2013-2014) and post- (white; 2015-2017) construction years.

Three years of post-project monitoring of Brown Trout populations suggest that habitat treatments have resulted in an increase in Brown Trout density and biomass related to the fish habitat improvements in both high- (Figures 1.7 and 1.8) and low-intensity treatment sites (Figures 1.9 and 1.10). However, the magnitude of change within the high-intensity treatment site was higher for the total number of Brown Trout (Table 1.1; 152% increase) compared with the low-intensity treatment site (Table 1.1; 56% increase). Brown Trout biomass, the total pounds of Brown Trout per area, increased even more within the high-intensity treatment site (Table 1.1; 401% increase) as compared with the low-intensity site (Table 1.1; 51% increase). This suggests that the Brown Trout population within the high-intensity site not only had more fish per linear distance (density increase) than the low-intensity site, but also the population within the high-intensity site experienced a shift toward larger, adult fish within the

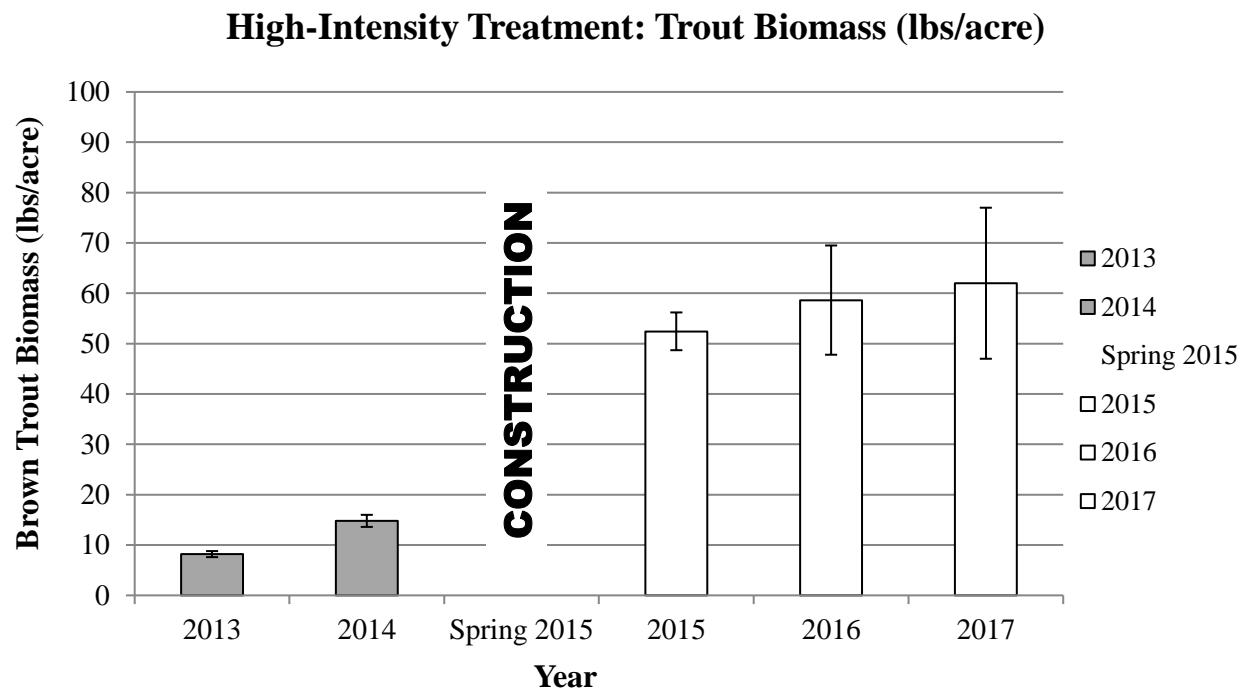
**Figure 1.8.** Brown Trout biomass (lbs/acre) within the “high-intensity” treatment site for pre- (shaded; 2013-2014) and post- (white; 2015-2017) construction years.

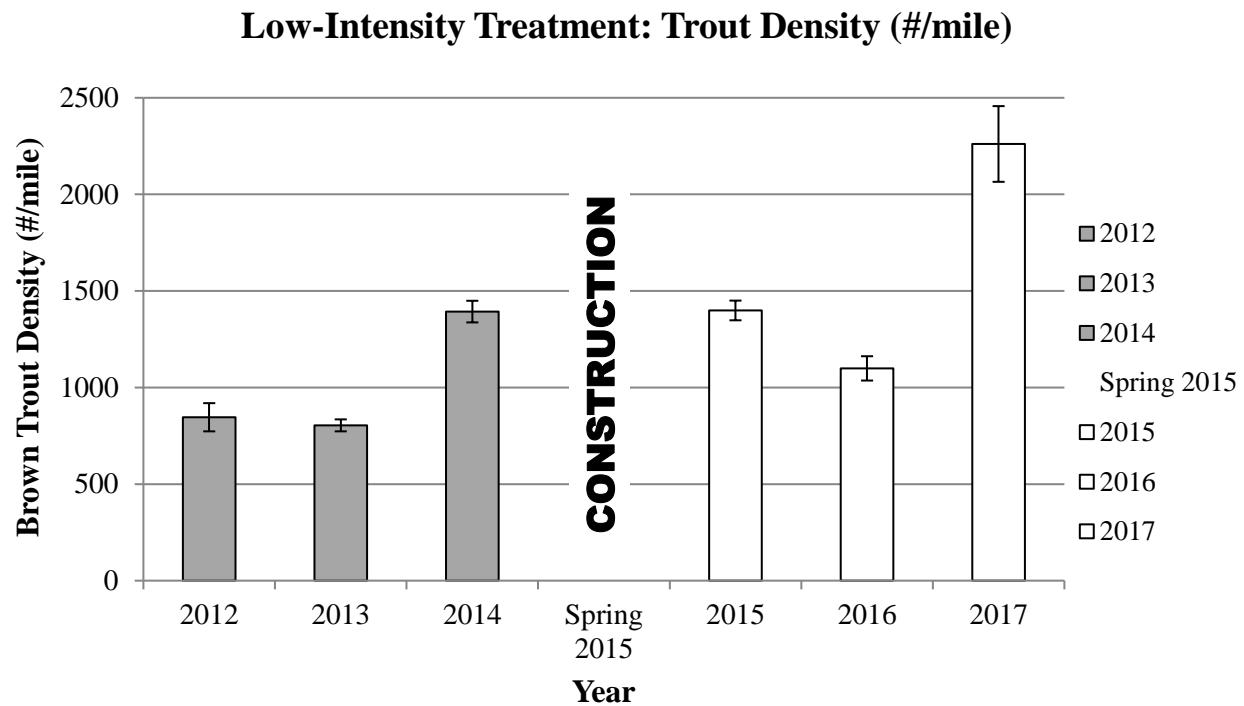
**Figure 1.9.** Brown Trout density (number/mile) within the “low-intensity” treatment site for pre- (shaded; 2013-2014) and post- (white; 2015-2017) construction years.

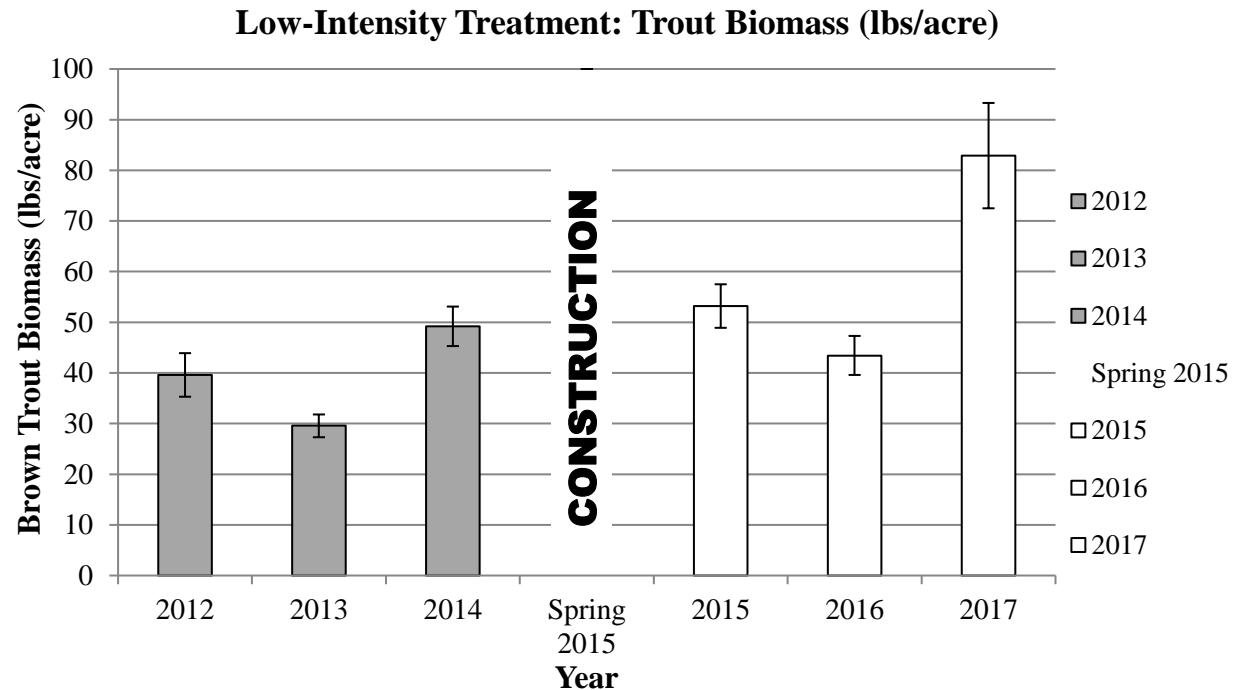
**Figure 1.10.** Brown Trout biomass (lbs/acre) within the “low-intensity” treatment site for pre- (shaded; 2013-2014) and post- (white; 2015-2017) construction years.

high-intensity treatment site (much larger increase in total Brown Trout biomass) as compared with the low-intensity treatment site. Monitoring of both sites will continue for the next two years for a total of five years post-construction.

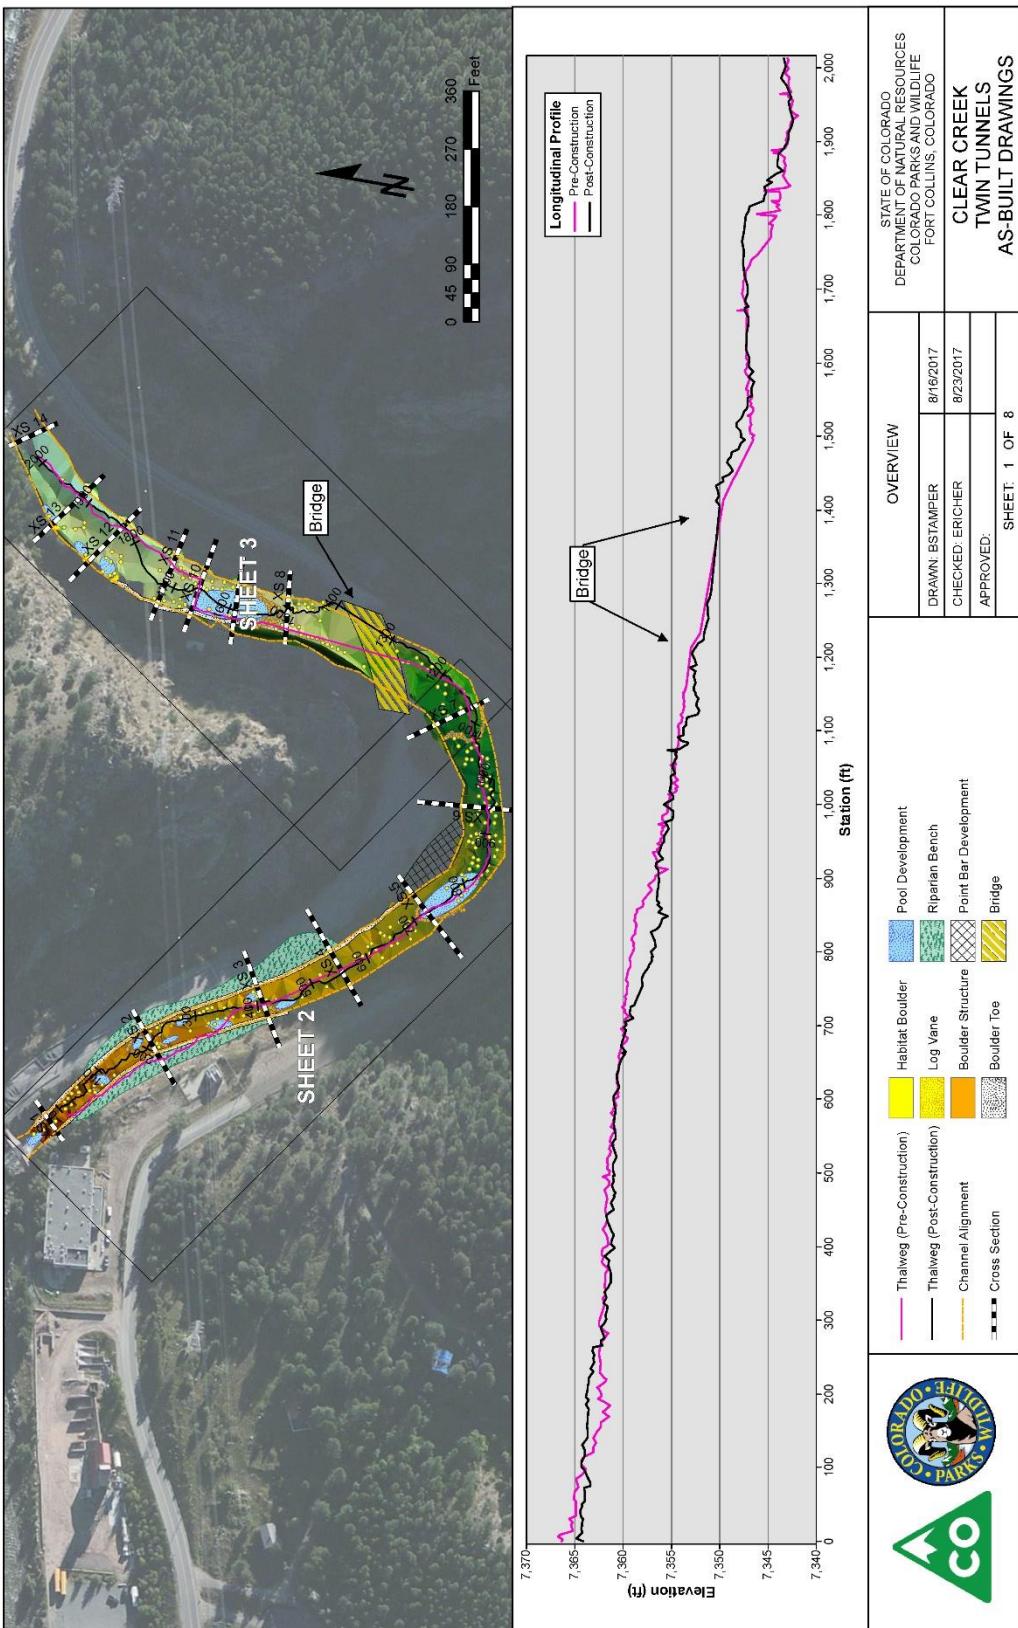
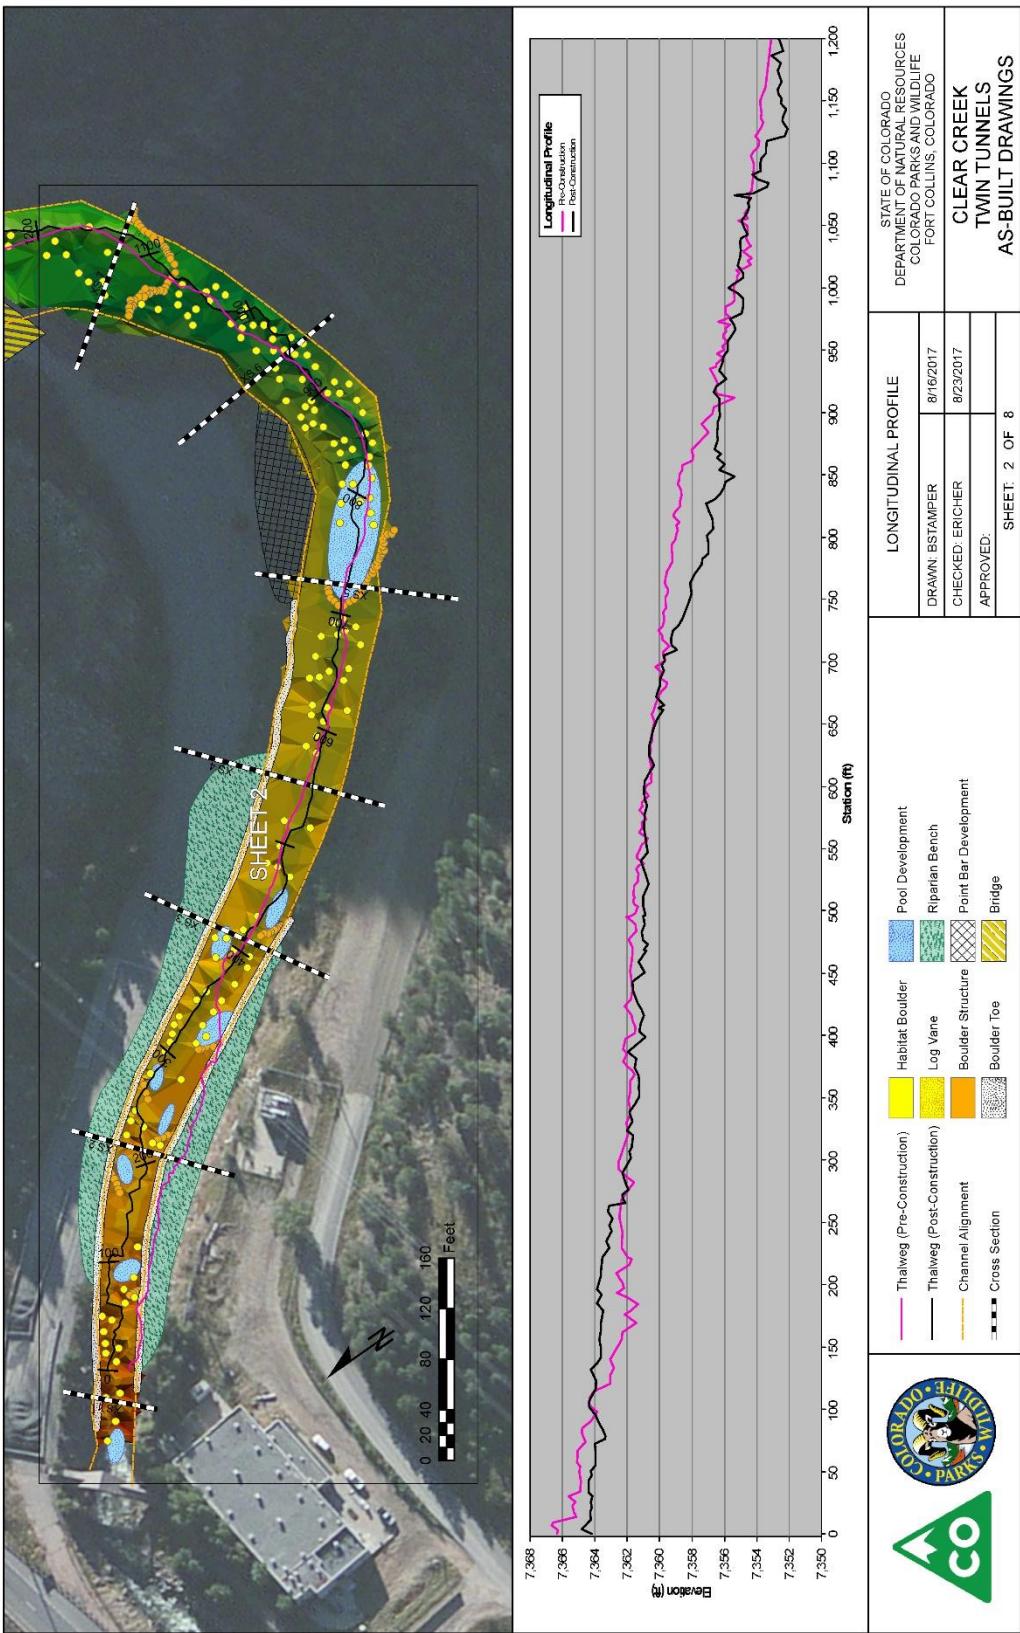
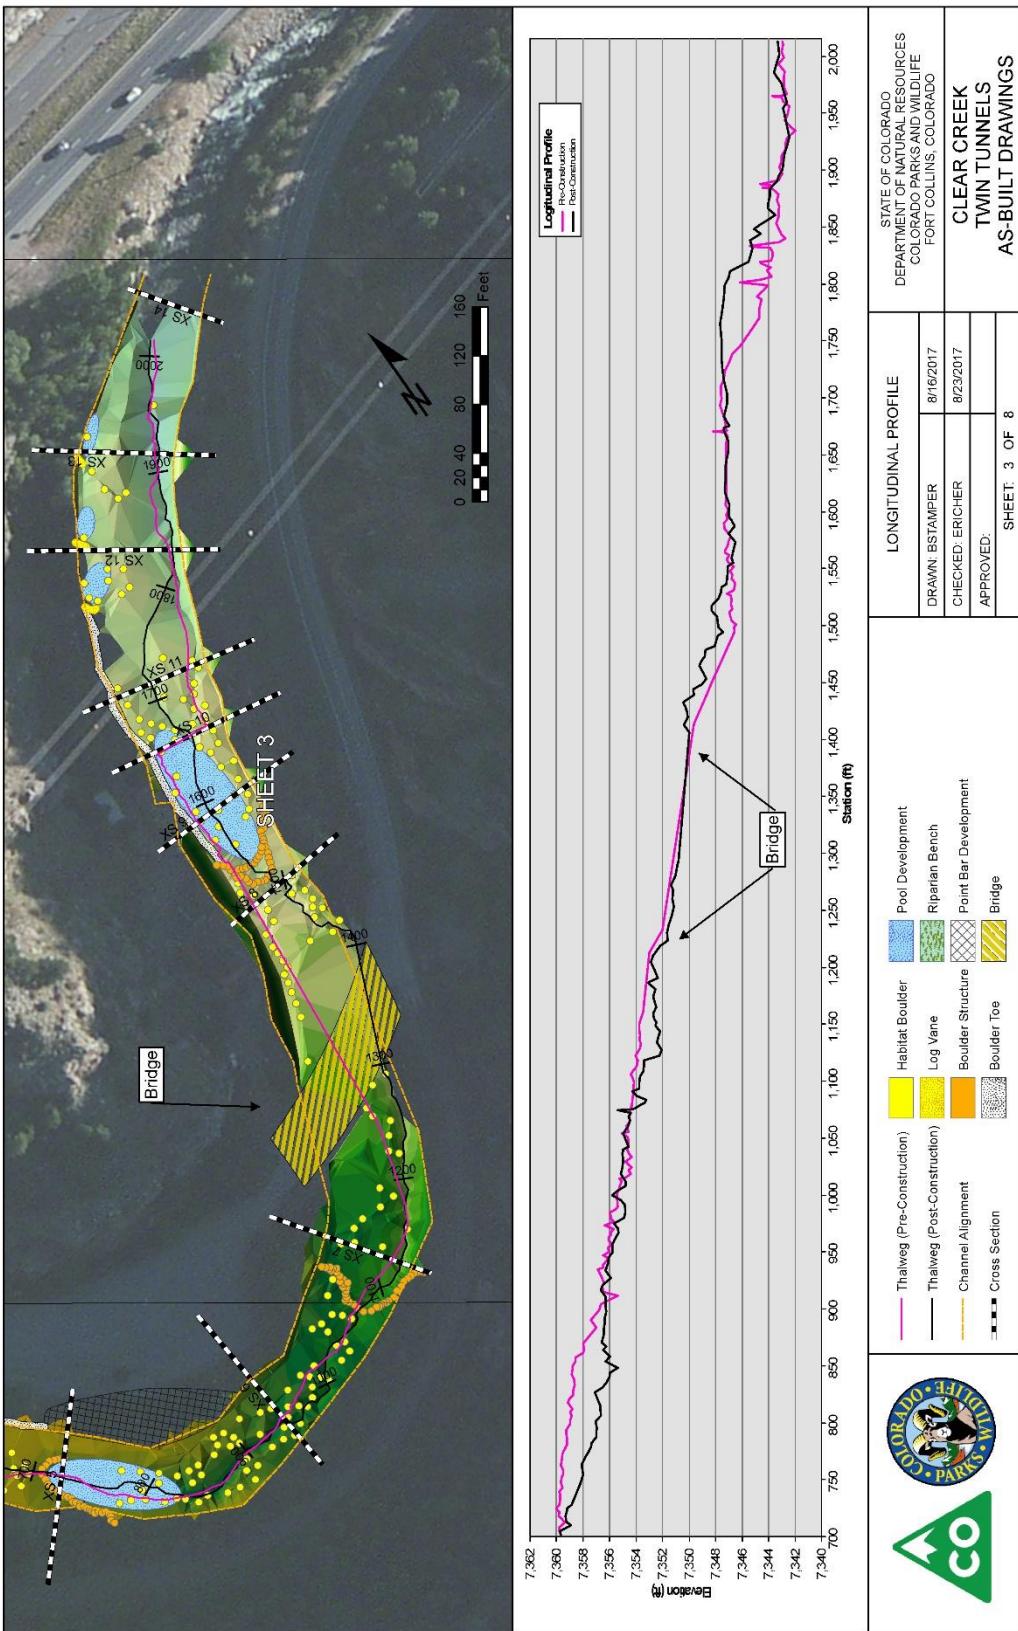
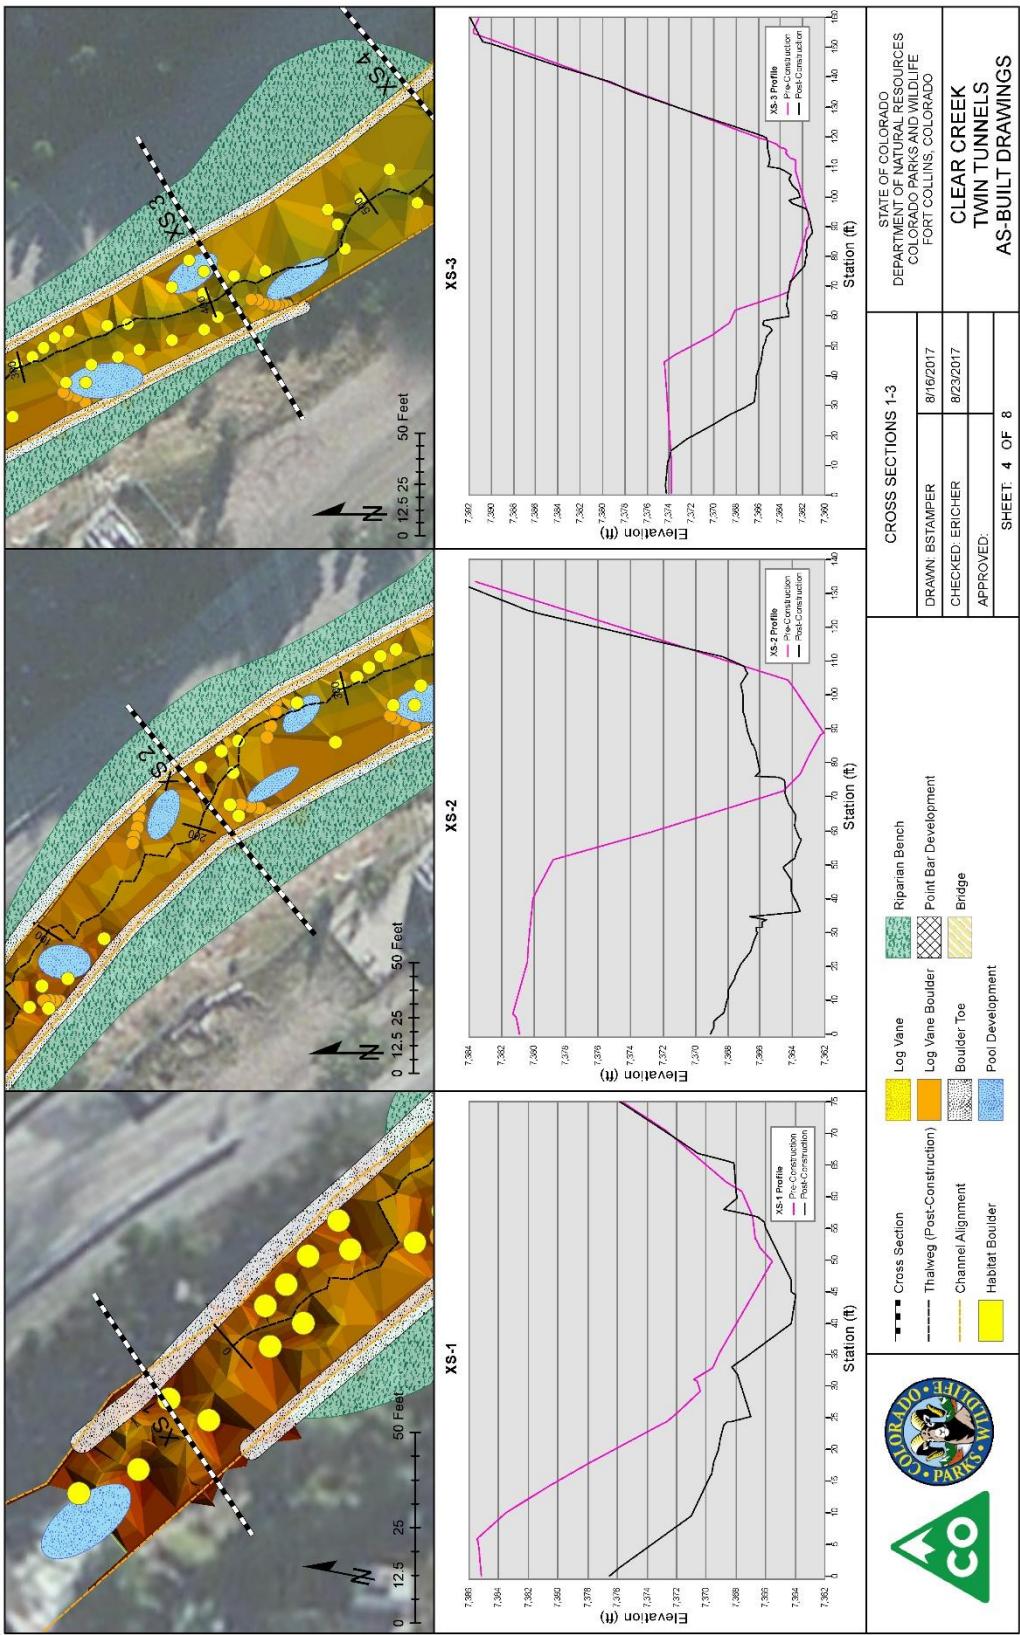
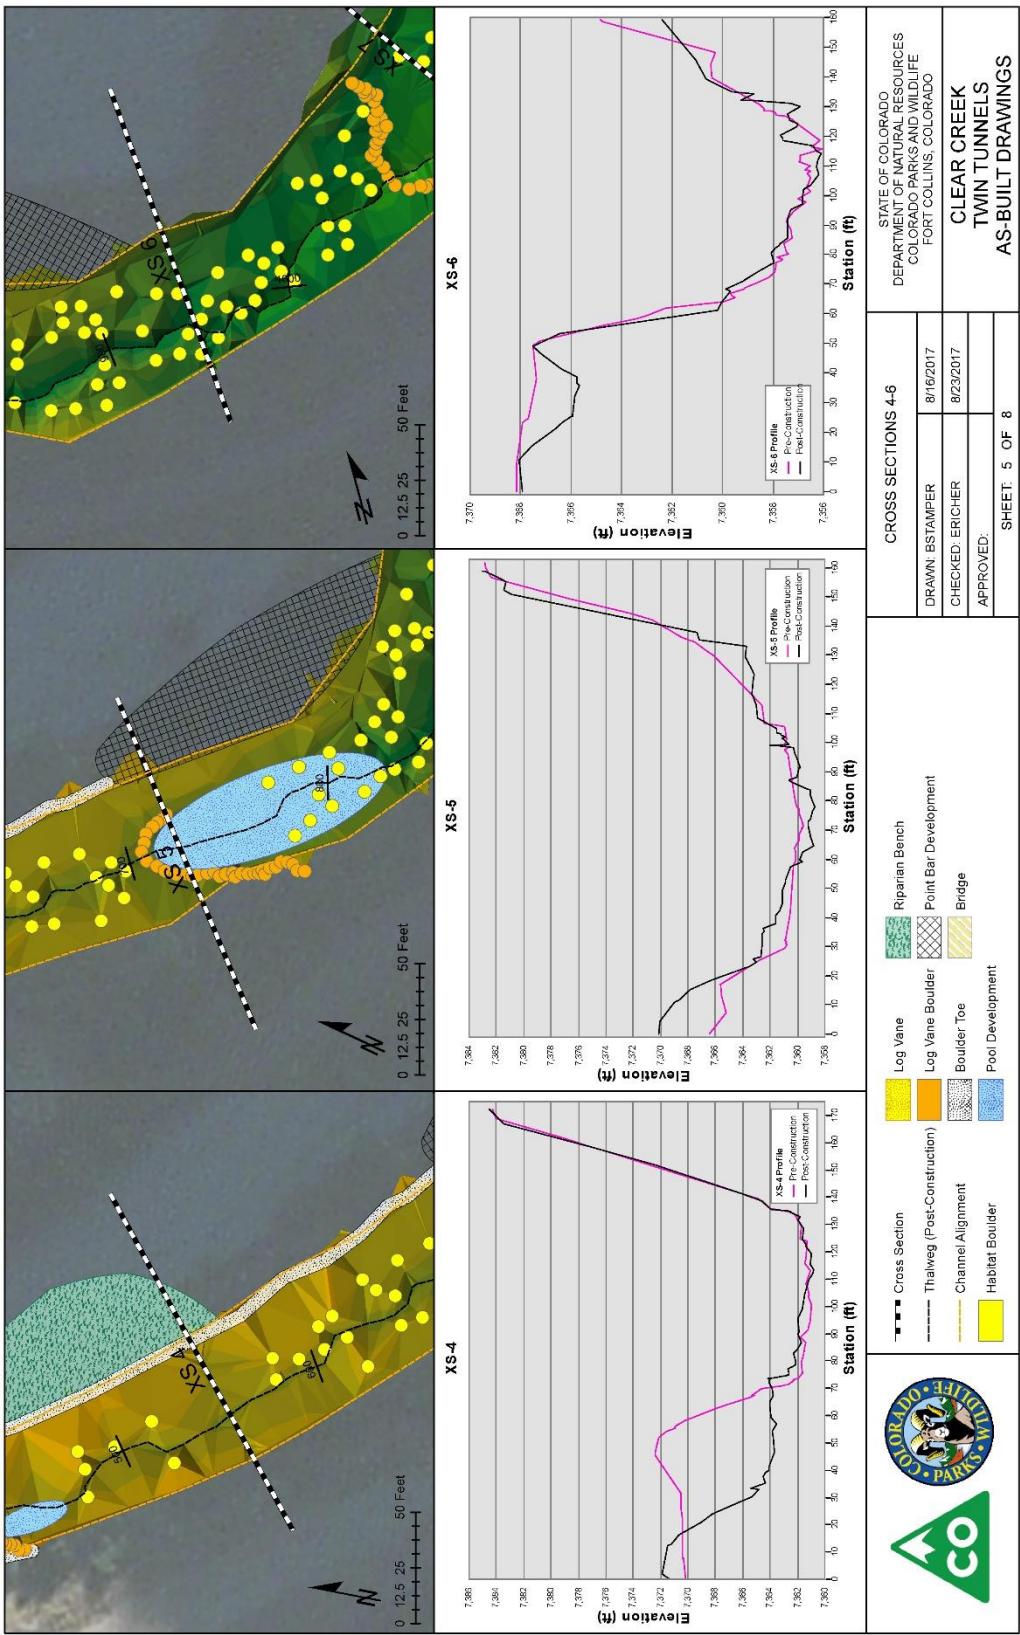
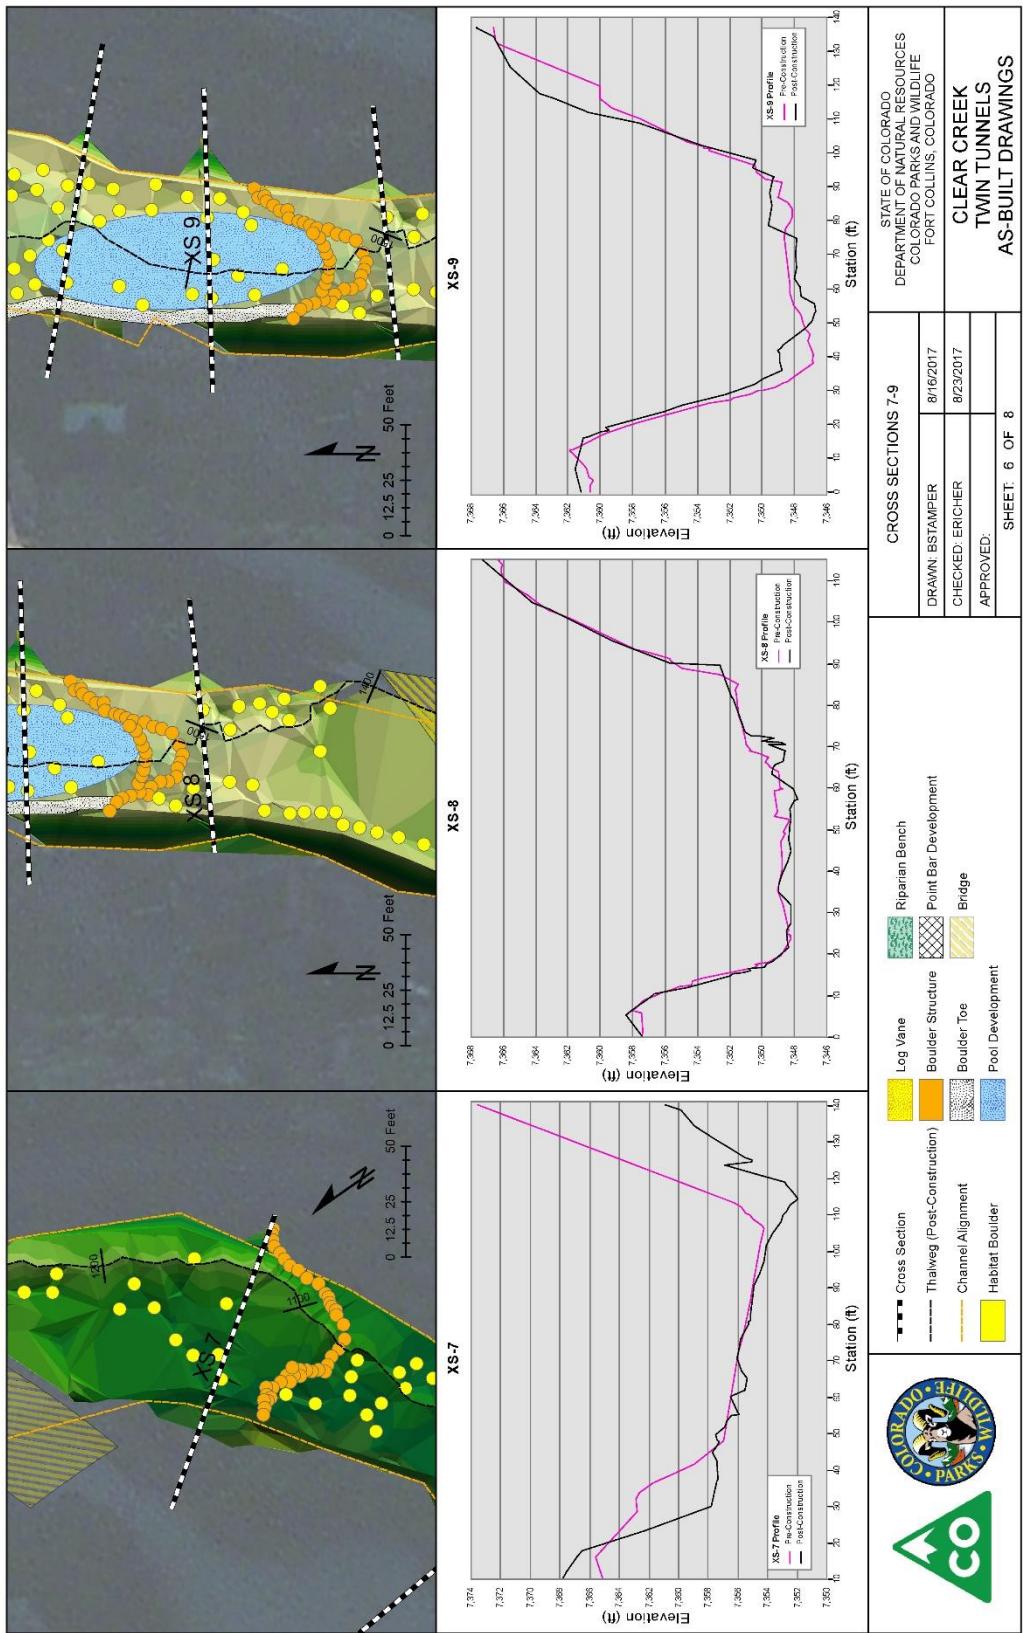
**As-Built Drawings**

**Twin Tunnels Stream Restoration Project:  
Clear Creek, Colorado**

Topographic and sediment surveys for the 0.4-mile Twin Tunnels Stream Restoration Project on Clear Creek were successfully completed during October 2016. Goals and objectives for the Twin Tunnels project were presented under Job 1, Action #1 in this report. Survey data were used to produce as-built drawings for the project, which are presented in Appendix A.

Longitudinal profiles and cross-sections are compared for pre-construction and post-construction conditions in the as-built drawing. As-built quantities for restoration treatments are presented in Table 1.2. Treatments included over 230 habitat boulders, three log vanes, and nine boulder structures. Boulder structures include six half-vanes (ribs) to enhance complexity in the upstream riffle, as well as two J-hook structures and one cross-vane to support pool development. Boulder toe, point-bar development, and riparian benches were used to improve floodplain connectivity in the reach upstream of the bridge. Improved floodplain connectivity is illustrated at cross-sections 1-5 in the as-built drawings (Appendix A).
