# Stream Habitat Investigations and Assistance

Federal Aid Project F-161-R24

Performance Report

## PERFORMANCE REPORT

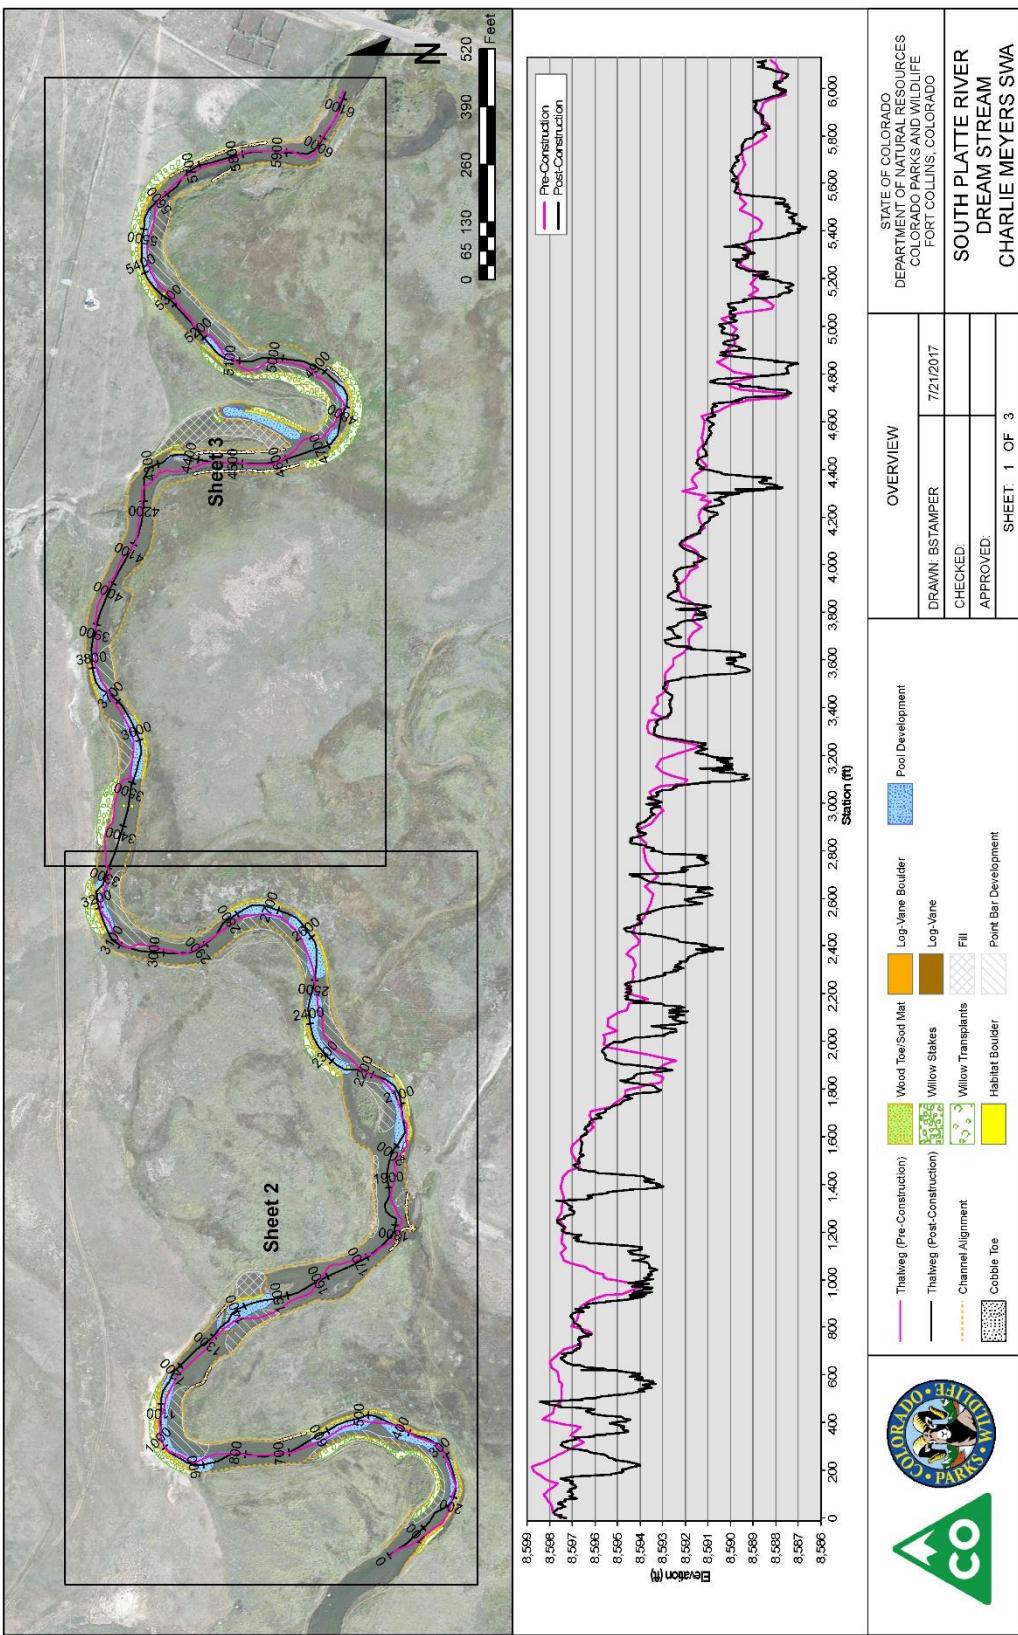
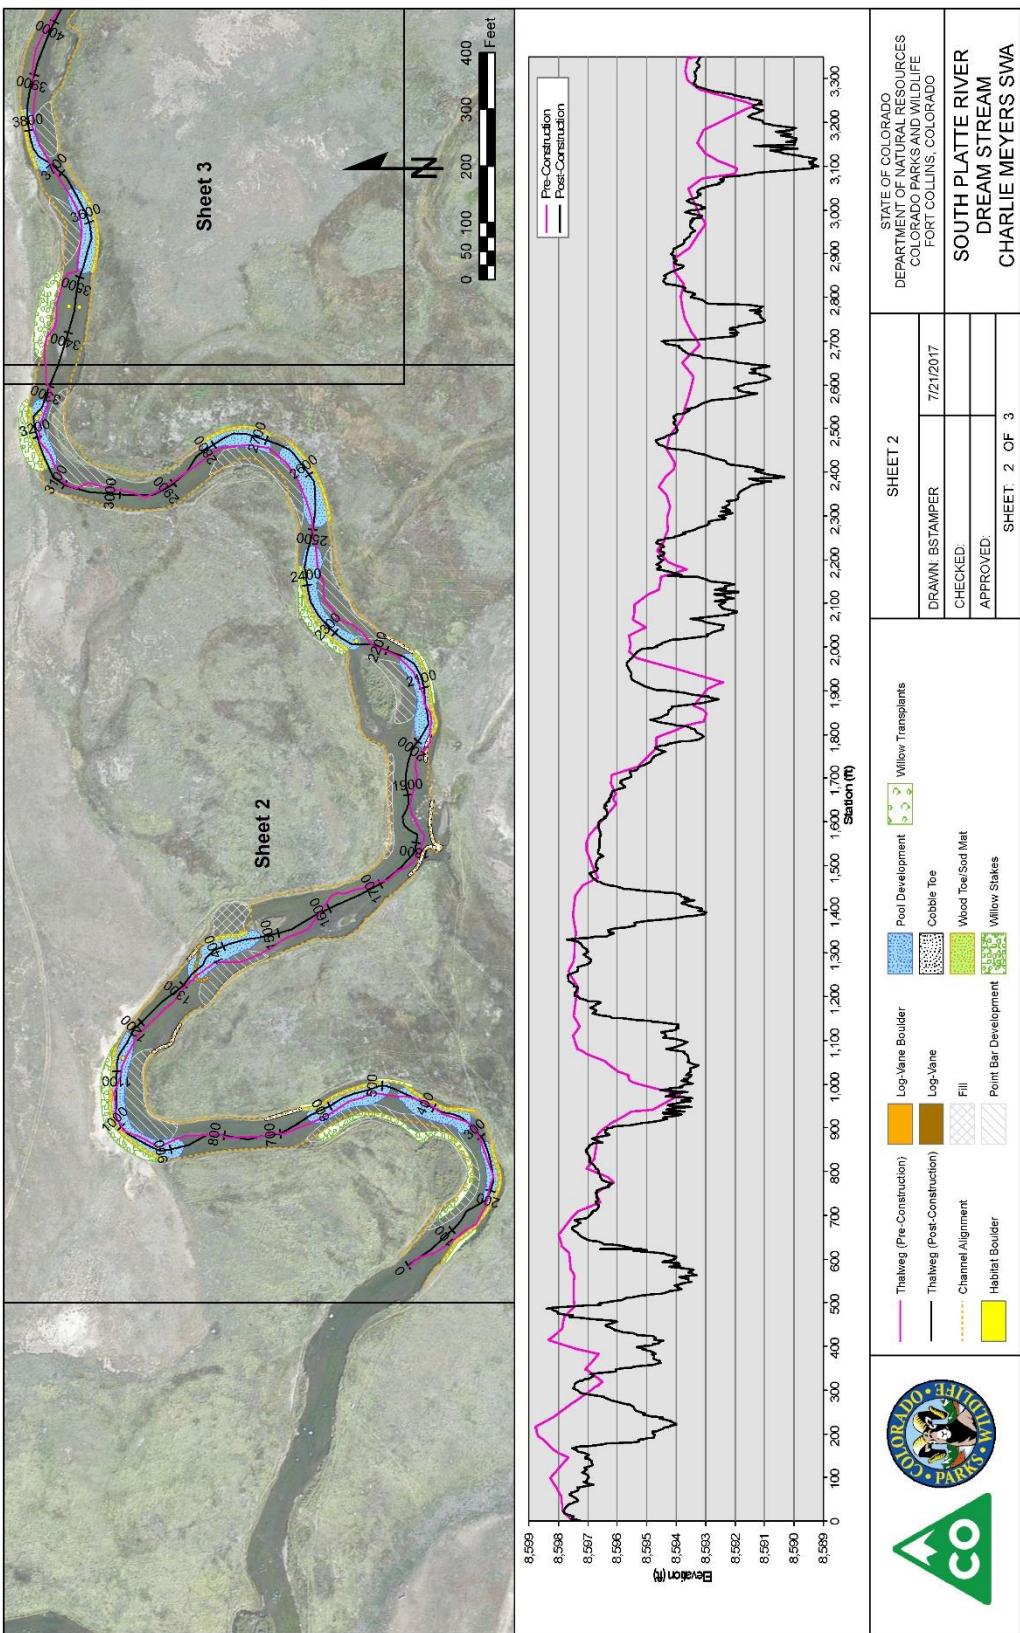
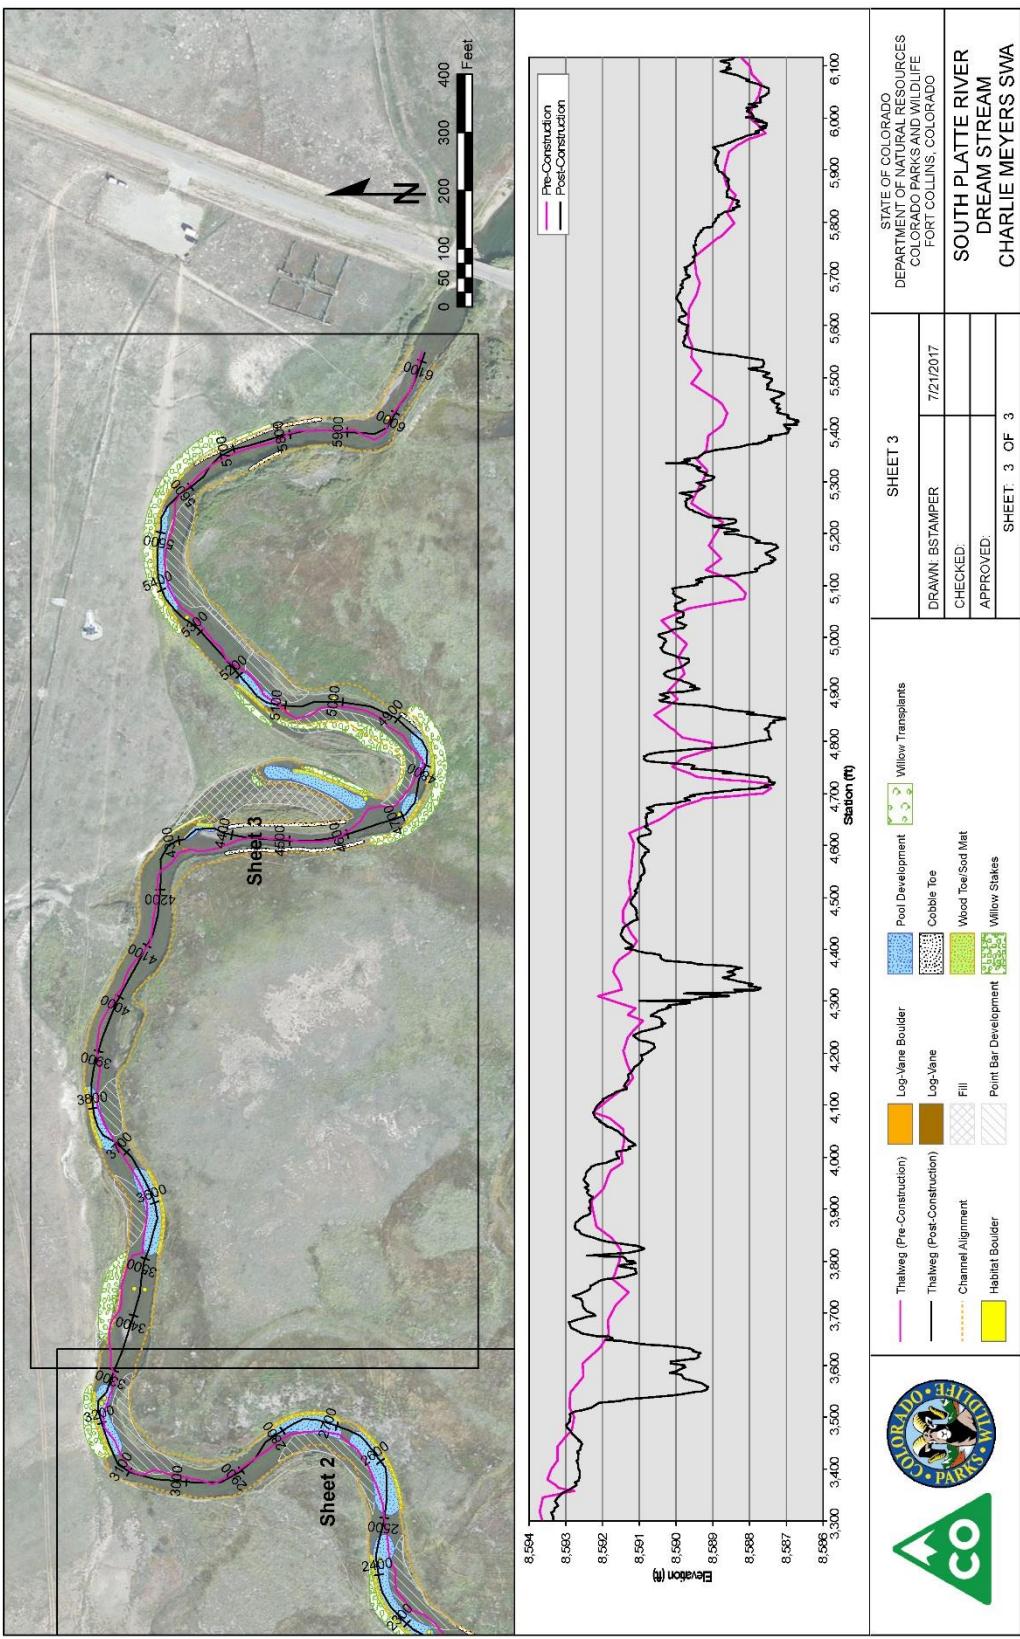
**As-Built Drawings**

**South Platte River Habitat Enhancement Project:  
Charlie Meyers State Wildlife Area**

As-built surveys for the 1.2-mile Charlie Meyers SWA Habitat Enhancement Project were completed during August 2016. Survey data were used to produce as-built drawings and 1D hydraulic models to support before-after habitat evaluation. As-built drawings for the project show the location of restoration treatments and comparison of pre-construction and post-construction longitudinal profiles (Appendix A). As-built quantities for restoration treatments are presented in Table 1.4. Treatments included 14 habitat boulders, three log/rock vanes, and nearly of mile of wood toe. Restoration of riparian vegetation was one of the primary objectives for the project, and almost an acre of stream bank was treated with willow stakes or transplants. To enhance bedform diversity and holding habitat for trout, approximately 1.7 acres of point bar development and 1.4 acres of pool development were conducted during project implementation. The effects of pool development are evident in the post-construction longitudinal profile included with the as-built drawings in Appendix A. Results from hydraulic modeling are still being analyzed to evaluate changes in width/depth ratio and bedform diversity.
