COLORADO PARKS & WILDLIFE

Electric Fish Barrier Research

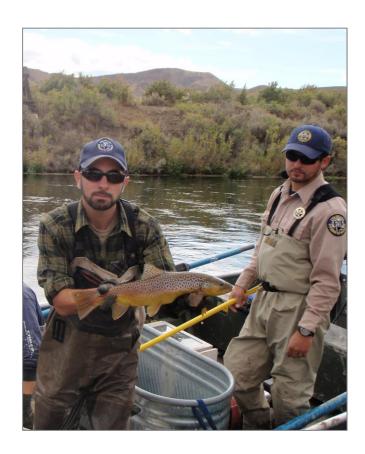
Brown trout numbers have declined since the barrier was built in 2012 but small fish that pass into the canal maintain a stable trout population.

- The electric barrier successfully prevents large fish from entering the canal and being lost to the Gunnison River population.
- No fish larger than 16 inches in length have passed the barrier, and only four fish larger than 12 inches have passed through the barrier.
- Smaller age 1, age 2, and some age 3 fish can pass through the barrier.
- The barrier prevents 26-71% of all of the spawning sized fish from entering the canal and being lost to the Gunnison River population.
- The number of brown trout in the canal declined after the barrier, but growth and survival of smaller fish that pass the barrier maintain a stable fish population.
- The electric barrier successfully protects larger brood fish in the Gunnison River but more work is needed to see if it can be adjusted to better exclude smaller fish.
