**STREAM HABITAT INVESTIGATIONS AND ASSISTANCE
PROJECT SUMMARY**

2020 Progress Report

Colorado Parks & Wildlife

September 2020

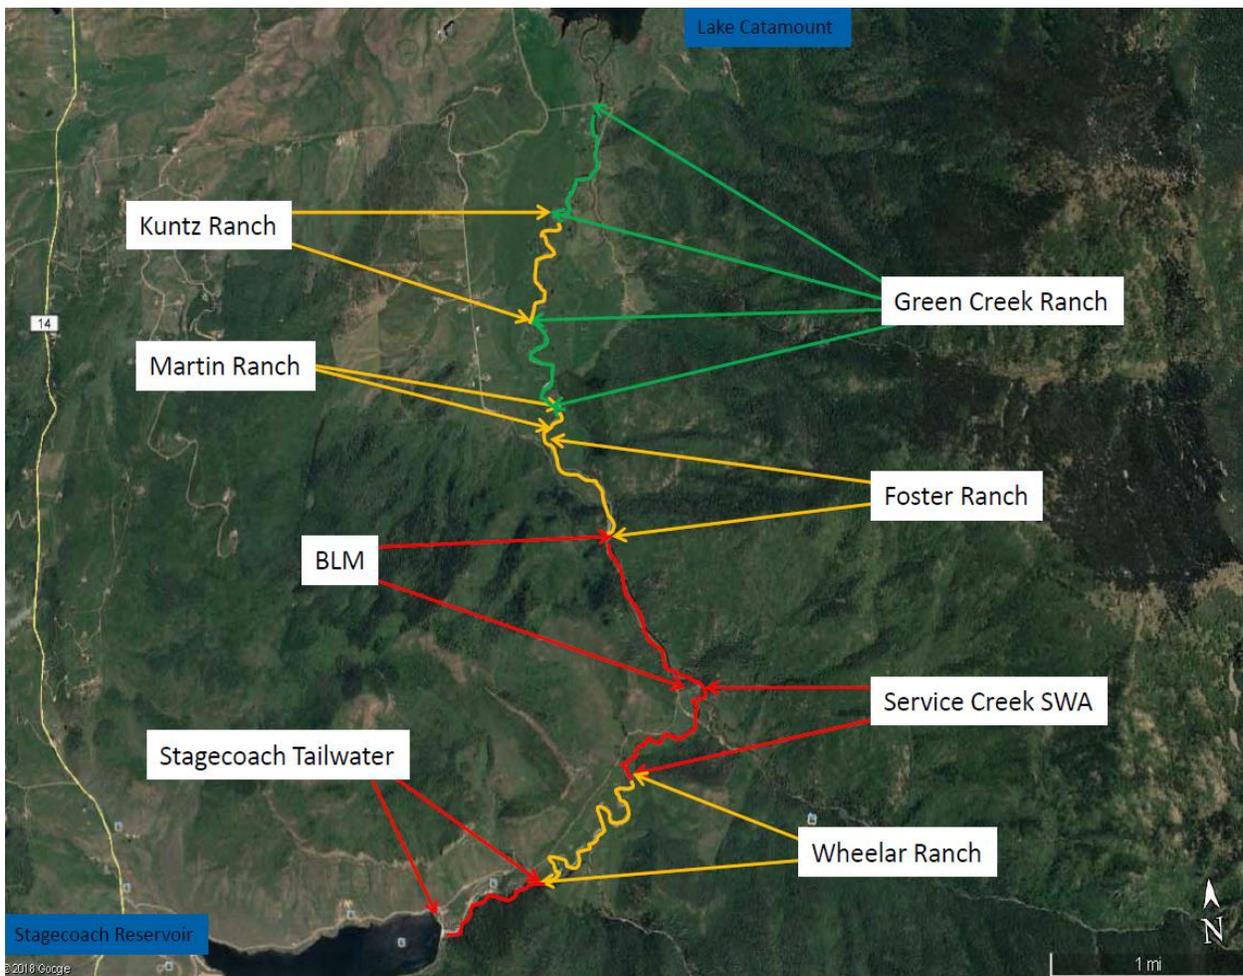
Figure 1. Study area located on a 7.7 mile river reach between Stagecoach Reservoir (upstream) and Lake Catamount (downstream) including the 5 distinct study sites including (from upstream to downstream): 1) Stagecoach Tailwater, 2) Wellar Ranch, 3) Service Creek SWA, 4) BLM, and 5) Green Creek Ranch.

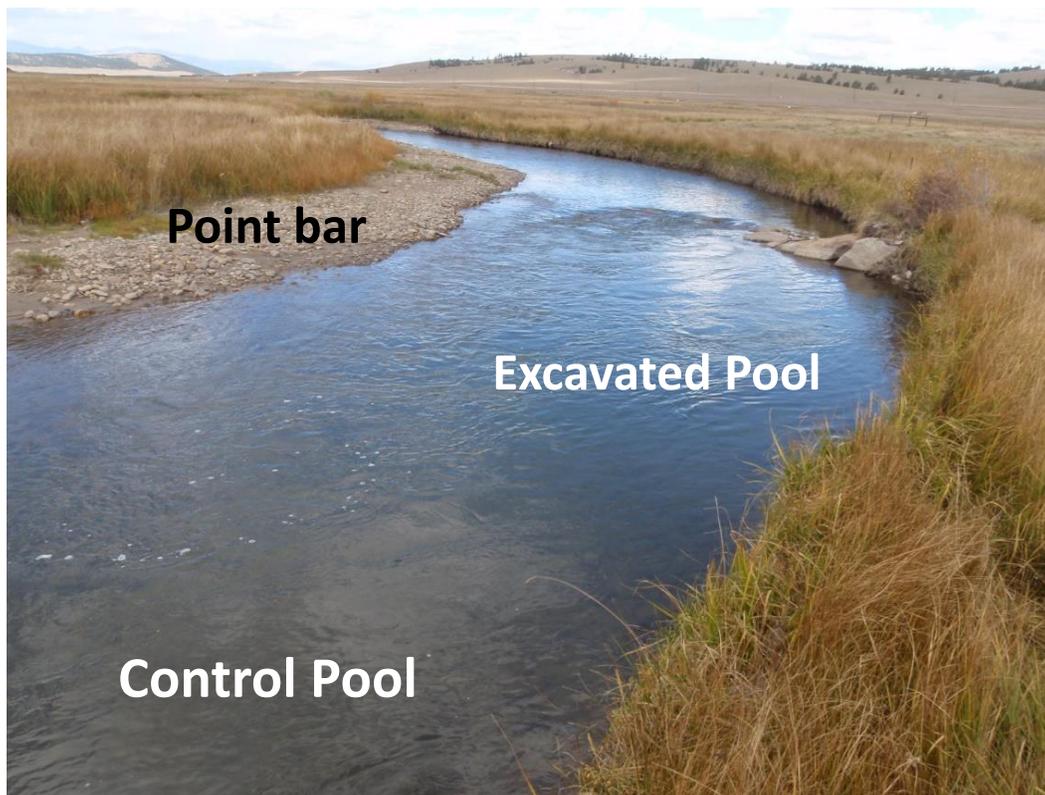
Figure 2. Control pool consisting of an excavated pool and constructed point bar. No wood was intentionally placed within these pools.

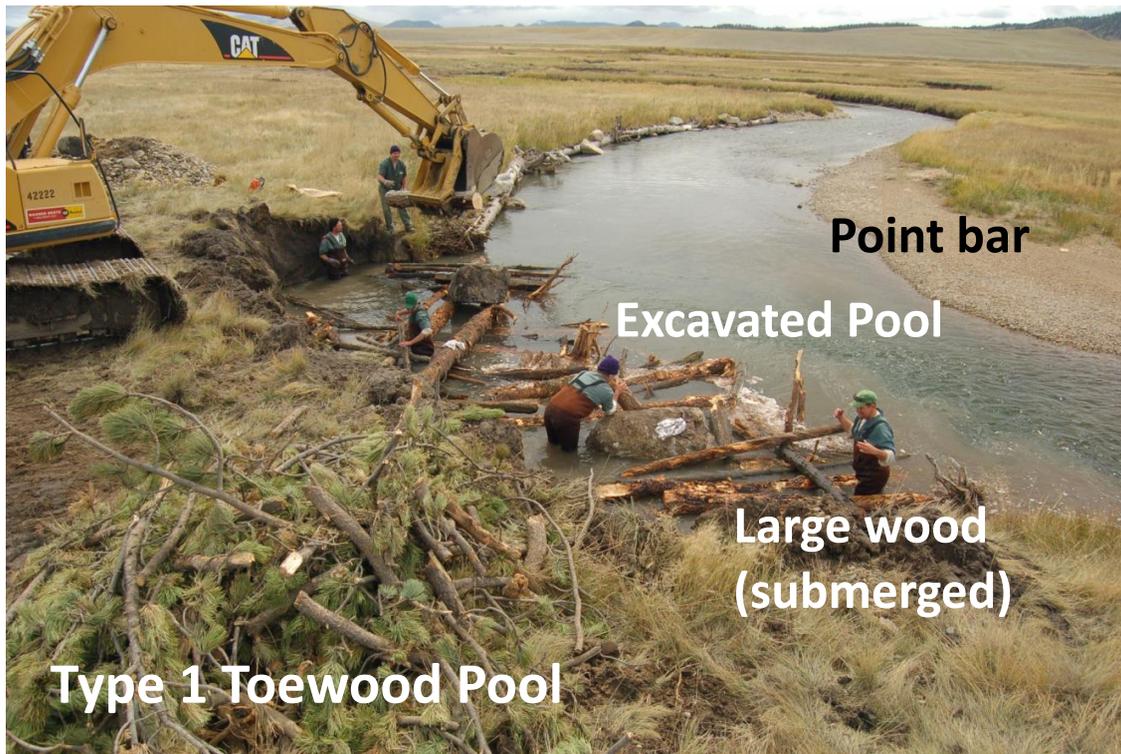
Figure 3. Type 1 toewood pool during construction, consisting of an excavated pool, constructed point bar and introduction of large wood placed at the bank toe of in a haphazard manner.

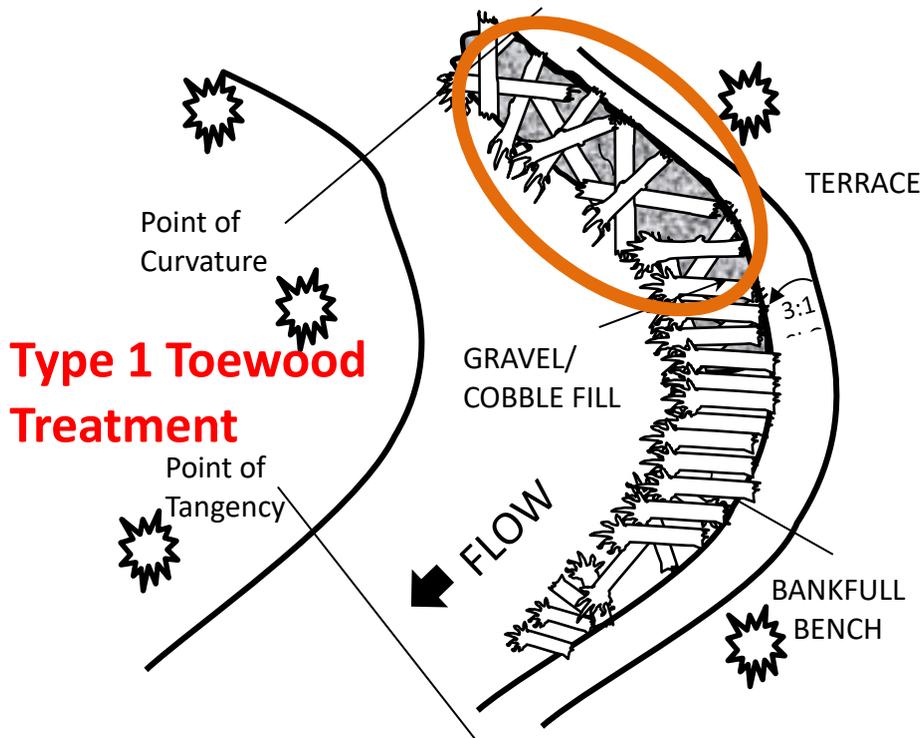
Figure 4. Plan view of the Type 1 toewood treatment concept (circled in orange) and haphazard arrangement of large wood with attached root wads. Sod mats would normally be placed on top of the large wood, brush (not shown) and top soil layers (not shown).

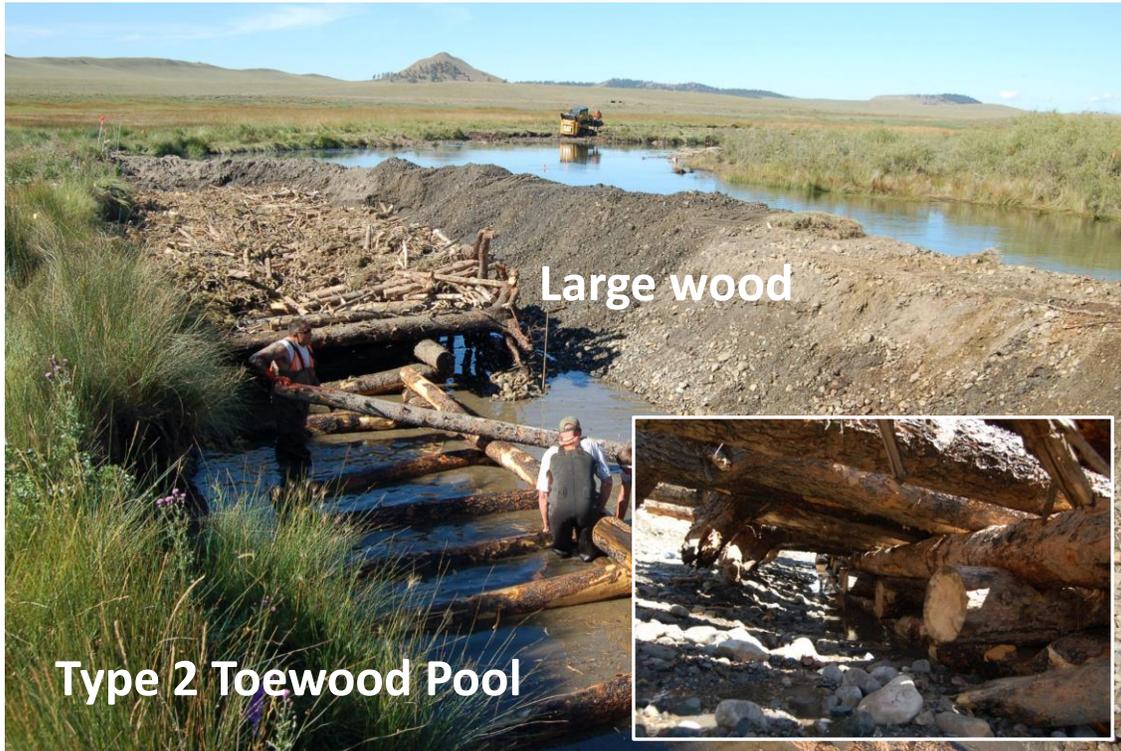
Figure 5. Type 2 toewood treatment during construction, consisting of an excavated pool, constructed point bar introduction of large wood at the bank toe to function as an undercut bank.

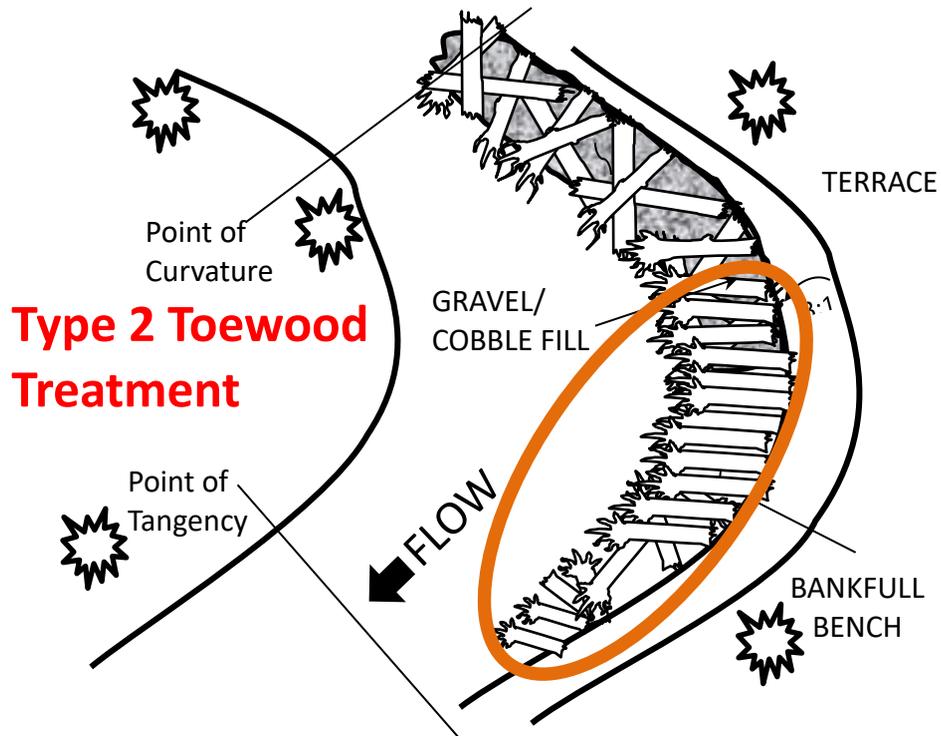
Figure 6. Plan view of the Type 2 toewood treatment concept (circled in orange) and introduction of large wood intentionally placed at the bank toe of the outside bend to function as an undercut bank. Sod mats would normally be placed on top of the large wood, brush (not shown) and top soil layers (not shown).

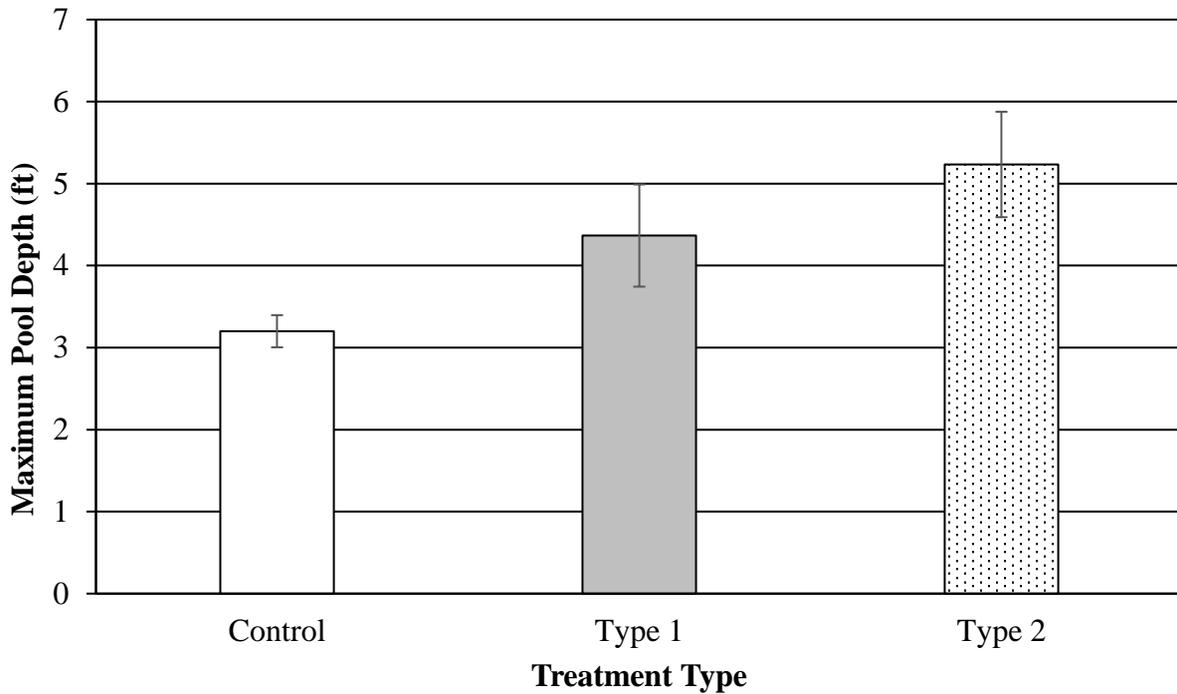
Figure 7. Average maximum pool depths (in feet) and 95% CI from Control (non-wood treated; n=3), Type 1 (haphazard toewood; n=3) and Type 2 (undercut toewood; n=3) treated lateral scour pools. Maximum pool depths were measured as the maximum difference between the streambed and water surface elevations in the vertical plane.

Providing deep pools as overwinter habitat and holding cover for adult trout was one of the primary goals of the habitat restoration project. This followed from an assessment of habitat conditions that identified overwinter habitat as a limiting factor for Brown Trout populations. Maximum pool depths were measured for individual pools that were included as part of this study. Maximum pool depths were defined as the location within a lateral scour pool run-pool-glide complex that had the greatest difference between the water surface and streambed surface elevations. As stream discharge was nearly constant during the short duration of the study, water surface could be used as a reliable indicator for determining maximum pool depth within pools. If discharge had been variable during the study duration, water surface would not be a good indicator of pool depth. Instead, the pool tail crest (for residual pool depth) or bankfull elevation could be used as alternative indicator to water surface for determining maximum pool depth. 95% confidence intervals (CI) for maximum pool depths associated with Type 1 and Type 2 toewood-treated pools do not overlap with 95% CI for non-wood treated pools (Control; Figure 7), suggesting that wood-treated pools maintained significantly deeper maximum pool depths than non-wood treated pools. However, the 95% CI for Type 1 and Type 2 wood-treated pools overlap suggesting no advantage in maintaining deeper pools between the two toewood techniques. Non-wood treated (Control) pools averaged a maximum depth of 3.2 ft. Type 1 and Type 2 pools were deeper on average than non-wood Control pools (4.4 ft and 5.2 ft, respectively). Treating lateral scour bends using toewood techniques helps maintain significantly deeper maximum pool depths over time than simply treating pools by excavating them and shaping point bars alone. Since there was no difference between Type 1 and Type 2 maximum pool depths (95% CI overlap), we combined all maximum pool depths from wood-treated toewood pools for comparison with the non-wood Control treatment (Figure 8). Wood-treated toewood pools averaged 1.6 ft deeper than maximum depths from non-wood treated Control pools (a 33% increase in maximum pool depth) and this difference was statistically significant (95% CI non-overlapping).

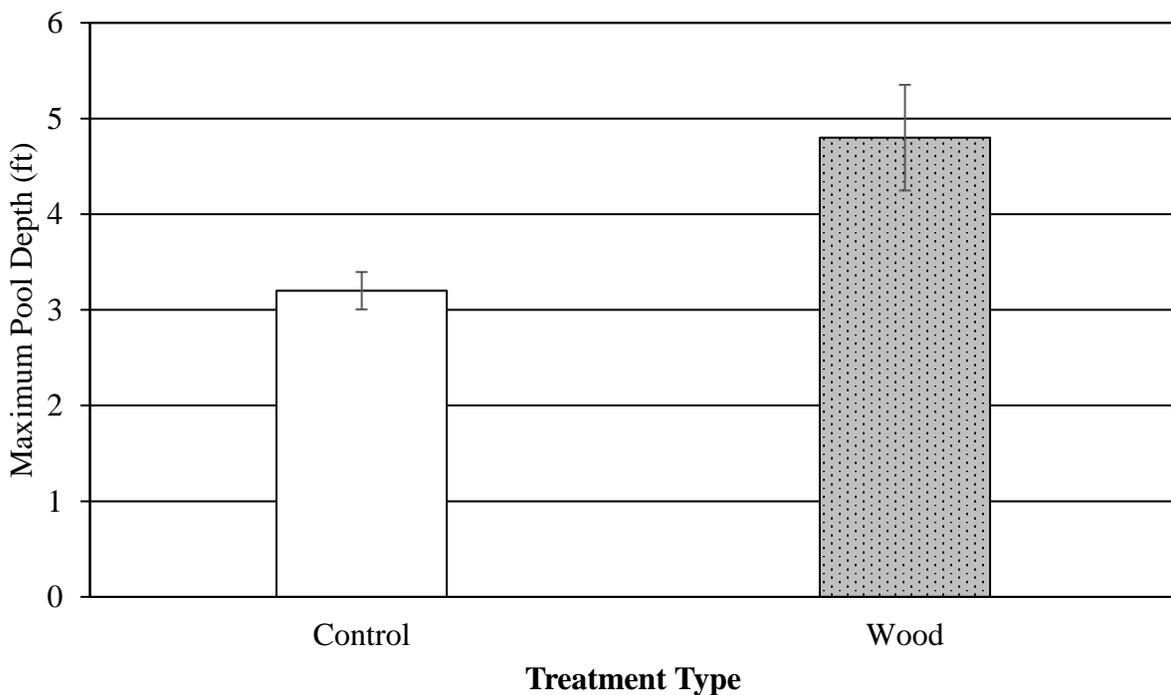
Figure 8. Average maximum pool depths (in feet) and 95% CI from Control (non-wood treated; n=3) and Wood (combined Type 1 and Type 2 toewood-treated; n=6) treated lateral scour pools. Maximum pool depths were measured as the maximum difference between the streambed and water surface elevations in the vertical plane.

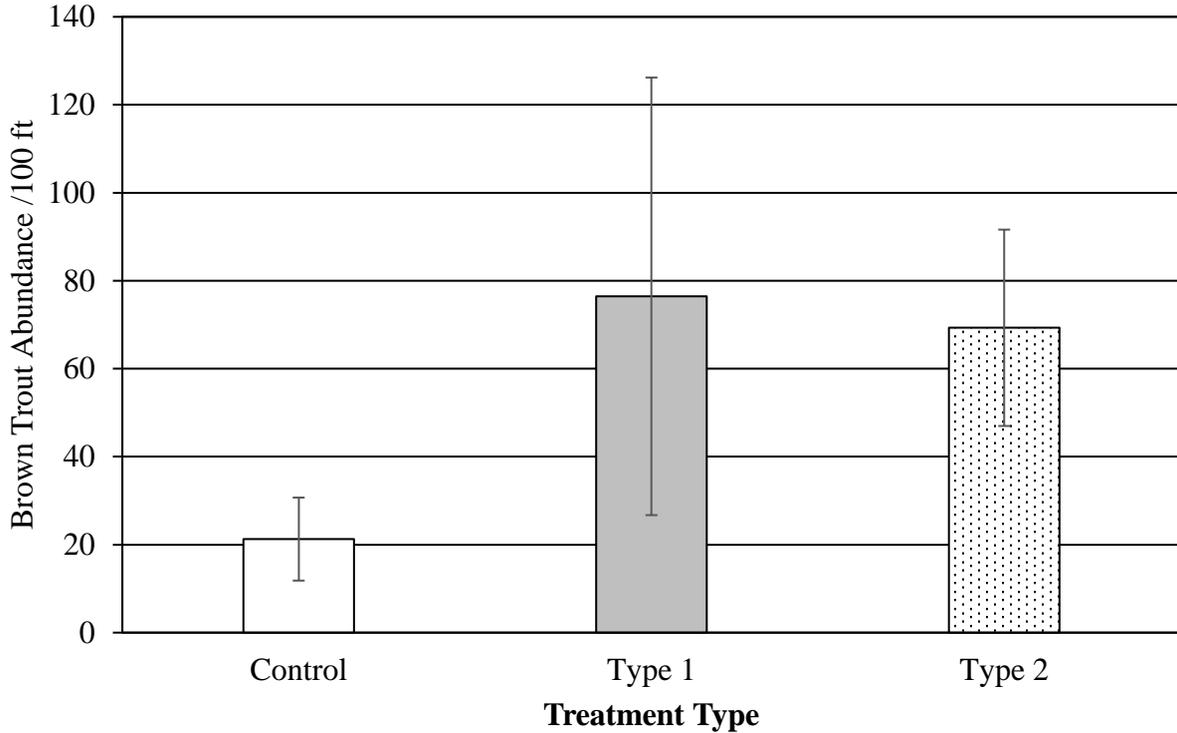
Figure 9. Average Brown Trout abundance (number of trout/100 ft of pool) and 95% CI from Control (non-wood treated; n=3), Type 1 (haphazard toewood; n=3) and Type 2 (undercut toewood; n=3) treated lateral scour pools.

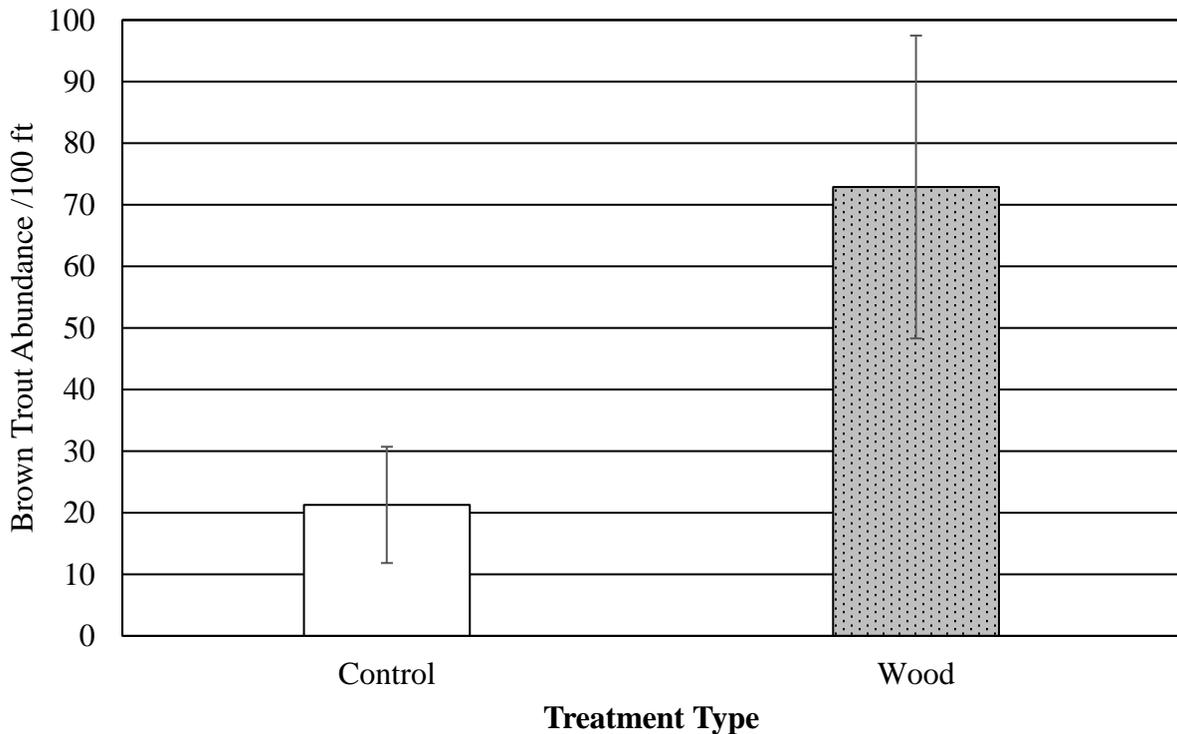
Figure 10. Average Brown Trout abundance (number of trout/100 ft of pool) and 95% CI from Control (non-wood treated; n=3) and Wood (combined Type 1 and Type 2 toewood-treated; n=6) treated lateral scour pools.

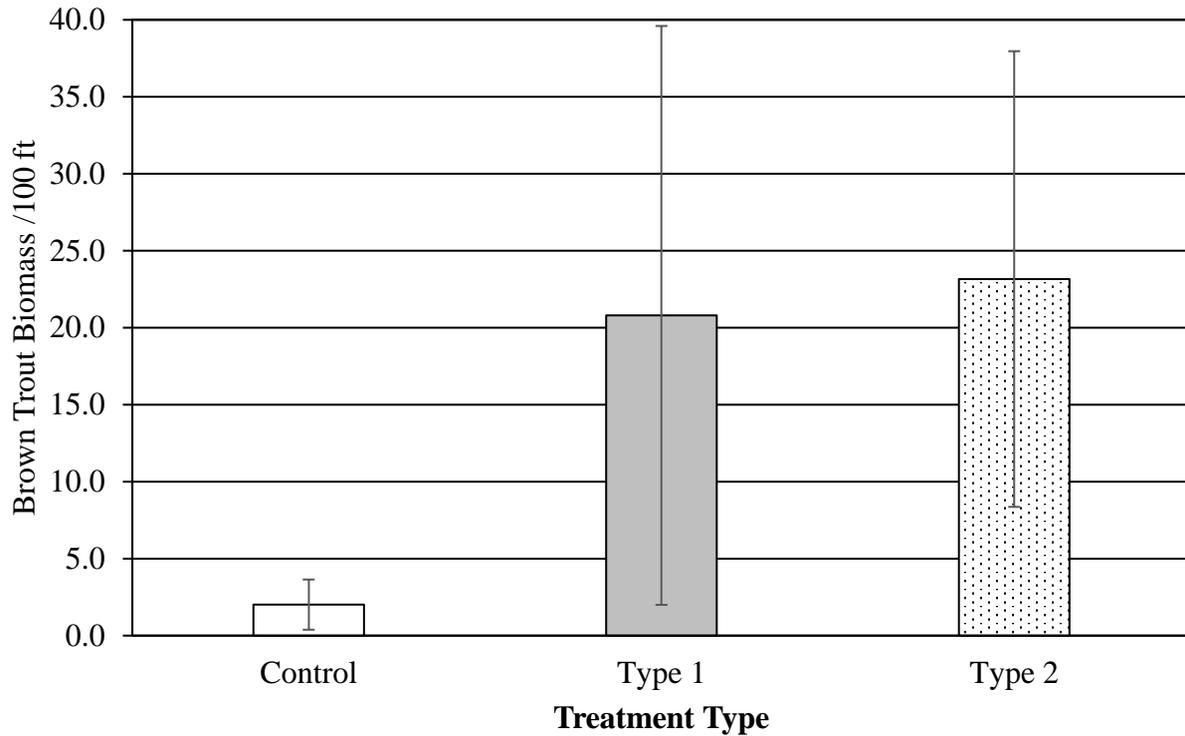
Figure 11. Average Brown Trout biomass (lbs of trout/100 ft of pool) and 95% CI from Control (non-wood treated; n=3), Type 1 (haphazard toewood; n=3) and Type 2 (undercut toewood; n=3) treated lateral scour pools.

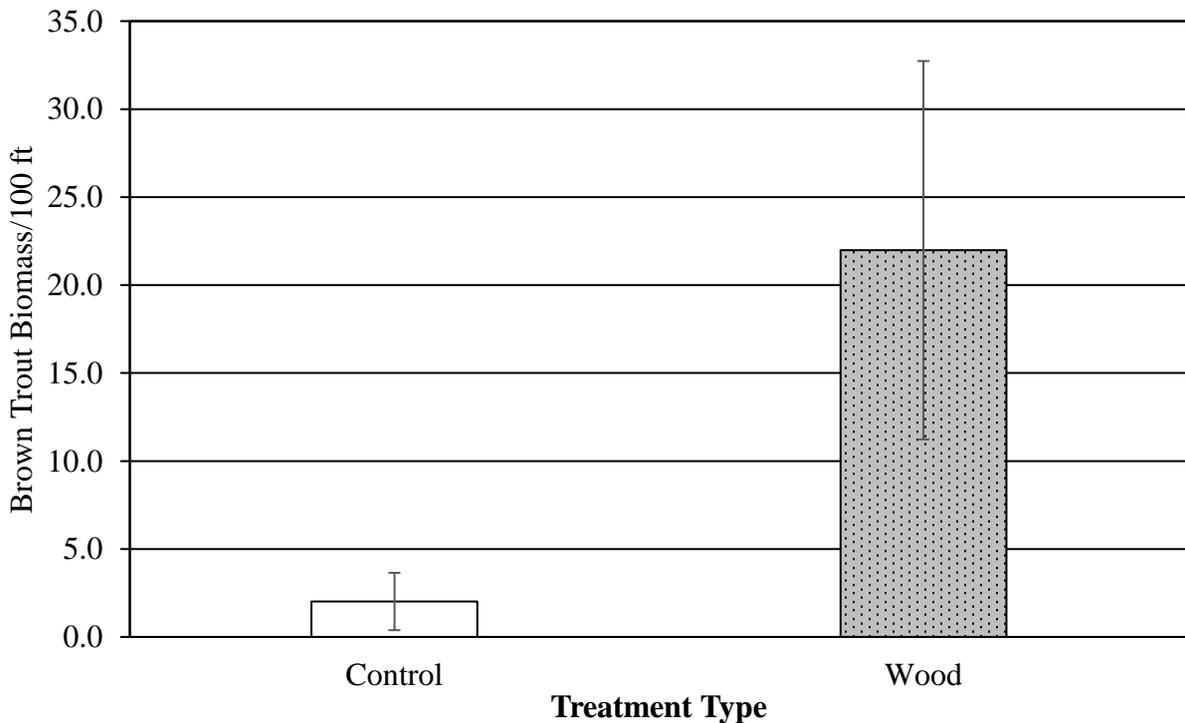
Figure 12. Average Brown Trout biomass (lbs of trout/100 ft of pool) and 95% CI from Control (non-wood treated; n=3) and Wood (combined Type 1 and Type 2 toewood-treated; n=6) treated lateral scour pools

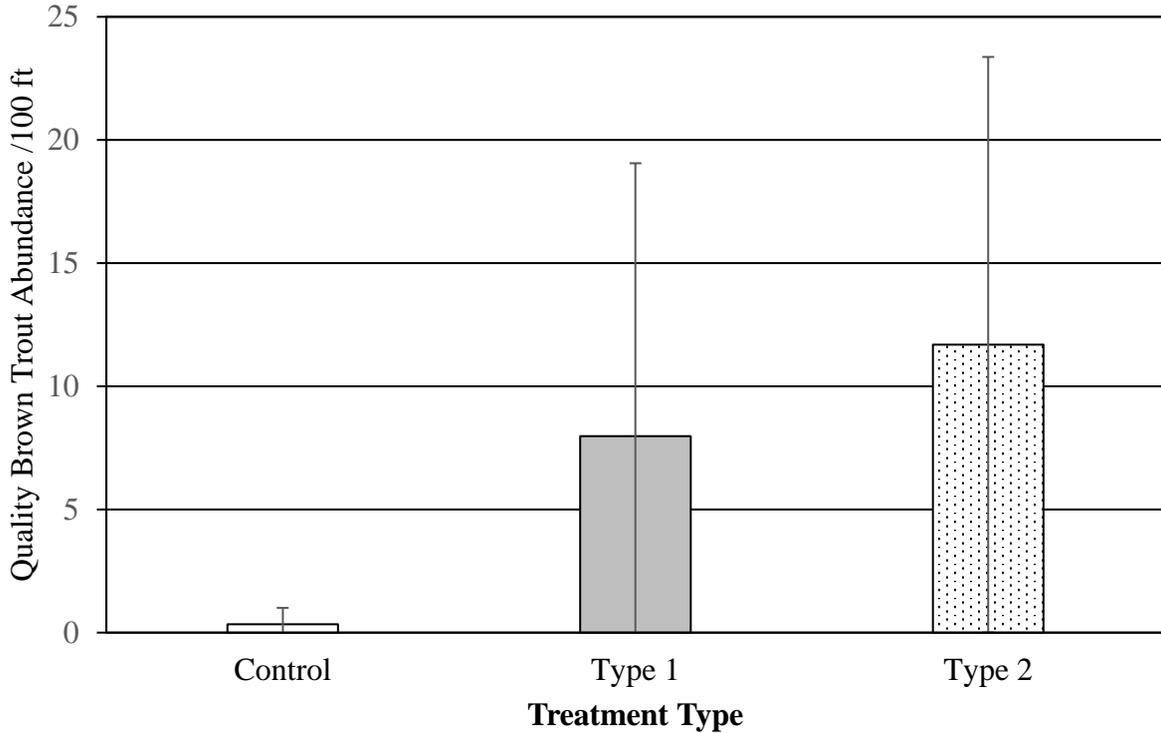
Figure 13. Average Quality Brown Trout (TL ≥ 14" TL) abundance (number of quality trout/100 ft of pool) and 95% CI from Control (non-wood treated; n=3), Type 1 (haphazard toewood; n=3) and Type 2 (undercut toewood; n=3) treated lateral scour pools.

The abundance of quality-sized Brown Trout (adult trout $\geq 14''$ TL) is important to estimate because quality-sized trout are desirable for anglers and they represent a portion of sexually mature individuals within a trout population. High quality habitats for wild trout will often have a diverse range of age classes represented, including large, sexually mature individuals. Quality Brown Trout abundance in Type 1 and Type 2 toewood treated pools was estimated to be higher (8 and 12 quality trout/100 ft of pool, respectively) than the non-wood treated Control pools (0.3 quality trout/100 ft of pool). All wood-treated toewood pools had quality Brown Trout present (range = 2-24 quality trout/100 ft of pool). However, only one of the three non-wood control pools had quality-sized Brown Trout present (range = 0-1 quality trout/100 ft of pool). The number of quality size Brown Trout found in individual study pools was highly variable for Type 1 and Type 2 toewood treated pools as is reflected in very wide 95% CI for abundance estimates (Figure 13). No significant differences between treatment types were detected. Since there was no difference between Type 1 and Type 2 quality Brown Trout abundance (95% CI overlap), all abundance estimates from wood-treated toewood pools were combined for comparison with the non-wood Control pool estimates (Figure 14). Wood-treated toewood pools held on average 28 times more Brown Trout than non-wood treated Control pools and this difference was statistically significant (95% CI non-overlapping).

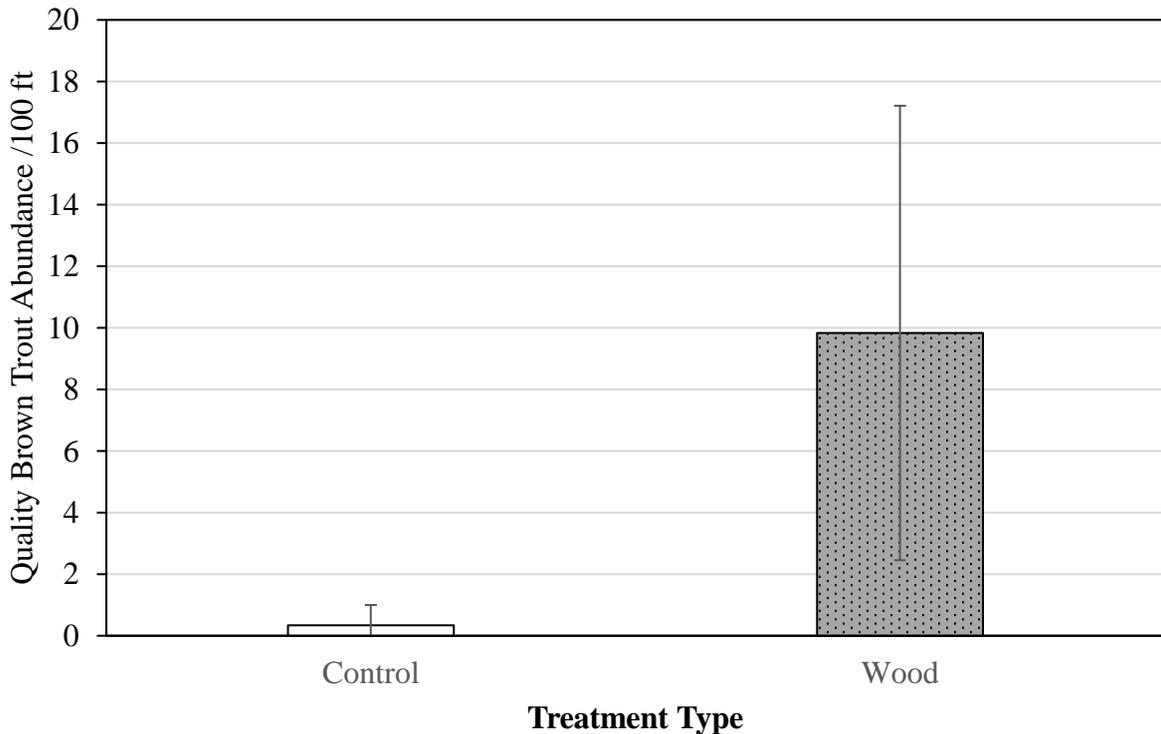
Figure 14. Average Quality Brown Trout (TL ≥ 14" TL) abundance (number of quality trout/100 ft of pool) and 95% CI from Control (non-wood treated; n=3) and Wood (combined Type 1 and Type 2 toewood-treated; n=6) treated lateral scour pools.

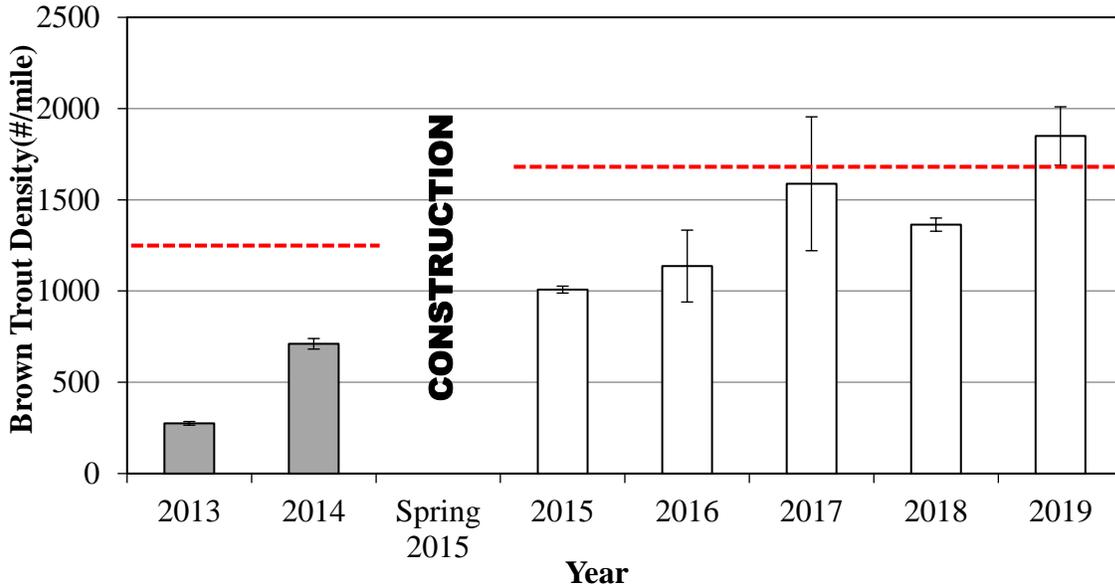
High-Intensity Treatment: Trout Density (#/mile)

Figure 15. Brown Trout density (number/mile) within the “high-intensity” treatment site for pre- (shaded; 2013-2014) and post- (white; 2015-2019) construction years. Red dashed line represents the average Brown Trout density within the control reach during the pre- and post-construction periods.

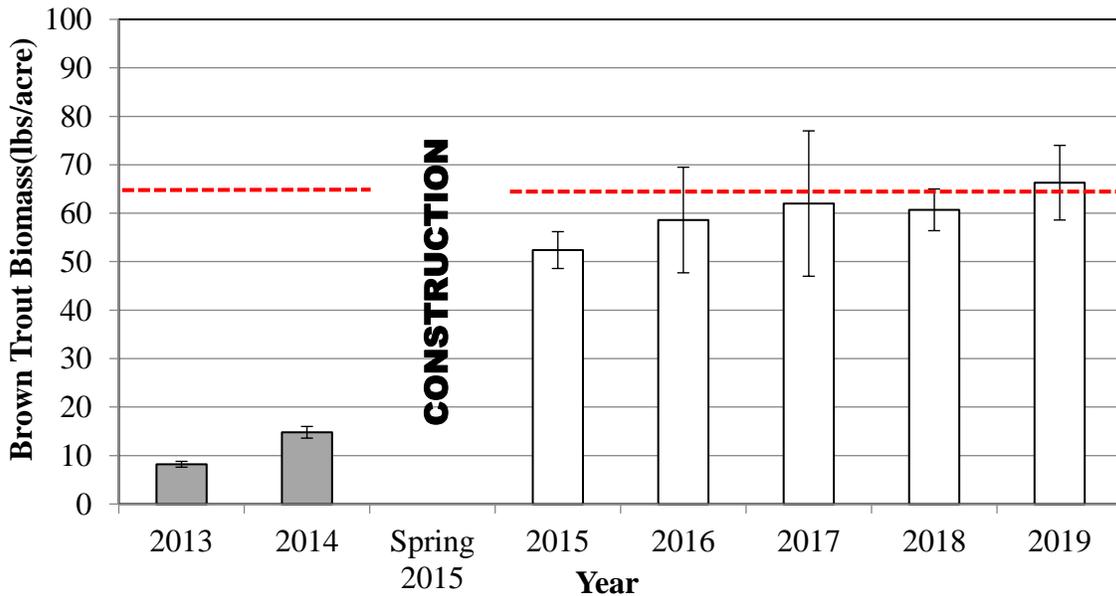
High-Intensity Treatment: Trout Biomass (lbs/acre)

Figure 16. Brown Trout biomass (lbs/acre) within the “high-intensity” treatment site for pre- (shaded; 2013-2014) and post- (white; 2015-2019) construction years. Red dashed line represents the average Brown Trout biomass within the control reach during the pre- and post-construction periods.

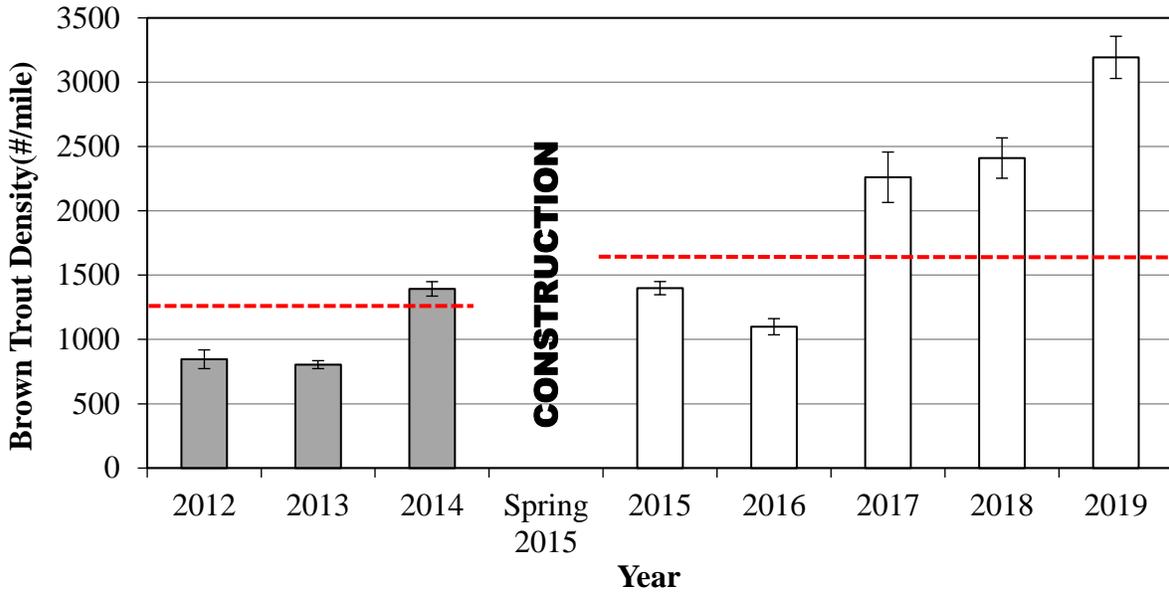
Low-Intensity Treatment: Trout Density (#/mile)

Figure 17. Brown Trout density (number/mile) within the “low-intensity” treatment site for pre- (shaded; 2013-2014) and post- (white; 2015-2019) construction years. Red dashed line represents the average Brown Trout density within the control reach during the pre- and post-construction periods.

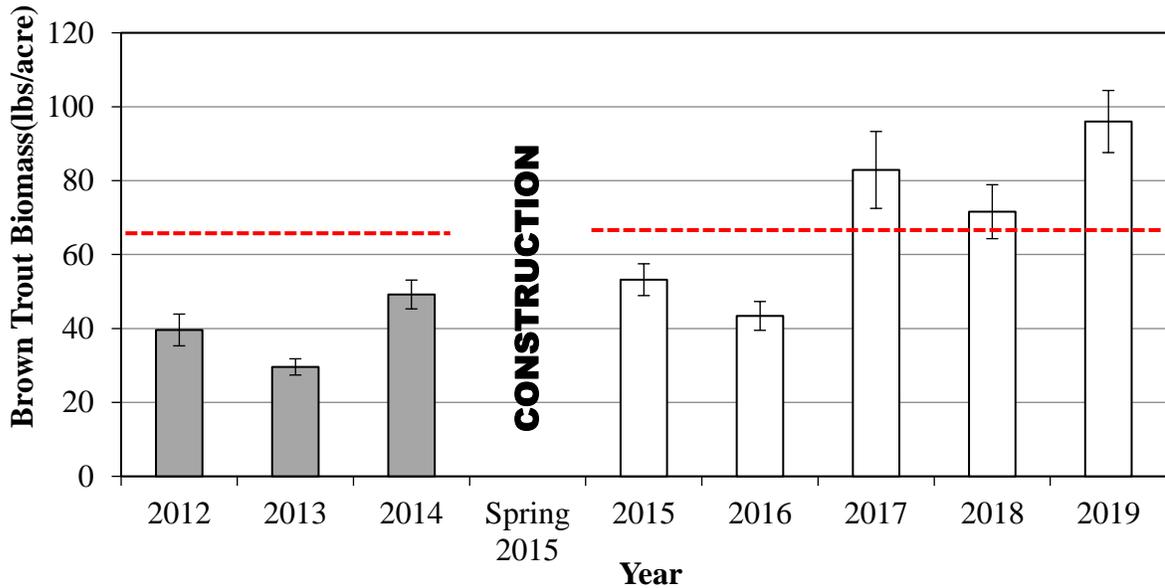
Low-Intensity Treatment: Trout Biomass (lbs/acre)

Figure 18. Brown Trout biomass (lbs/acre) within the “low-intensity” treatment site for pre- (shaded; 2013-2014) and post- (white; 2015-2019) construction years. Red dashed line represents the average Brown Trout biomass within the control reach during the pre- and post-construction periods.

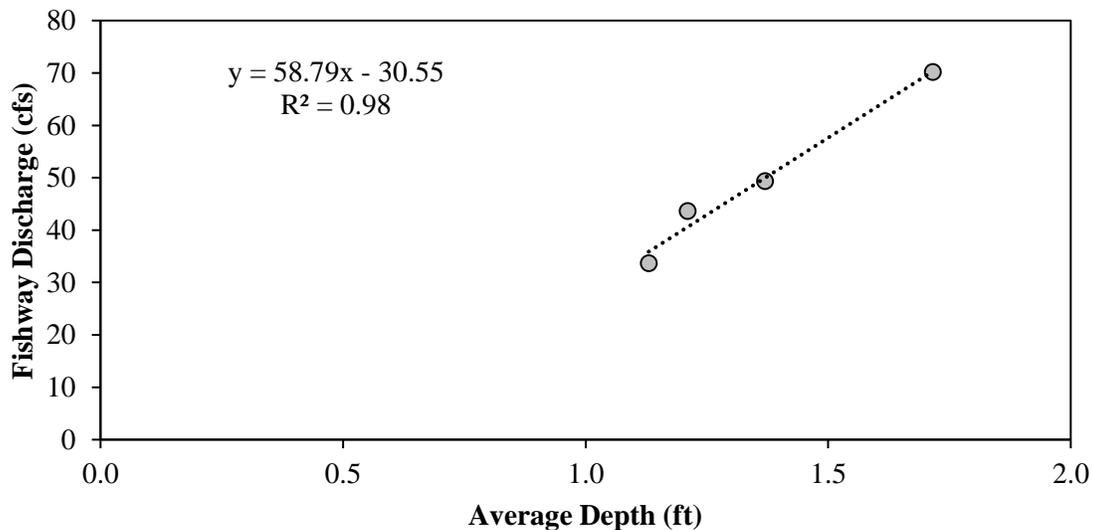
Figure 19. Relationship between average water depth and total fishway discharge at the upstream most section of the Watson Diversion fishway on the Cache la Poudre River.

The stage-discharge relationship for the Watson fishway indicates that the maximum observed fishway capacity was 70.2 cfs, compared to the minimum design capacity of 30 cfs (Figure 19). Depth-average velocity within the flat discharge measurement section was higher than the target design velocity of 3.0 ft/s, and ranged from 3.7-5.1 ft/s. This suggests that the discharge measurement section may impair passage for weaker swimming species and smaller trout under some flows. We recommend that roughness elements be incorporated into the discharge measurement section to reduce velocities and improve passage conditions.

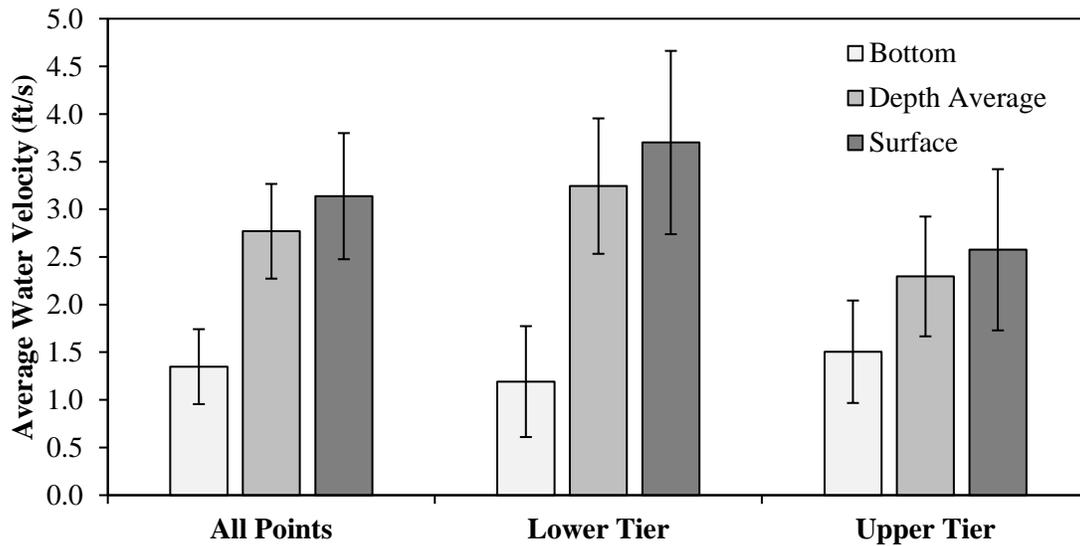
Figure 20. Water velocity results from hydraulic measurements within the Watson Diversion fishway on the Cache la Poudre River at a fishway discharge of 33.6 cfs, including all points, points on the lower tier only, and points on the upper tier only. Error bars represent 95% confidence intervals.

on the upper tier were lower than velocities on the lower tier, as designed (Figure 20). However, we have observed high velocities (>5 ft/s) on the upper tier in locations where the fishway makes a bend or turn. These areas of elevated velocity indicate that a continuous pathway meeting the design criteria for water velocity is not present on the upper tier. We recommend that 2D or 3D modeling be conducted for future fishway designs to evaluate potential areas of hydraulic complexity that would not be captured by a 1D hydraulic analysis.
