Stream Habitat Investigations and Assistance

Federal Aid Project F-161-R25

Performance Report

Colorado Parks & Wildlife

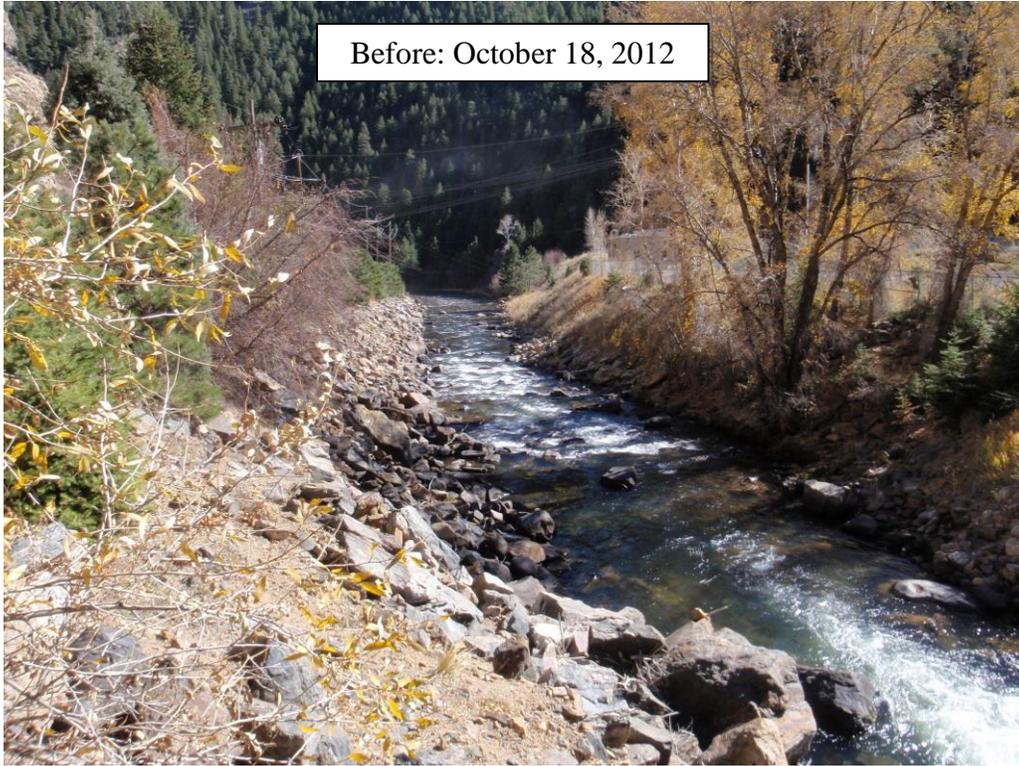
Figure 1.1. Pre-construction photo of the highly-confined “high-intensity” stream site as part of the Twin Tunnels project on Clear Creek.

The high-intensity treatment site is an approximately 1,300-ft long stream segment upstream of the Dog House Bridge. Primary treatments within this site consisted of riprap removal and

removal of excess bank material to create a new flood plain and shape a new active channel that would align with the current channel-forming discharge (bankfull Q). This involved conversion of the existing highly-confined, channelized and riprapped, single-stage Rosgen F-stream type (confinement ratio <1.4; channel slope < 2%) to a moderately-confined, three-stage Rosgen Bc-stream type (confinement ratio 1.4-2.2; channel slope= 0.9%). Confinement was defined as the width of the valley at two times the average depth at bankfull (bkf) elevation divided by the bkf channel width. The pre-construction single-stage channel was converted to a post-construction three-stage channel with functional floodplain. The average confinement pre-construction within the high-intensity treatment reach was 1.2 (Figure 1.1; highly-confined channel). The average confinement post-construction was increased to nearly 2.0 (Figure 1.2; moderately-confined channel) due to the removal of riprap and expansion of floodplain area by removal of fill material. Other treatments within the high-intensity site included: addition of 153 habitat boulders (65% of total for the project or 153 of 234 total), installation of eight boulder structures (J-hooks, boulder half vanes, and cross vanes; 89% of total for the project or eight of nine total), 2,458 linear feet (lf) of boulder toe (91% of total for the project or 2,458 lf of 2,708 lf total), 10 constructed pools (71% of total number of pools for the project or 10 out of 14 total), 5,420 square feet (sf) of point bar development (100% of total for the project), and 18,775 sf of new floodplain (or “riparian bench”) development (100% of total for the project).

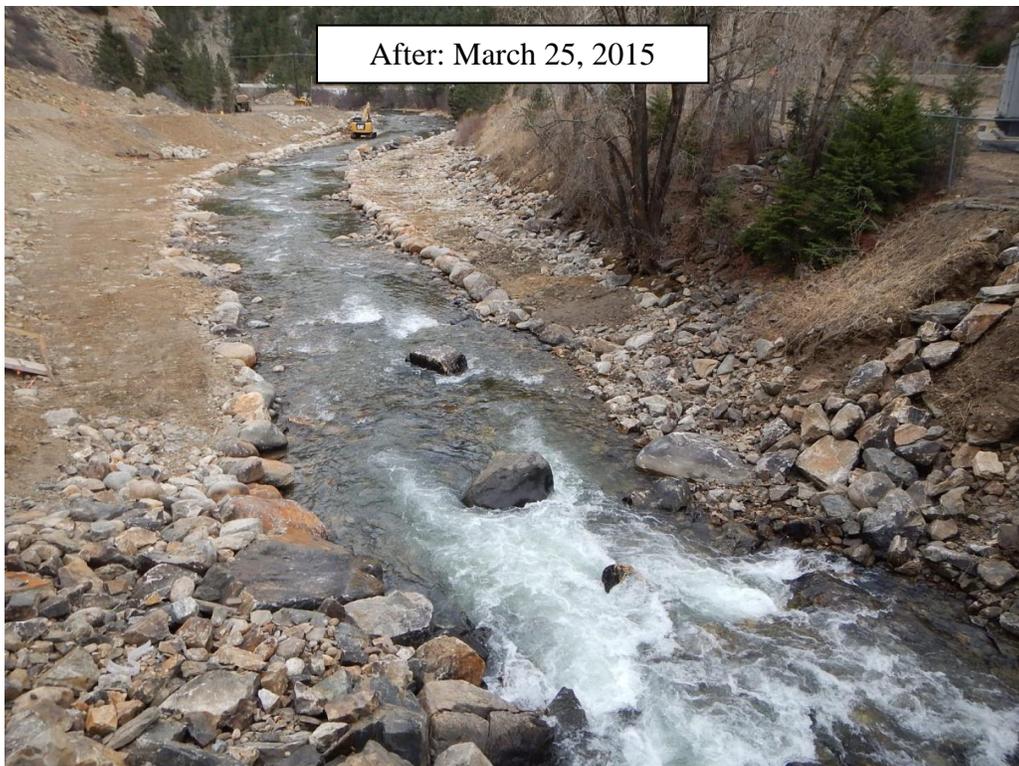
Figure 1.2. Post-construction photo of the moderately-confined “high-intensity” stream site as part of the Twin Tunnels project on Clear Creek.

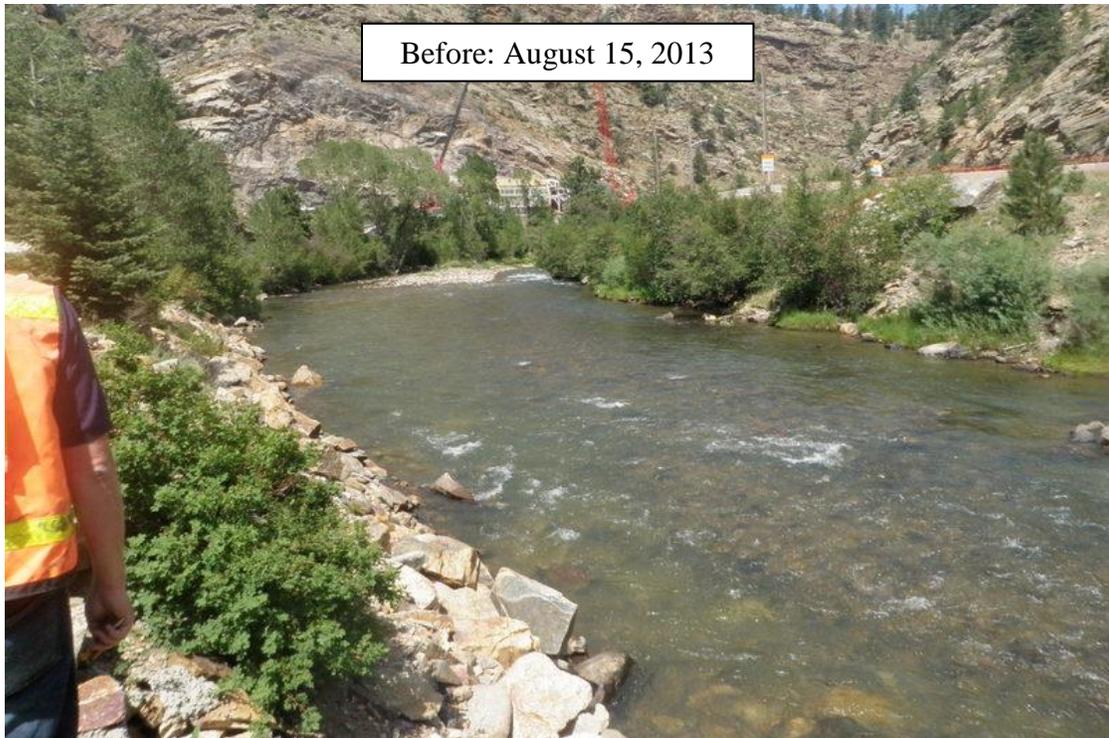
Figure 1.3. Pre-construction photo of the downstream “low-intensity” stream site as part of the Twin Tunnels project on Clear Creek.

The low-intensity treatment site consisted of an approximately 650-ft long stream segment located downstream of the Dog House Bridge. Unlike the high-intensity site, the channel geometry was not altered in this reach (no removal of riprap or excess bank material, conversion of single-stage to three-stage channel, point bar development, or riparian bench development). The average confinement for this reach before (Figure 1.3) compared with after (Figure 1.4) the project did not change (1.2). The low-intensity treatment site remained highly confined, riprapped, and constrained between two roadways. Treatments in the low-intensity segment included addition of habitat boulders (35% of total for the project or 81 of 234 total), installation of one boulder structure (cross-vane; 11% of total for the project or one of nine total), 250 lf of boulder toe (9% of total for the project or 250 lf of 2,708 lf total), and four constructed pools of which three were located off the main channel in a side-channel (Figures 1.5 and 1.6; 29% of total number of pools for the project or four out of 14 total). No point bar development or riparian benches were constructed within the low-intensity treatment segment.

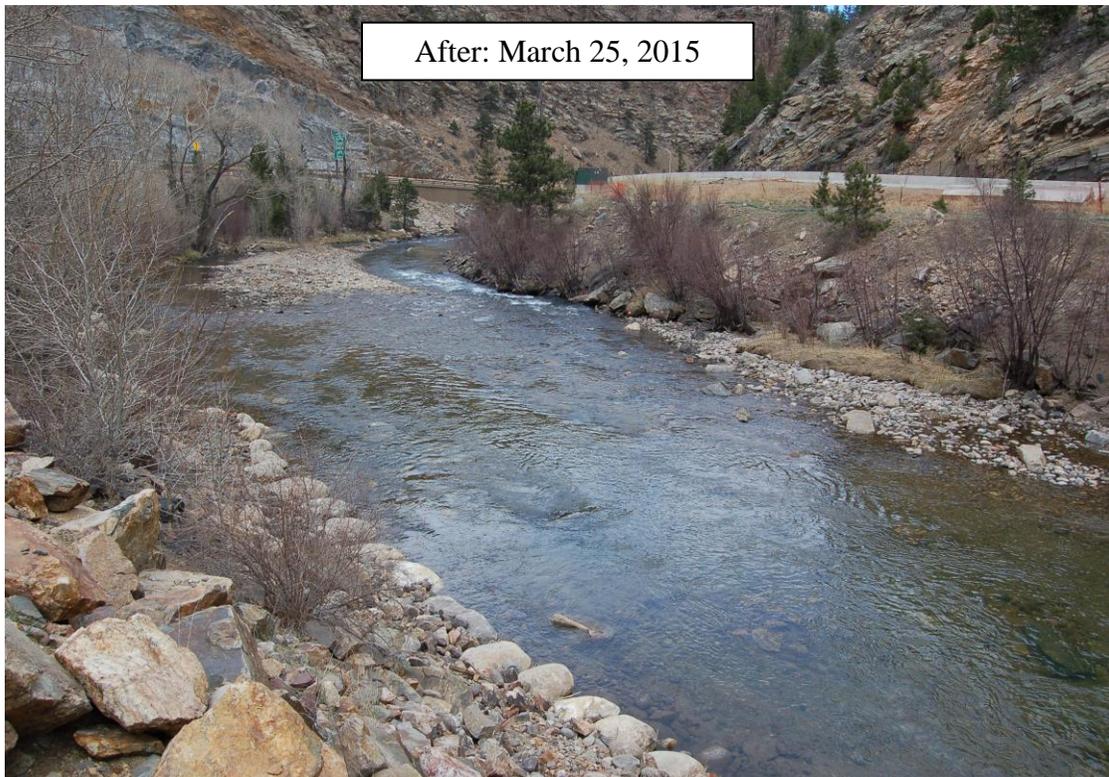
Figure 1.4. Post-construction photo of the downstream “low-intensity” stream site as part of the Twin Tunnels project on Clear Creek.

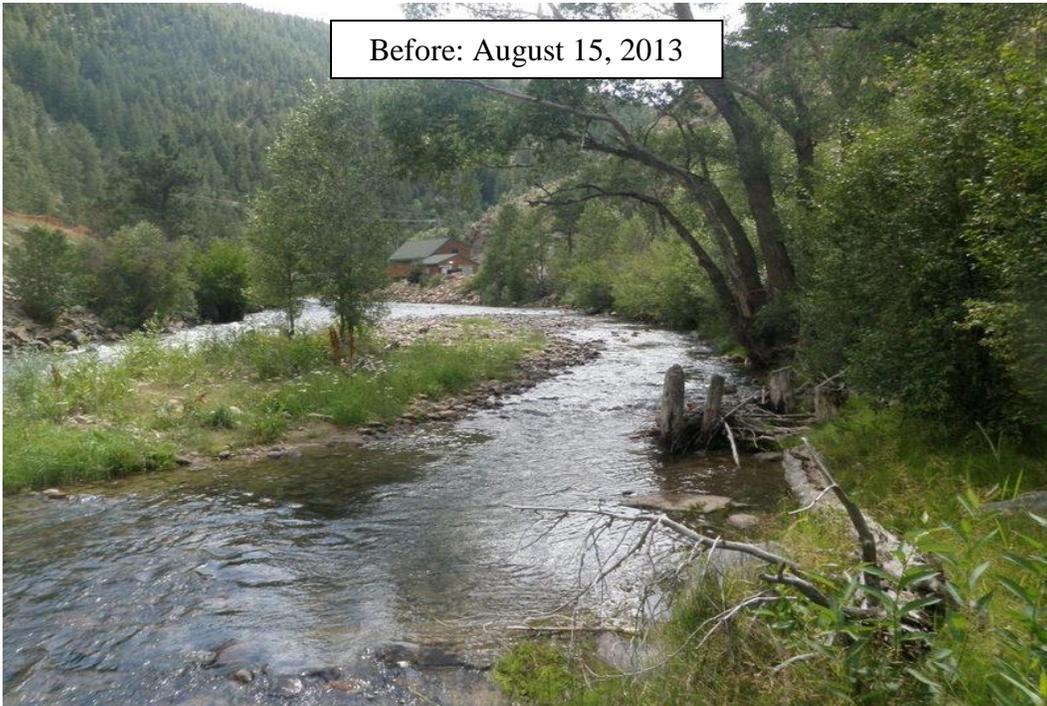
Figure 1.5. Pre-construction photo of the downstream “low-intensity” stream site (side-channel treatment) as part of the Twin Tunnels project on Clear Creek.

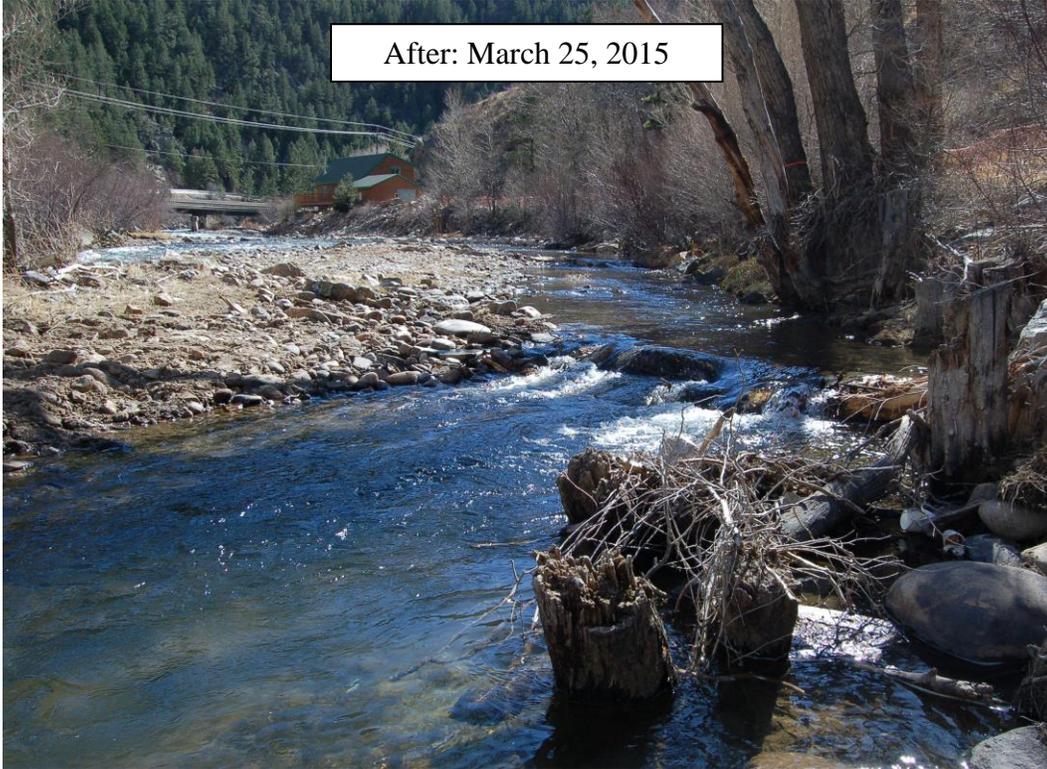
Figure 1.6. Post-construction photo of the downstream “low-intensity” stream site (side-channel treatment) as part of the Twin Tunnels project on Clear Creek.

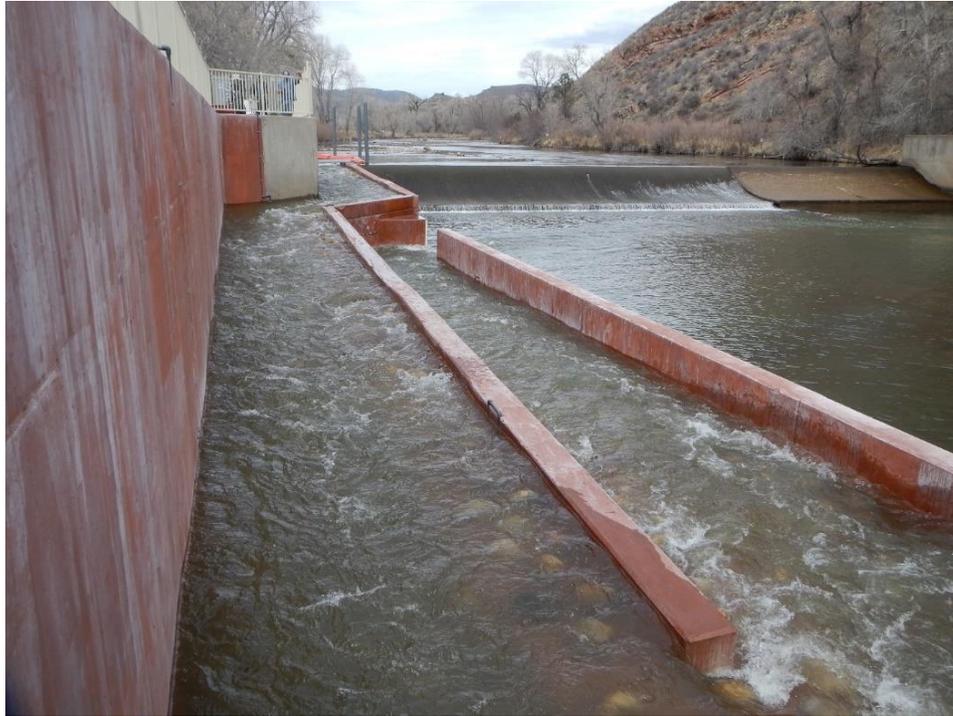
Figure 2.1. Engineering rock-ramp fish passage structure at the Watson Lake diversion structure on the Cache la Poudre River, Colorado.

To evaluate hydraulics within the fishway, point measurements for water depth, bottom velocity, depth-average velocity, and surface velocity were collected along five transects under the same discharge conditions. Measurements were collected at six points along each transect, with three points located on the lower and upper tiers, respectively. Water depth ranged from 0.50-1.80 ft, with an average of 1.26 ft. Results for velocity measurements are presented in Figure 2.2, including average values with 95% confidence intervals for the lower tier, upper tier, and all points combined. Water velocities were typically lower on the upper tier when compared to the lower tier. Water velocities also increased from the bottom to the top of the water column. In general, bottom and depth-average water velocities agreed with the target fish passage criteria of 2-3 ft/s, and bottom velocities were less than 2 ft/s for all measurement locations. The average
