The Bridge That Was

Castlewood Canyon State Park

The Castlewood Dam

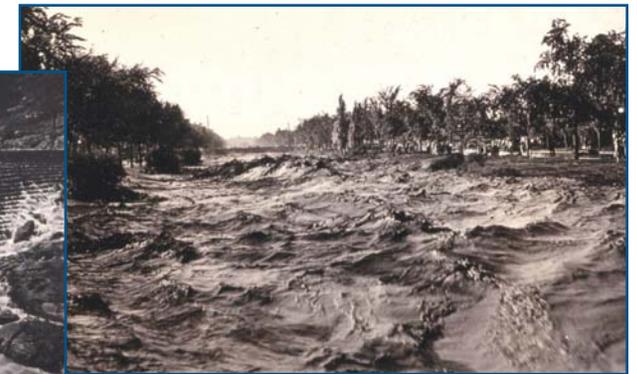
The wall of water grew higher as it approached Denver and reached the city about 7:00 a.m. It traveled down the concrete canal that follows Speer Boulevard. Reports vary about the depth of the water, but aerial photos show that much of the lowlands along Cherry Creek and the South Platte River were submerged. Damage was extensive, but only two people died.

Looking down Speer Boulevard
