## Blue River Above Dillon Reservoir

2019 fishery survey report

Jon Ewert — Aquatic Biologist, Colorado Parks and Wildlife

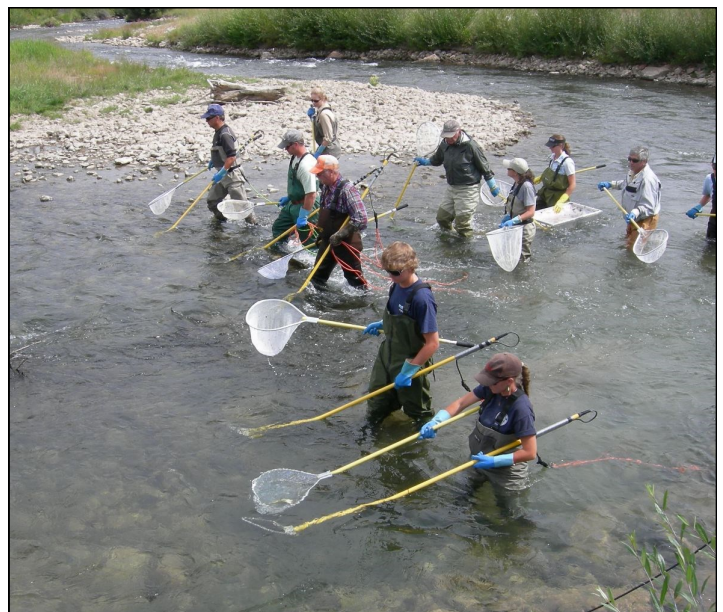
Figure 2. Electrofishing crew.

We conducted two-pass depletion population estimates of the reach by using a bank-based electrofishing array with 5 electrodes (Figure 2). Effort has been made to survey the reach as close to the same date as possible on each occasion if flows allow.

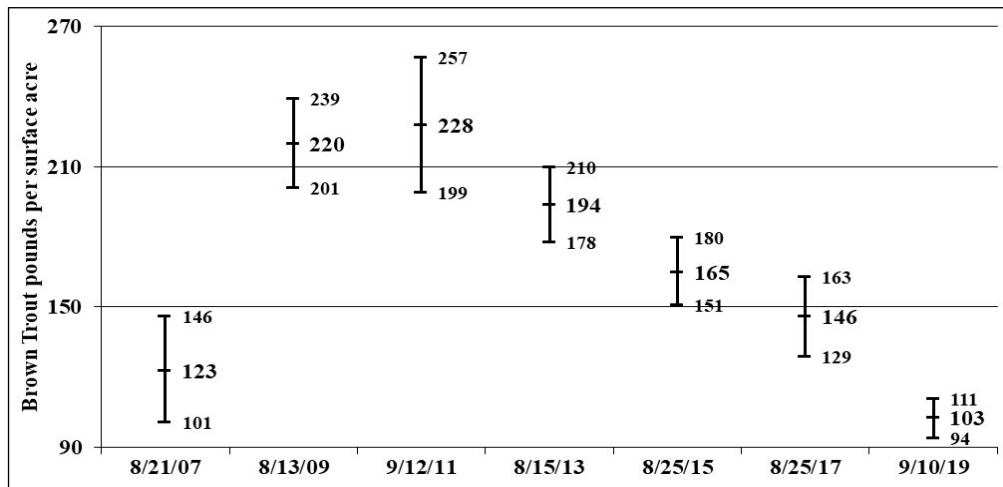
Figure 3. Brown Trout biomass estimates in pounds per surface acre, Fourmile Bridge reach, 2007-2019. Error bars display 95% confidence intervals.

cuses on the Brown Trout population. Figure 3 (following page) contains Brown Trout biomass density estimates for all of the surveys. There is an obvious and significant decline occurring in this fishery. In each of the past four surveys, the biomass estimate has fallen outside the 95% confidence interval of the previous estimate. The 2019 survey yielded the lowest estimate to date, which is less than half of the peak values observed in 2009 and 2011. The consistency and repeated observations of this downward trend over a period of several years make it a virtual certainty that this is not an artifact of sampling error.

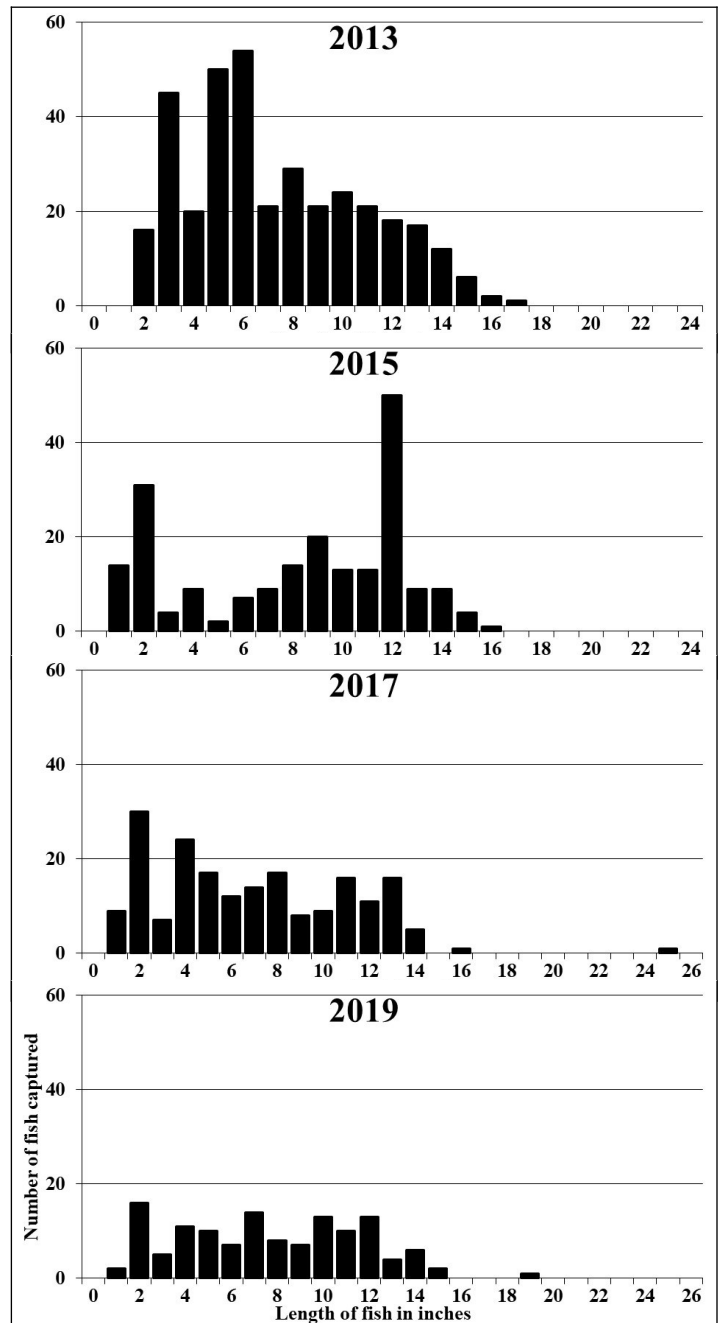
Figure 5. Size distribution of Brown Trout captured in the last four surveys of the Fourmile Bridge reach.

Figure 5 (following page) contains the size distribution of all Brown Trout captured in the past four surveys. The decline over time of all size classes of fish is evident.

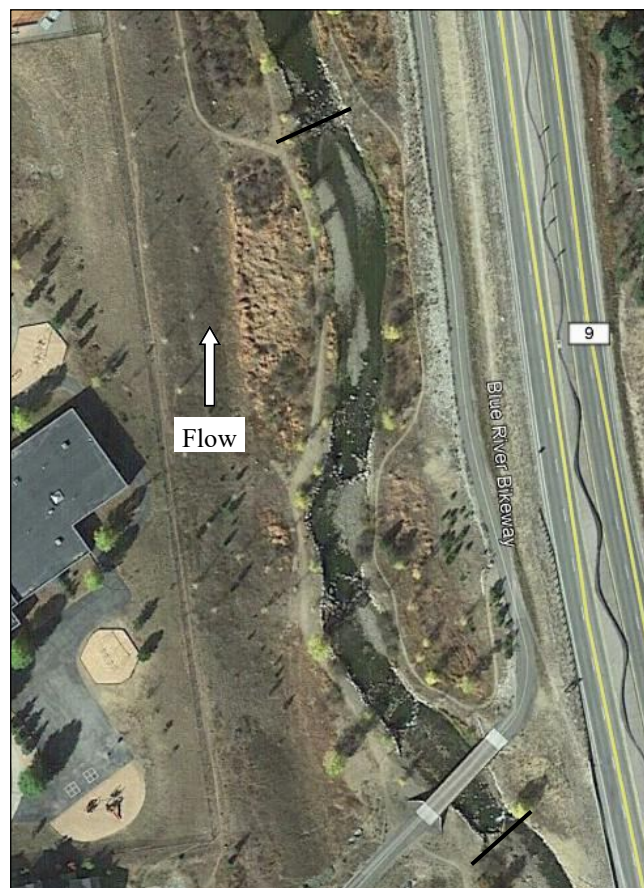
Figure 7. Location of Valley Brook Road station. Downstream (top) and upstream (bottom) terminus marked by black lines.

On September 10, 2019, we also conducted a fish population survey on a reach in Breckenridge known locally as “the steps” based on the configuration of stream stabilization structures that have been constructed there. The station was located immediately downstream of Valley Brook Road, adjacent to Upper Blue Elementary School (Figure 7, right). The surveyed reach measured 634 feet in length and 33 feet in average width. The downstream end of the station was located at the top of one of the step-like rock structures. The station encompassed three of the structures, and ended at the base of a structure. Due to its location in town, this area of the Blue receives heavy angler traffic, mostly from visiting tourists.

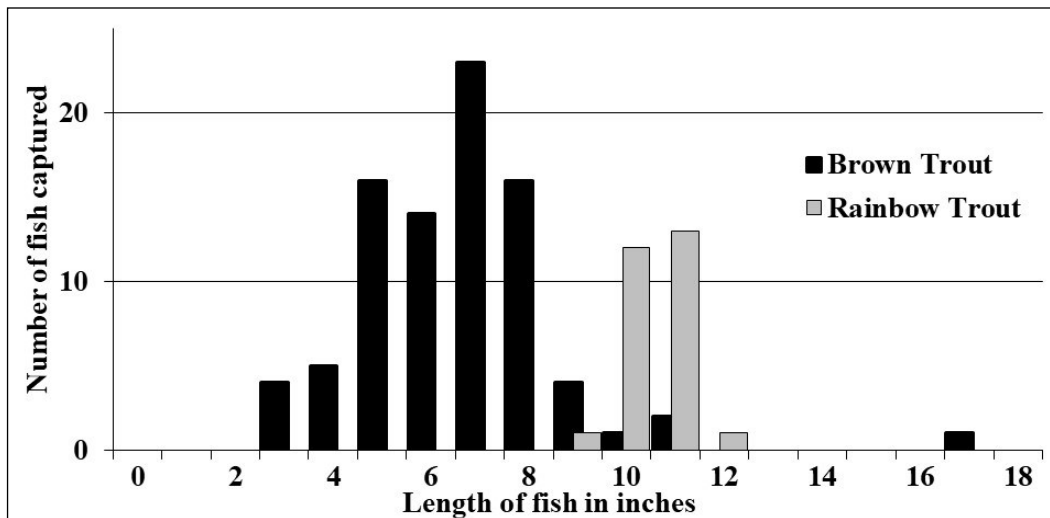
Figure 8. Size distribution of trout captured in the Valley Brook Road station, 2019.

Figure 8 (following page) contains the size distribution of Brown and Rainbow Trout that we captured. Based on their size range, all of the Rainbow Trout appeared to have originated from stocking occurring in 2019. We found no evidence of either successful reproduction of Rainbows or holdover and growth of fish stocked in previous years.
