Stream Habitat Investigations and Assistance

Federal Aid Project F-161-R18

Job Progress Report

Colorado Parks & Wildlife

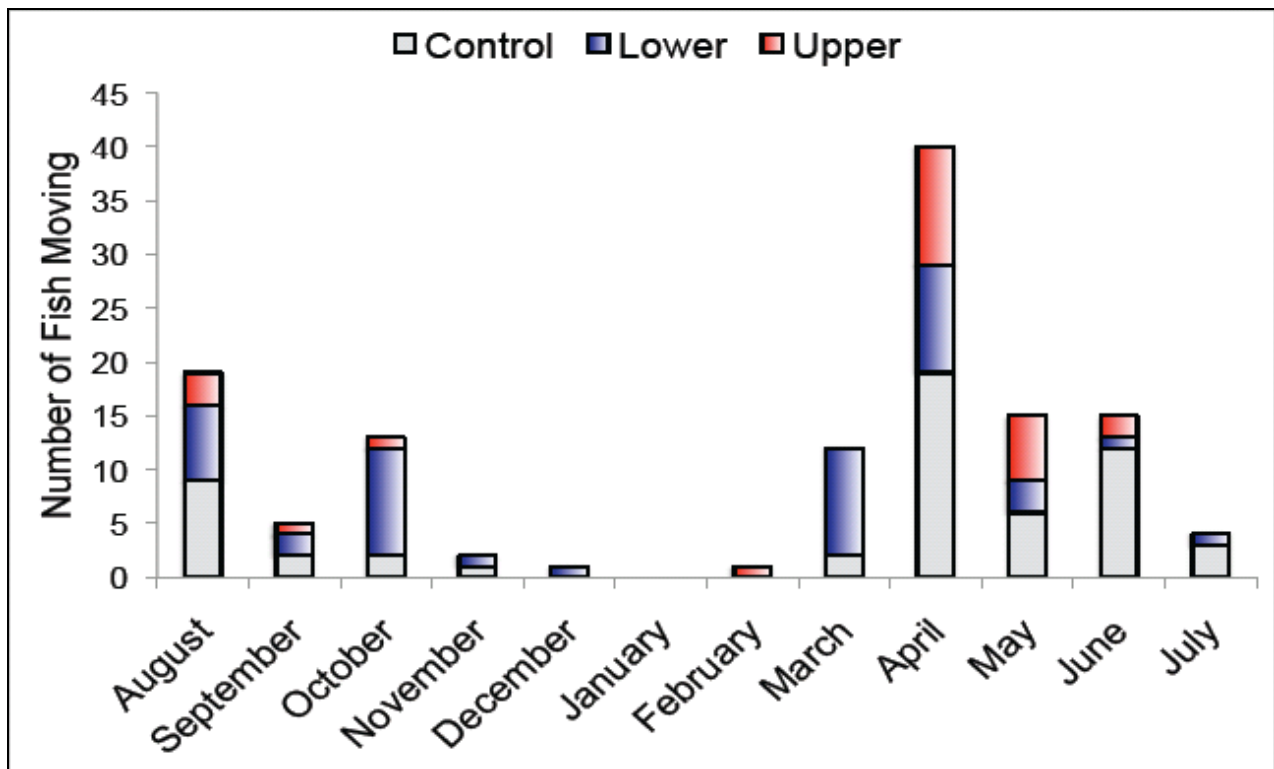
Figure 5. Seasonal pattern of movement at two structures and the control reach on South Boulder Creek.

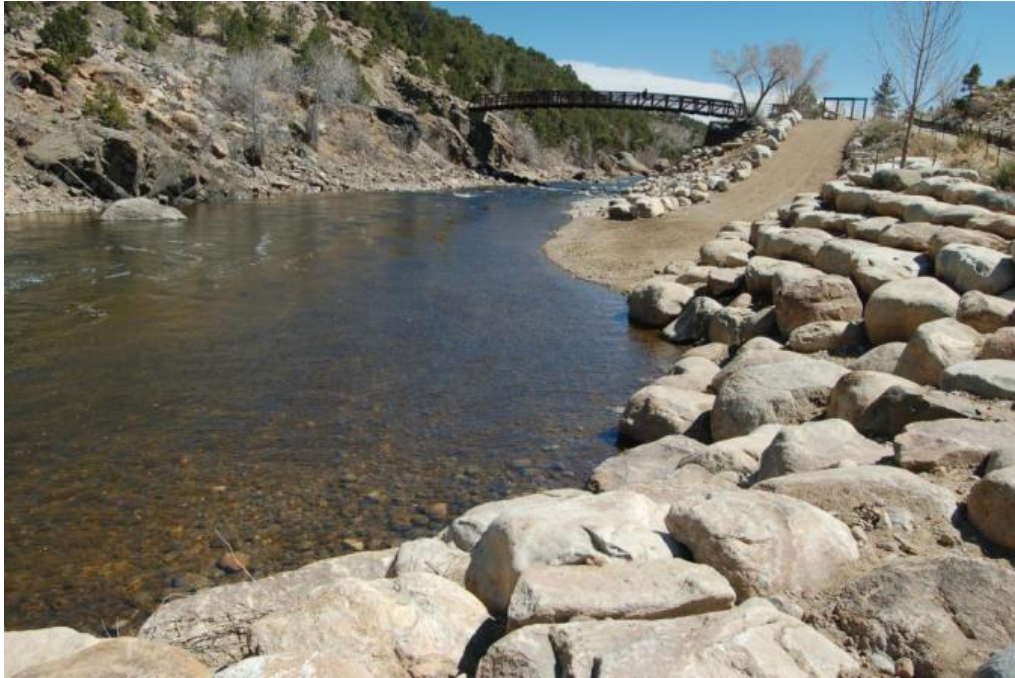
Figure 6. Typical lateral bank boulder armoring associated with WWP structures near Buena Vista, CO.

Grout (or cement) used in active river channels also require frequent maintenance and supervision. River channels are by nature active and require some degree of freedom to move horizontally within their adjacent floodplain areas. As natural rivers adjust or move over time, rigid concrete does not allow the ability for rivers to move particularly laterally. Often the river will “flank” the structure (erode behind the structure and bypass the structure) or concrete material will break apart and fracture leading to costly maintenance and frequent repairs. This is why many WWPs in Colorado have heavily-armored boulder banks or terraces associated with each WWP structure to prevent the river from moving laterally and to “fix” the river in a rigid sense (Figure 6).

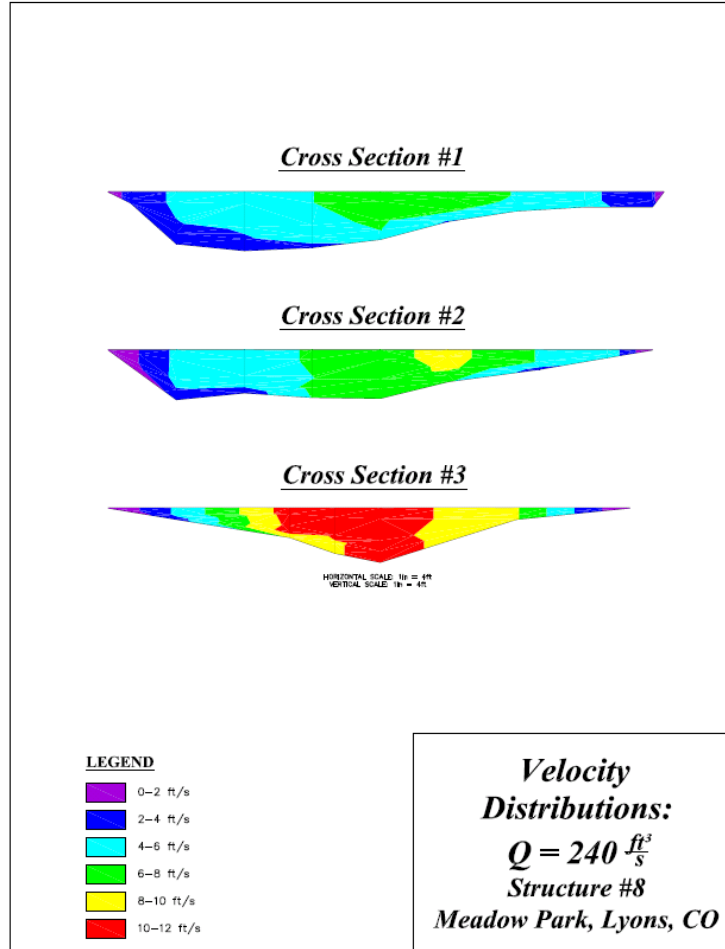
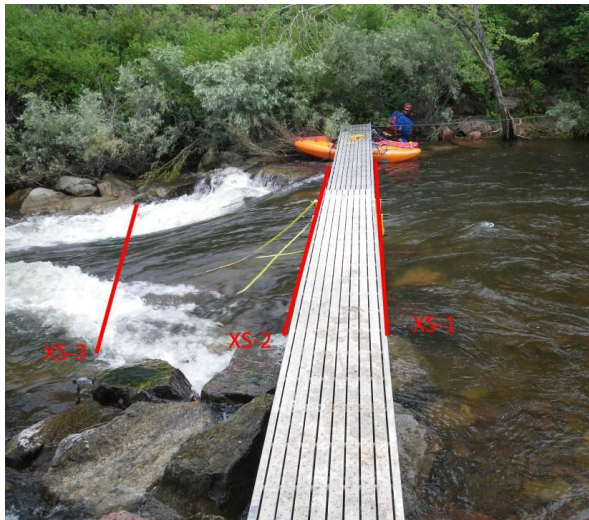
Figure 7: A. Velocity distribution profile through a typical WWP structure from St. Vrain Creek, Lyons, CO. Velocities were recorded using a flow meter corresponding to a discharge rate of 240 cfs. B. Locations where each of three cross-section velocity profiles were measured.

Velocities measured within WWP structures, especially during low flow periods when water is fully contained within a narrow cross-sectional area, have frequently exceeded 10 ft/second (Figure 7). These velocities are well above published swimming velocities for even the strongest swimming species (e.g. rainbow trout, Figure 8). In addition, fish that are adapted to natural conditions within a given stream reach are not adapted to these high velocities. Such high velocities are outside the range of expected velocities for the natural stream reaches where these species live.

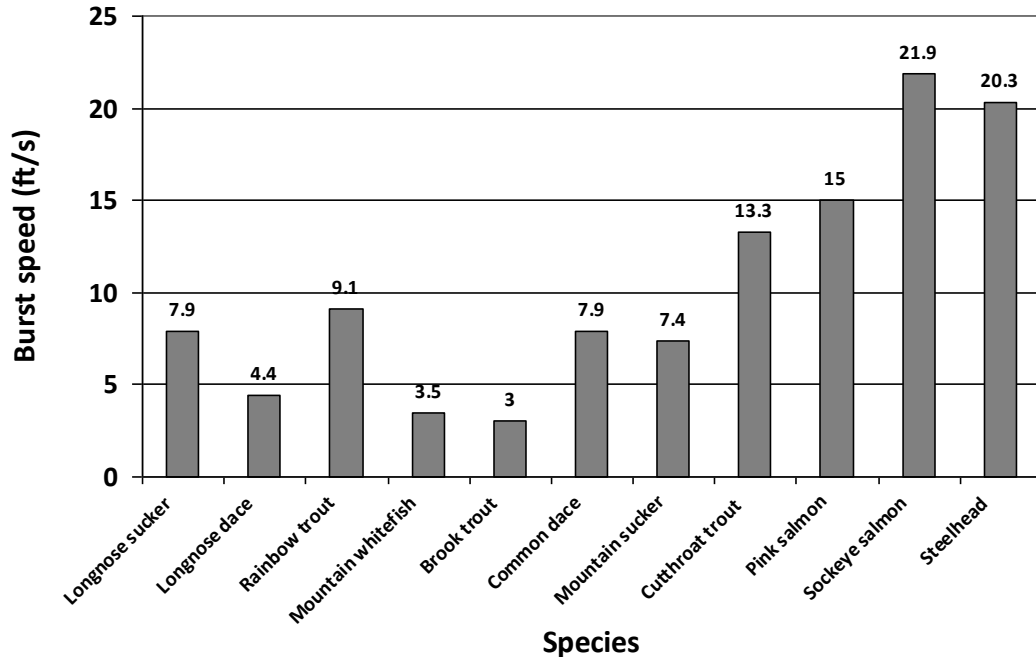
Figure 8: Maximum fish burst swim speeds from published sources. Burst swim speeds are commonly defined as the maximum speed a fish can sustain for no more than 20 seconds. Many Colorado fishes cannot swim faster than 10 ft/s.

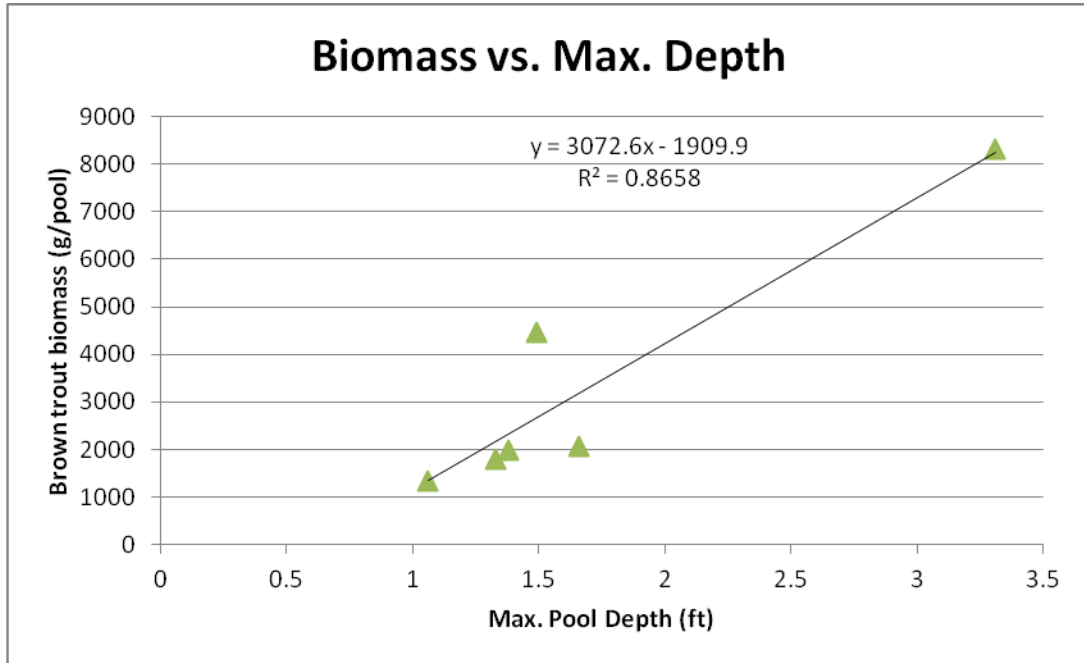
Figure 12. Relationship between brown trout biomass in grams/pool versus maximum pool depth in feet for natural (or control) pools. Data from monitoring shows a positive correlation between fish biomass and maximum pool depth, suggesting that fish biomass increases with increasing pool depth.

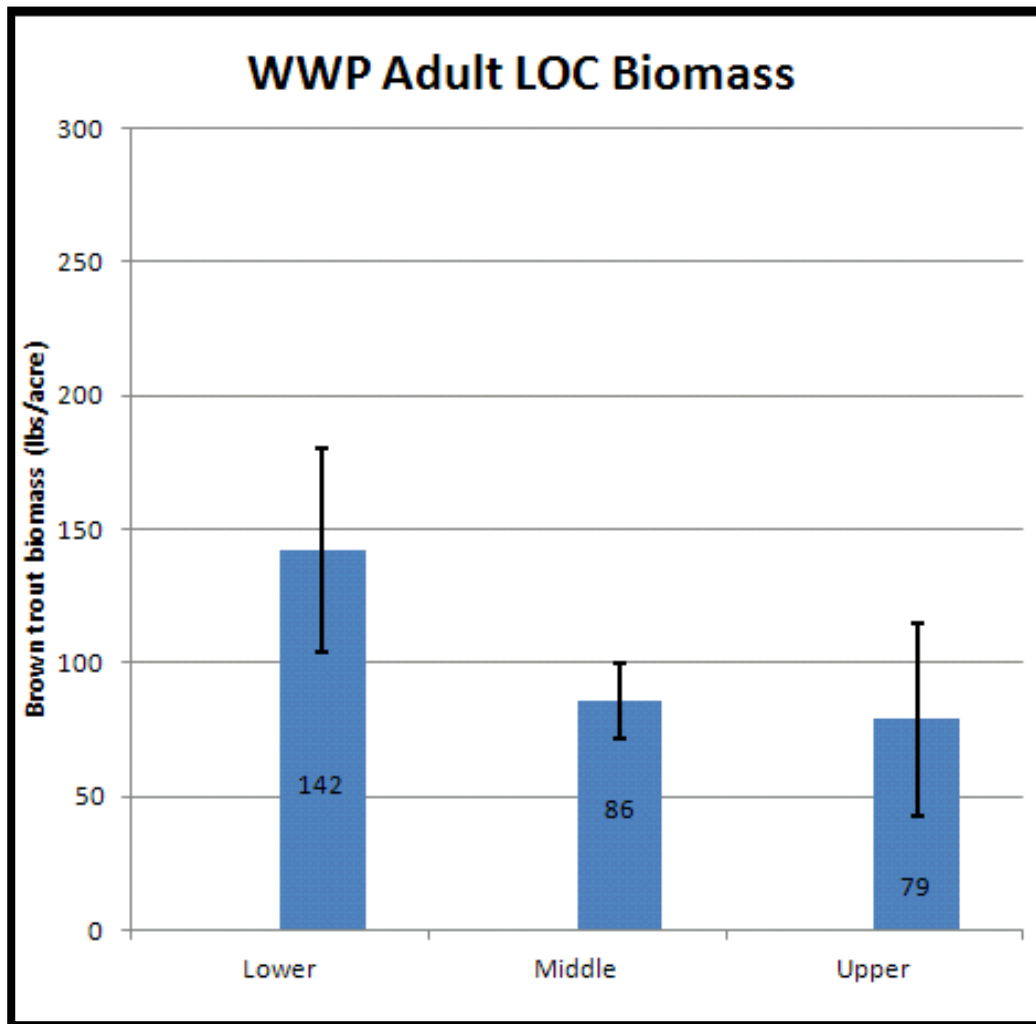
Figure 13. Results of fish population monitoring using electrofishing sampling gear. Blue bars represent brown trout biomass in WWP pools. Brown trout biomass measured in lbs/acre appears on the y-axis. Each of the three pools within each study reach is labeled on the x-axis as “Lower,” “Middle,” and “Upper.”

We also were able to sample the WWP pools during the peak spawning period for brown trout in November 2011. During this time, there is net-directed upstream movement of adult brown trout seeking out optimal spawning conditions located further upstream in the watershed. We found that there was nearly twice the biomass of brown trout in the lower-most pool than either the middle- or upper-most pools (Figure 13). We surveyed all three of the pools and found that all of them had very similar maximum pool depths, pool volumes, and pool surface areas. With all things being (nearly) equal, why would there be more fish in the lower-most pool compared to the two upstream pools given that brown trout were motivated to move upstream at this time (behaviorally)? We came up with two explanations: 1) brown trout movements were impeded or blocked by the lower-most WWP structures so they were getting crowded at this lower pool or 2) brown trout were massing at the lower-most WWP pool because some other fish species (forage fish) that were trying to move upstream during the same time period were getting stuck (impeded or blocked) at this location. This provided brown trout opportunity to feed on these forage fish since these fish were blocked from moving upstream from this point.

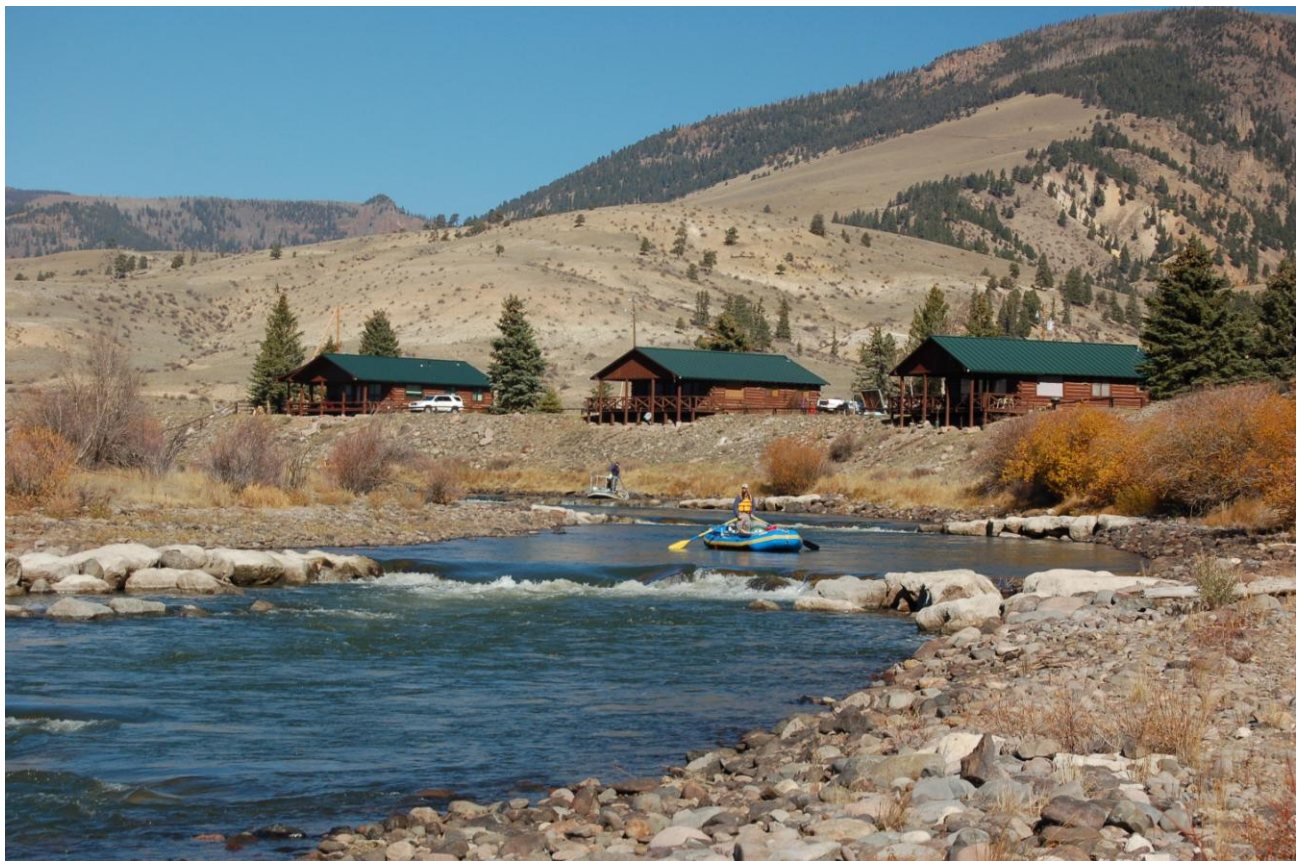
Figure 1. Upper Wason: Representative photo of the Upper Reach of the Wason Ranch. Notice the periodic large boulder-constructed cross-channel structures (cross vanes) used for grade control, creating deep pools, and narrowing the channels.

three reaches (J-hooks, vanes, cross vanes, off-channel developments) with many large, deep excavated pools for adult fish holding cover (Figure 1). The Lower Wason has fewer instream structures (J-hooks, cross vanes, excavated pools, etc.) than the Upper reach and consequently much fewer deep pools. Aside from containing fewer deep pools, the Lower reach is characterized overall by more randomly distributed boulders, wider channel dimensions and more streamside vegetation than the Upper reach (Figure 2). The La Garita reach has had the least amount of channel alterations/ improvements conducted on it. There are no instream structures in this reach such as J-hooks, cross vanes, W-weirs, or developed off-channel habitats. It has vegetated banks that are in similar condition to the Lower Wason reach, fewer large boulders than the Lower Wason and has more long areas of slow moving deep water (long runs). The channel width of the La Garita is probably closer to the Lower Wason than the Upper reach (Figure 3).

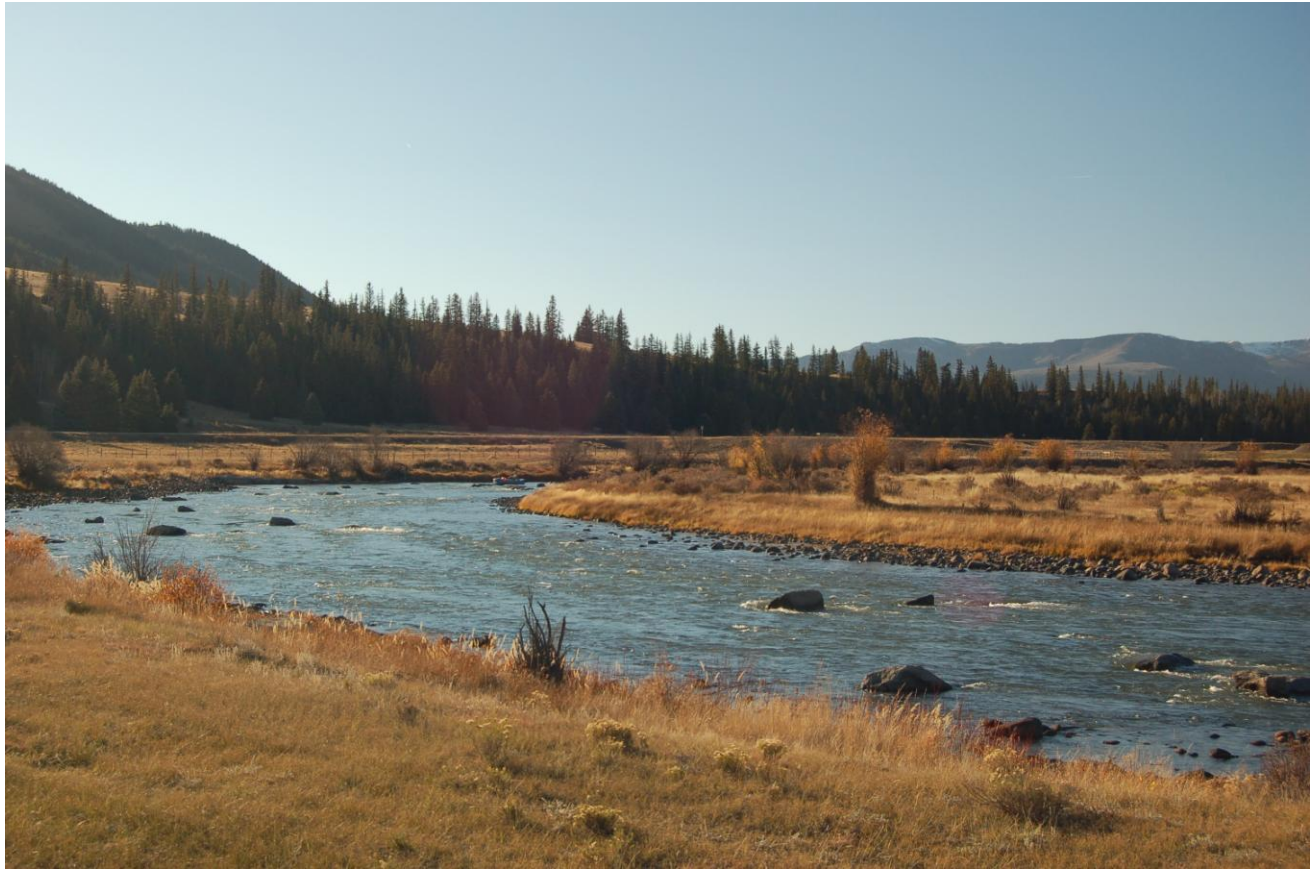
Figure 2. Lower Wason: Representative photo of the Lower Reach of the Wason Ranch. Notice the abundance of large protruding boulders, long riffles, coarse cobble substrate, lack of deep pools, lack of woody vegetation (alders and willows) and absence of large cross-channel structures.

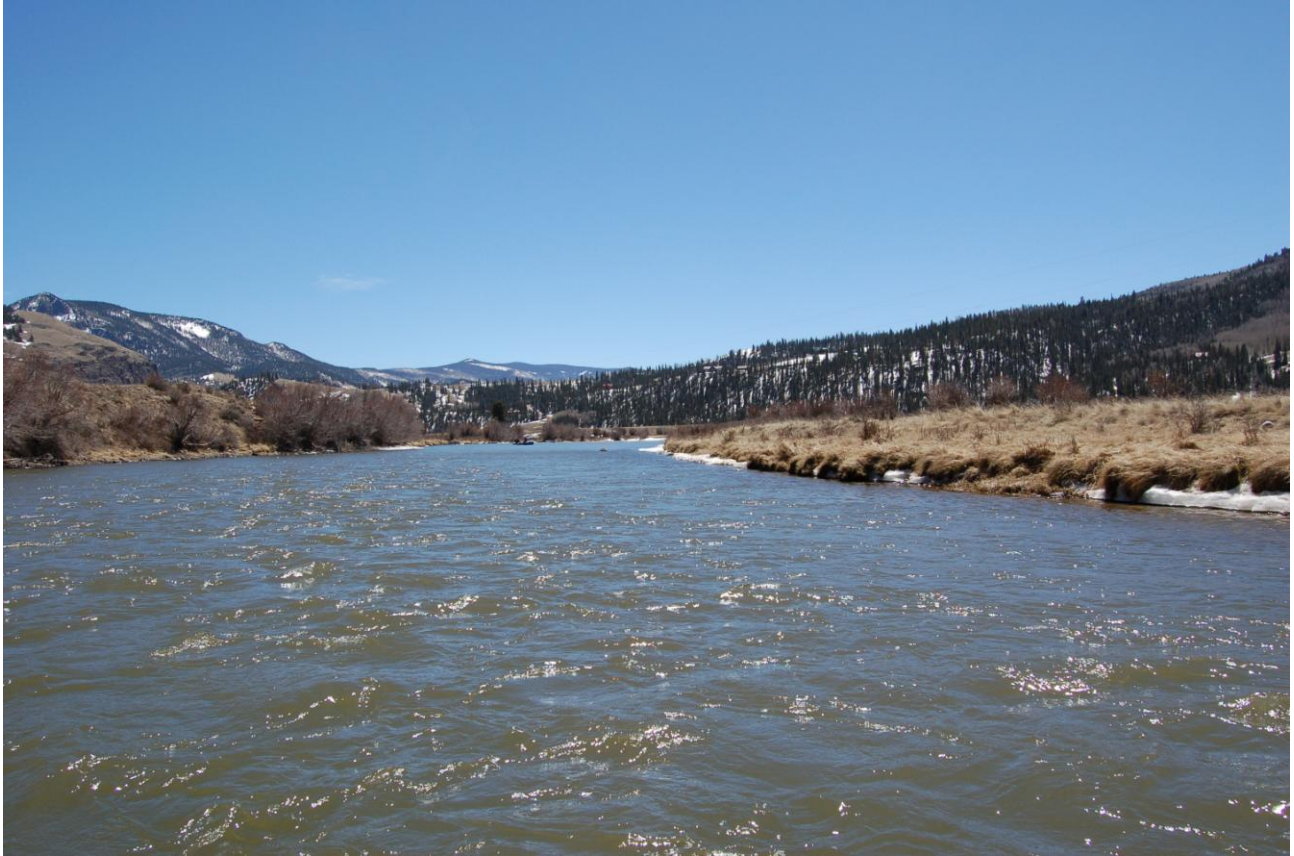
Figure 3. Control Reach: Representative photo of the La Garita Reach downstream of the Upper and Lower Wason. Notice the over-wide channel with sparse woody vegetation (alders and willows), dominance of long, continuous riffles and run habitat, lack of deep pools and lack of large protruding boulders.

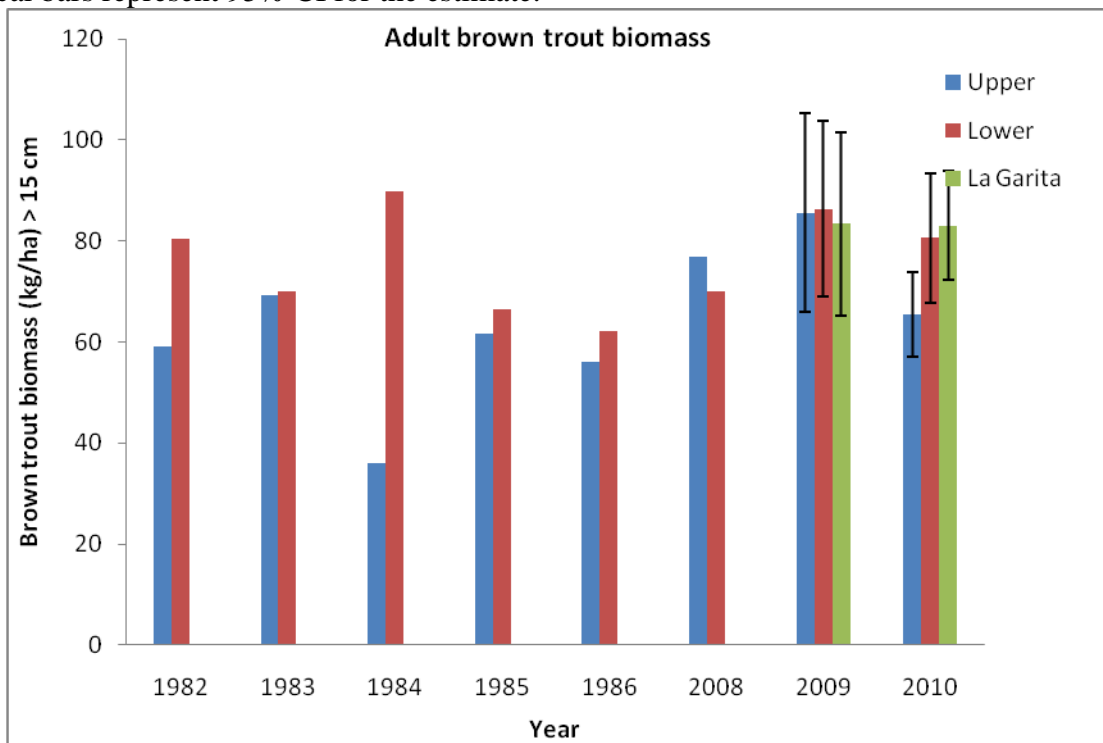
Figure 5. Biomass (kg/ha) of adult (6 inch and longer) brown trout in the Upper Wason, Lower Wason and La Garita reaches. Pre-restoration sampling estimates include years: 1982, 1983, 1984, 1985 and 1986. Post-restoration sampling estimates include years: 2008, 2009 and 2010. Black vertical bars represent 95% CI for the estimate.
