Stream Habitat Investigations and Assistance

Federal Aid Project F-161-R20

Job Progress Report

Project Title: Stream Habitat Investigations and Assistance

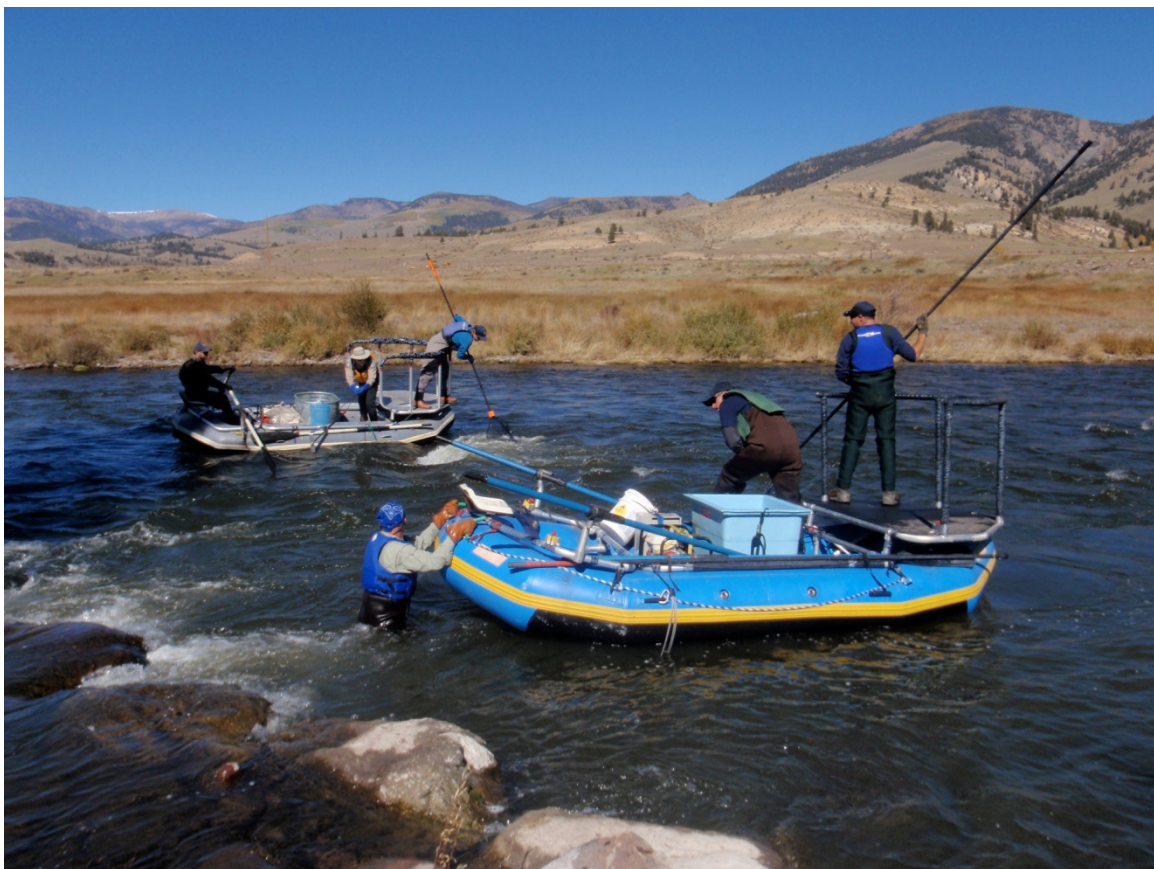
Figure 1.1. Raft electrofishing on Upper Wason section of the Rio Grande River, October 2014.

We collected fish sampling data on treated sections of the Rio Grande River on Wason Ranch (3.8 miles) and untreated portions of the Rio Grande River on La Garita Ranch (2.4 miles) by electrofishing with two rafts equipped with throw electrodes (Figure 1.1). Data collected included fish population estimates, fish size by relative abundance, and species composition. Four years of fish data have been collected on the Wason Ranch since Dave Rosgen completed work in 2006.

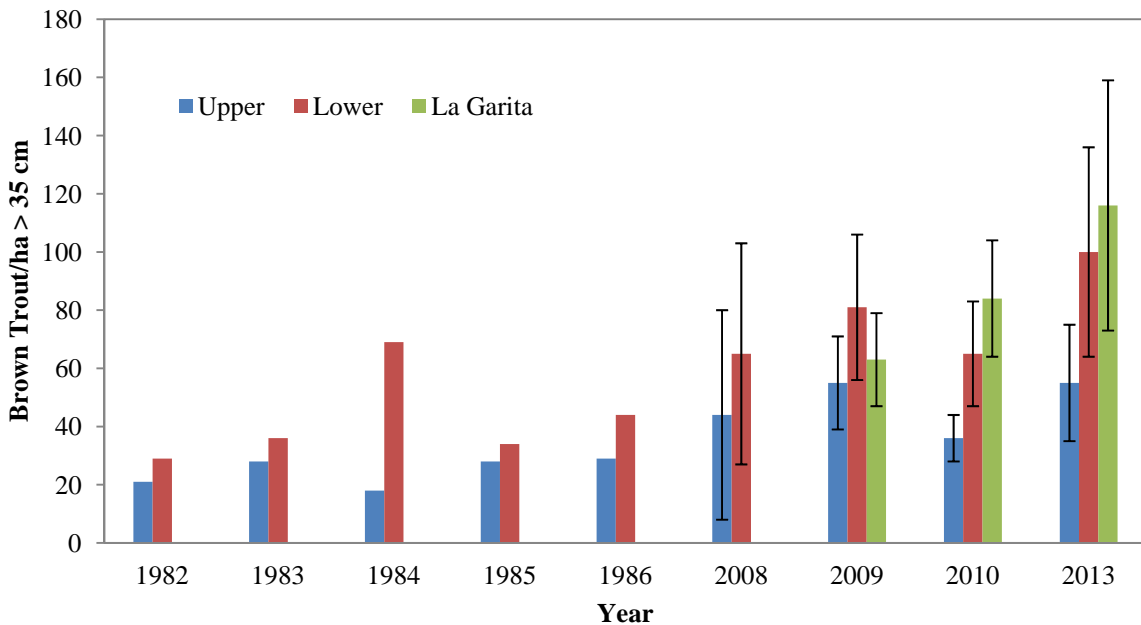
Figure 1.4. Density (trout/ha) of quality-sized brown trout (>35 cm) in the Upper Wason, Lower Wason and La Garita reaches. Pre-restoration sampling estimates include years: 1982, 1983, 1984, 1985 and 1986. Post-restoration sampling estimates include years: 2008, 2009, 2010 and 2013. Black vertical bars represent 95% CI for the estimate.

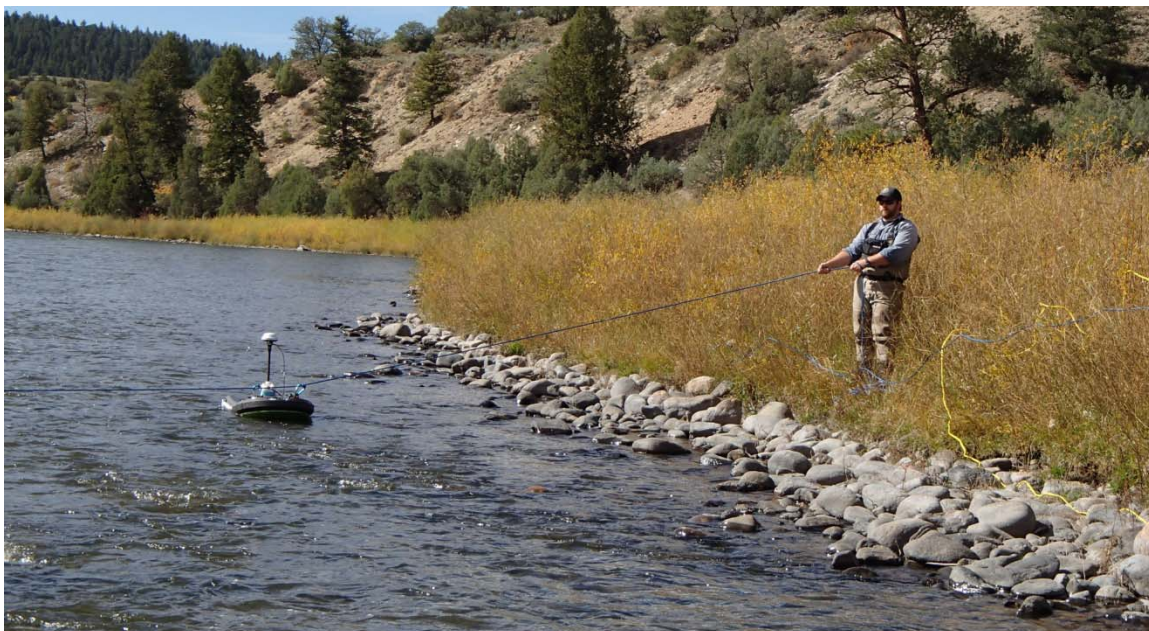
Figure 2.1 Surveying riffle morphology with the SonTek ADCP HydroSurveyor on the Colorado River near Pumphouse.

ADCP is being utilized at the Charlie Meyers SWA to evaluate changes in channel morphology and velocity distributions before and after implementation of the stream rehabilitation and habitat enhancement project. An ADCP was used to survey five pools within the project reach during spring 2013, prior to instream construction. These surveys will be repeated during fall 2015 after in-stream construction is completed. The SonTek RiverSurveyor with HydroSurveyor software was purchased in June 2013. Pilot studies have demonstrated the utility of the ADCP system for surveying and evaluating habitat, particularly in large river systems that cannot be surveyed by wading. This state-of-the-art equipment was used to survey riffle habitat on the Colorado River, calculate stream discharge, and measure in-channel velocity distributions (Figure 2.1 and 2.2). This piece of equipment was also used to survey baseline morphology and hydraulic conditions at the proposed whitewater park site in Montrose, Colorado (see Job A.5).

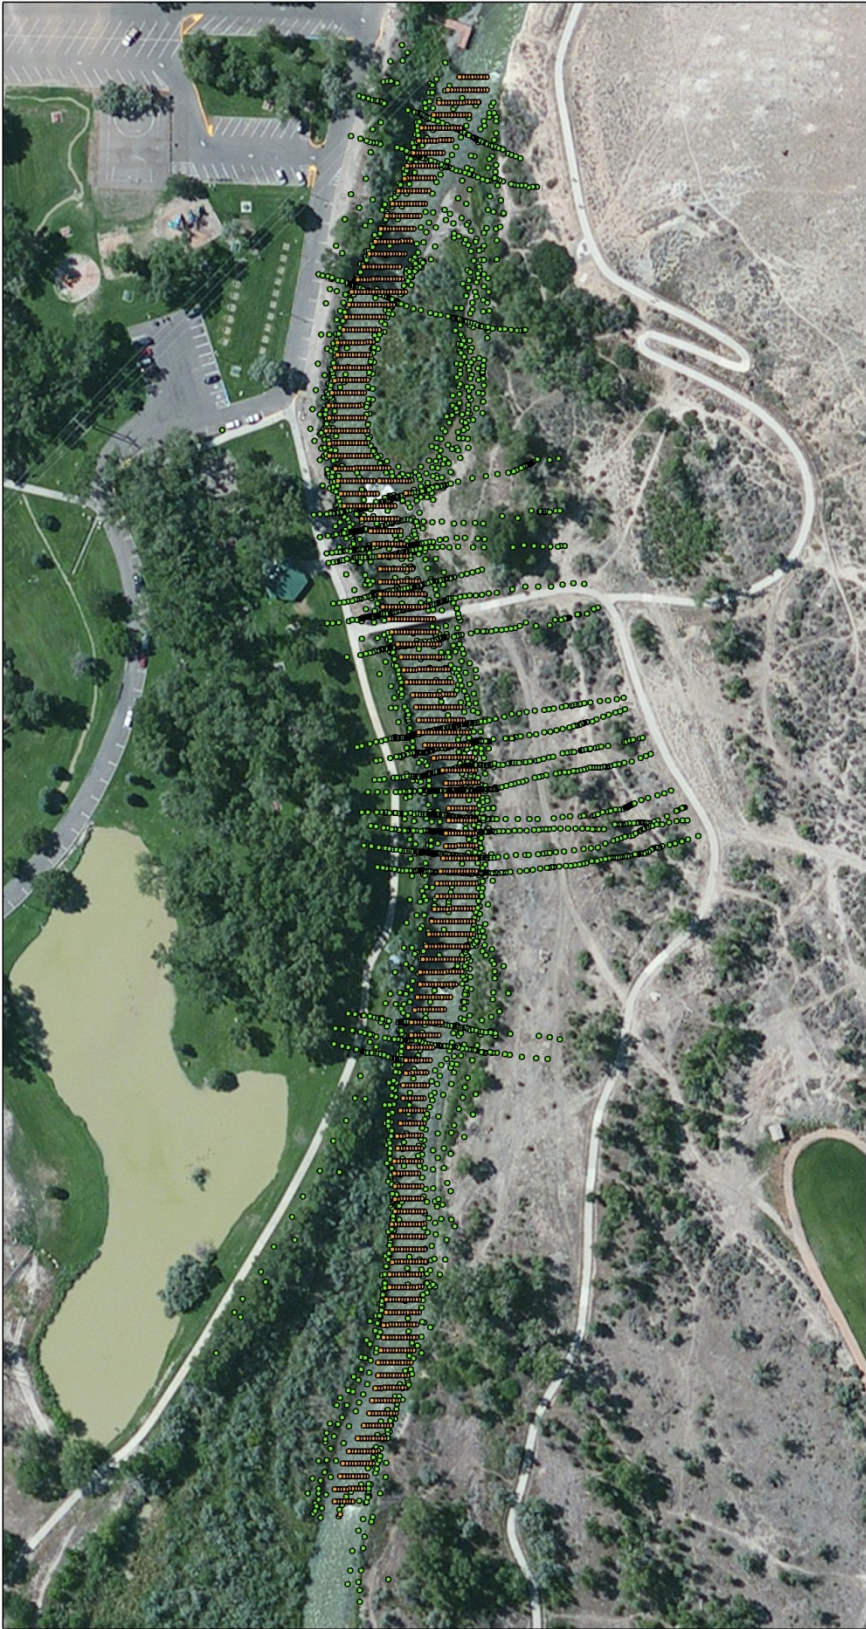
BASELINE SURVEY DATA		STATE OF COLORADO DEPARTMENT OF NATURAL RESOURCES COLORADO PARKS AND WILDLIFE FORT COLLINS, COLORADO		
			DRAWN: ERICHER	8/1/2014		CRYSTAL RIVER WEXNER PROPERTY PLAN VIEW	
			CHECKED: APPROVED:				
SHEET: 1 OF 1

Legend <ul style="list-style-type: none"> ● Survey Data (2013) ● Survey Data (2012)

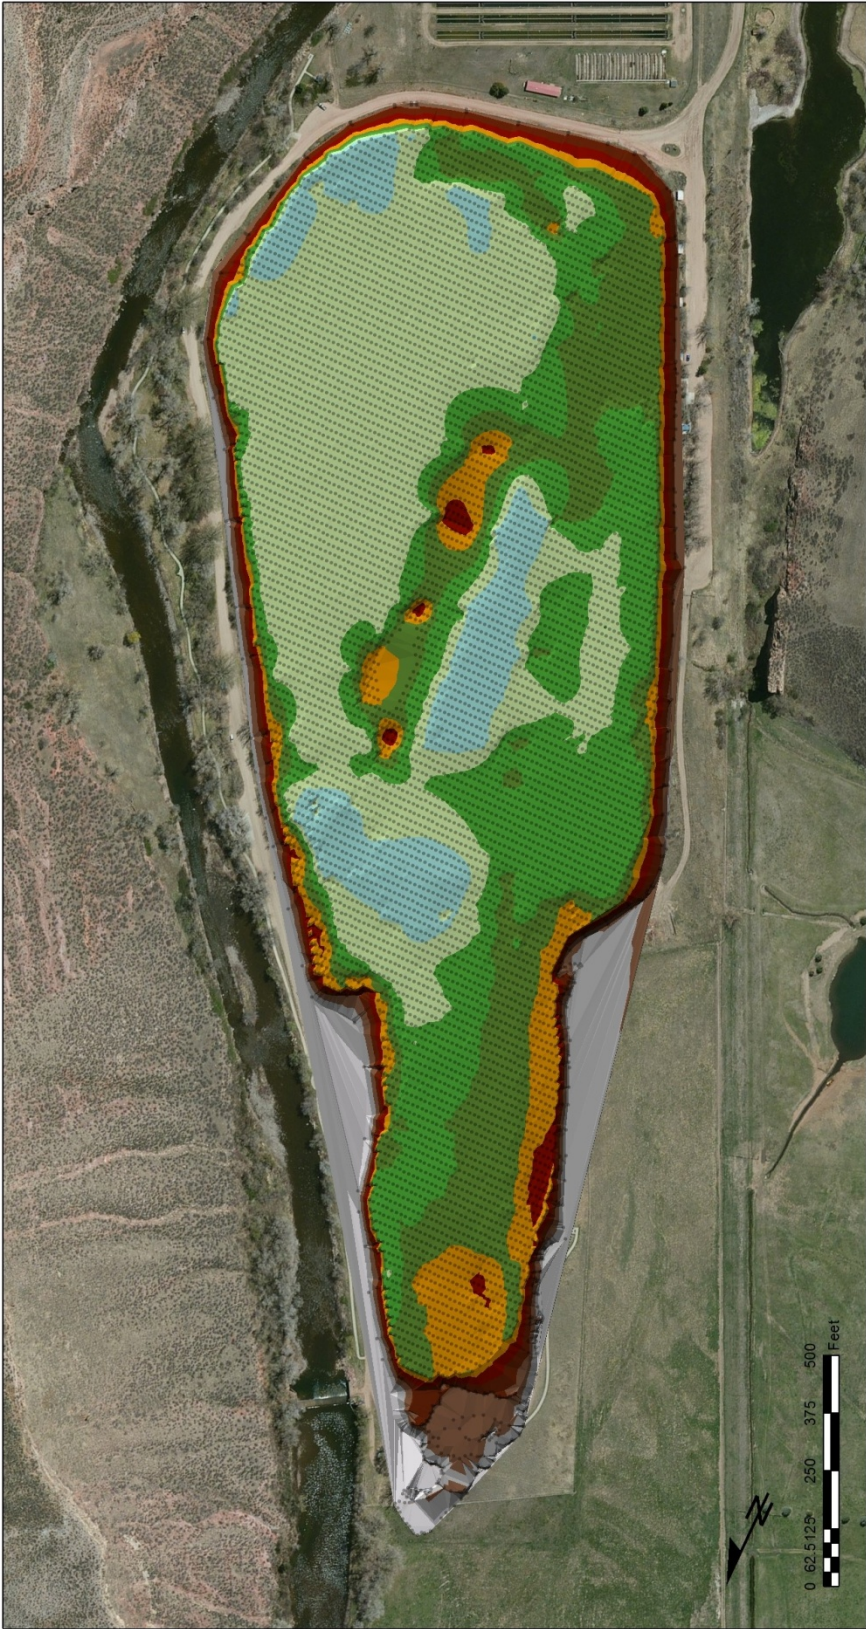
UNCOMPAGHRE RIVER
 MONTROSE WHITEWATER PARK
 PLAN VIEW

Legend
 Survey Data (2014)
 HydroSurveyor Data (2014)

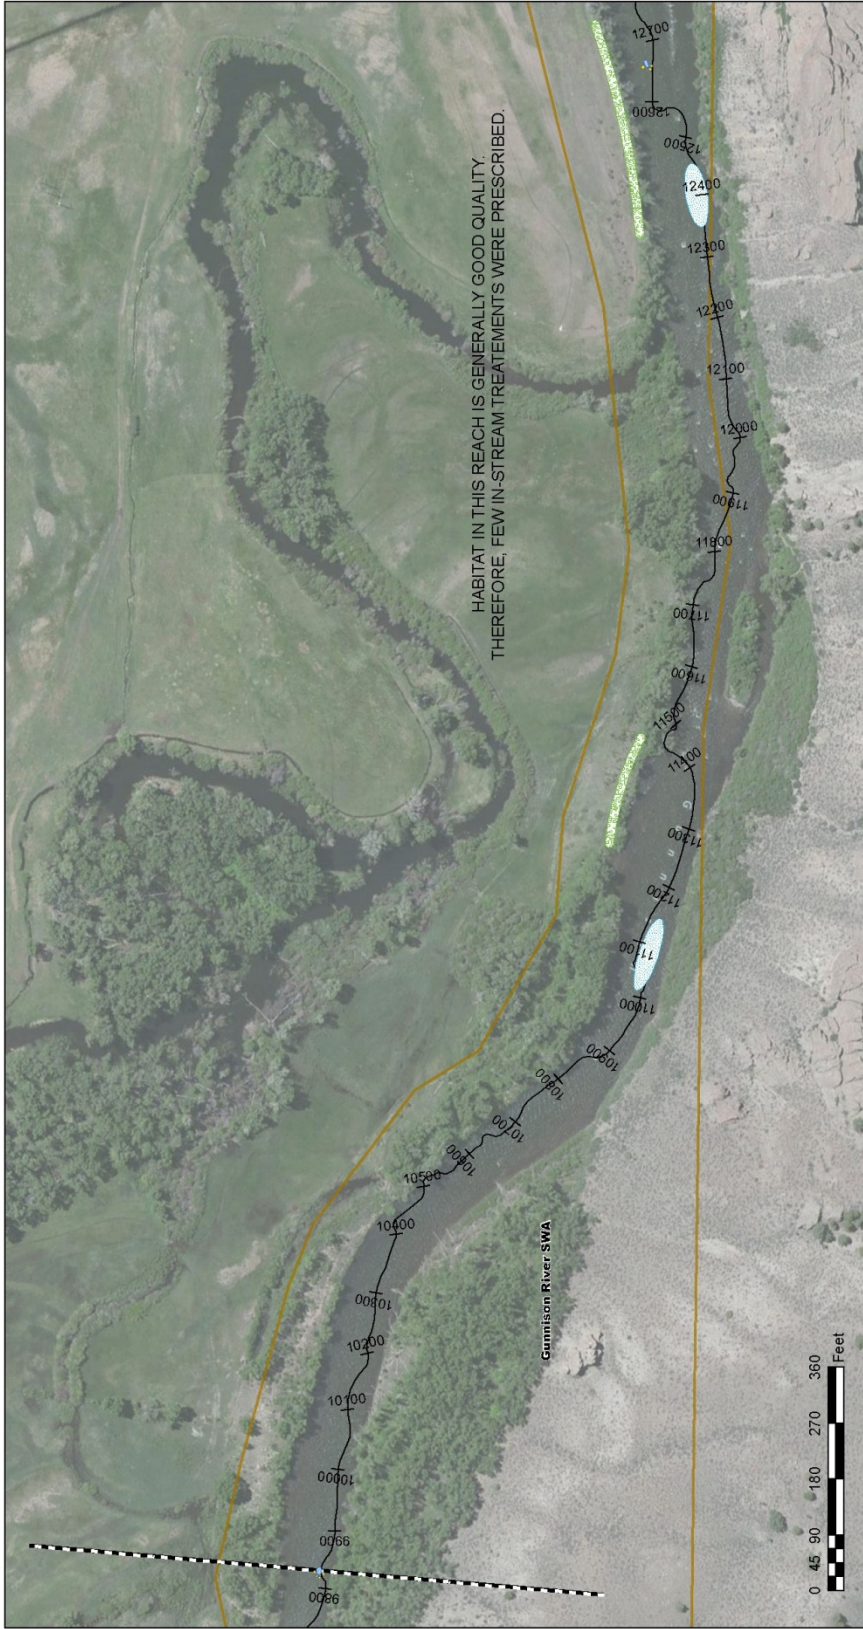
HABITAT IN THIS REACH IS GENERALLY GOOD QUALITY THEREFORE, FEW IN-STREAM TREATMENTS WERE PRESCRIBED.

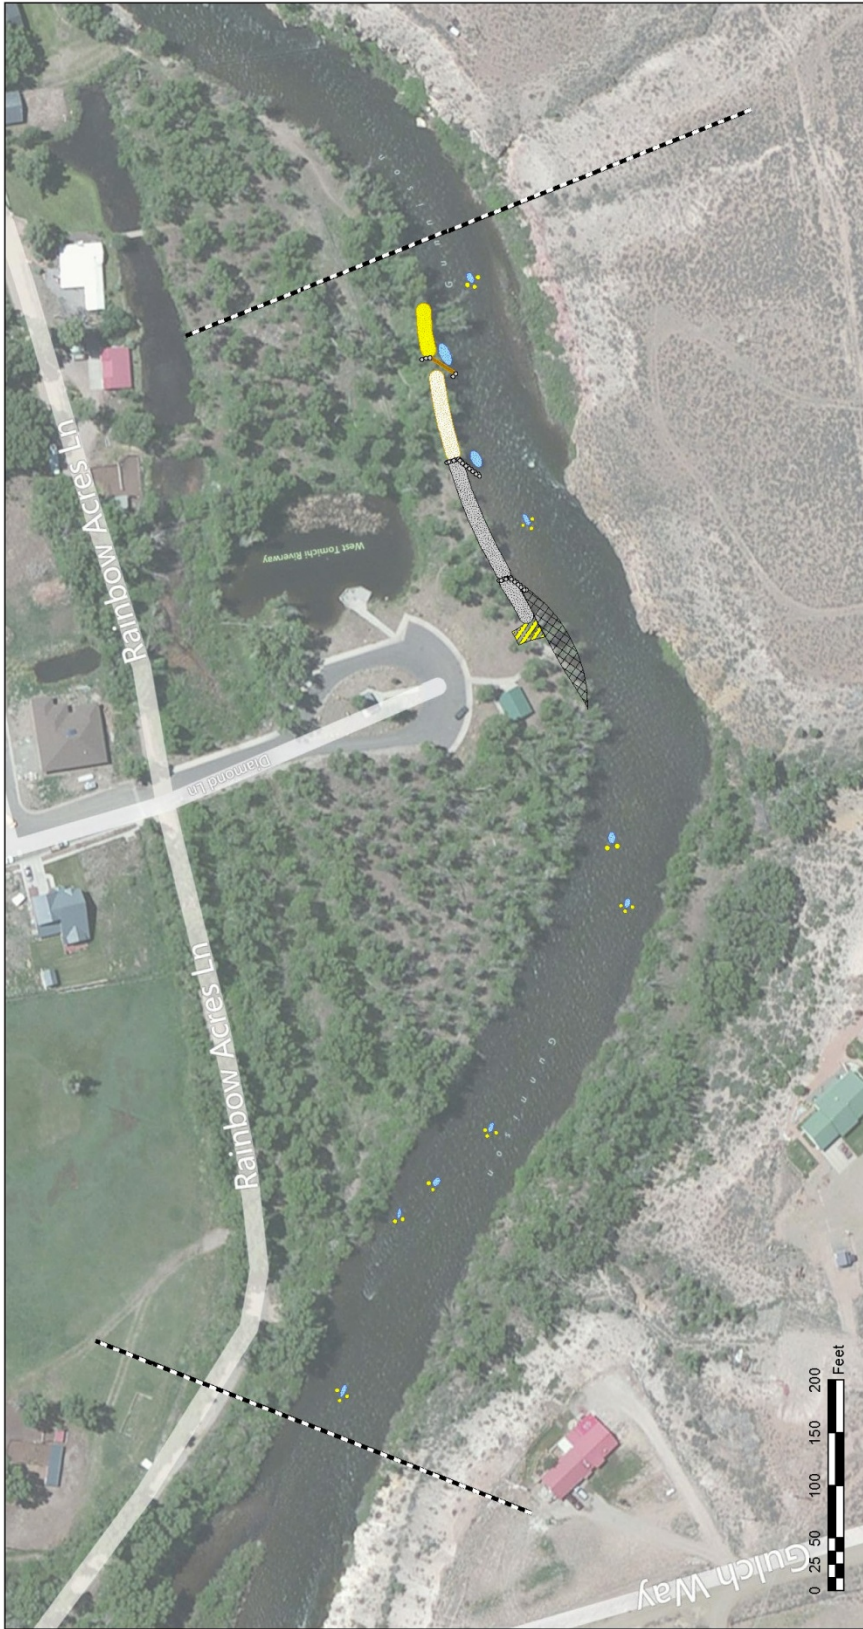
SEGMENT 6

Thalweg	Develop Cobble Bar	Gunnison SWA
Segment Breaks	Develop Point Bar	
Cobble Toe	Fill	
Brush Toe	Riparian Enhancement	
Wood Toe	Cobble Boat Ramp	
	Develop Cobble Bar	
	Develop Point Bar	
	Fill	
	Riparian Enhancement	
	Cobble Boat Ramp	
	Develop Cobble Bar	
	Develop Point Bar	
	Fill	
	Riparian Enhancement	
	Cobble Boat Ramp

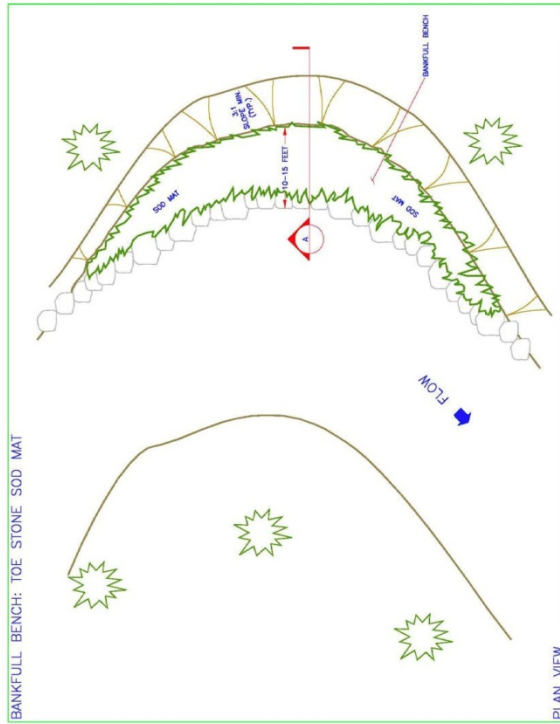
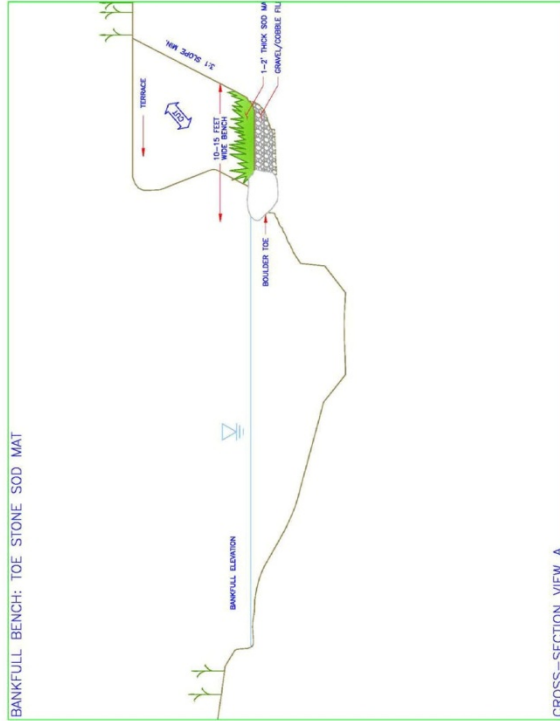
STATE OF COLORADO DEPARTMENT OF NATURAL RESOURCES COLORADO PARKS AND WILDLIFE FORT COLLINS, COLORADO		COBBLE/BOULDER TOE DETAIL	
DRAWN: ERICHER	9/25/2013		
CHECKED:			
APPROVED:			
GUNNISON RIVER SWA CONCEPTUAL DESIGN DETAIL DRAWINGS		SHEET: 14 OF 20

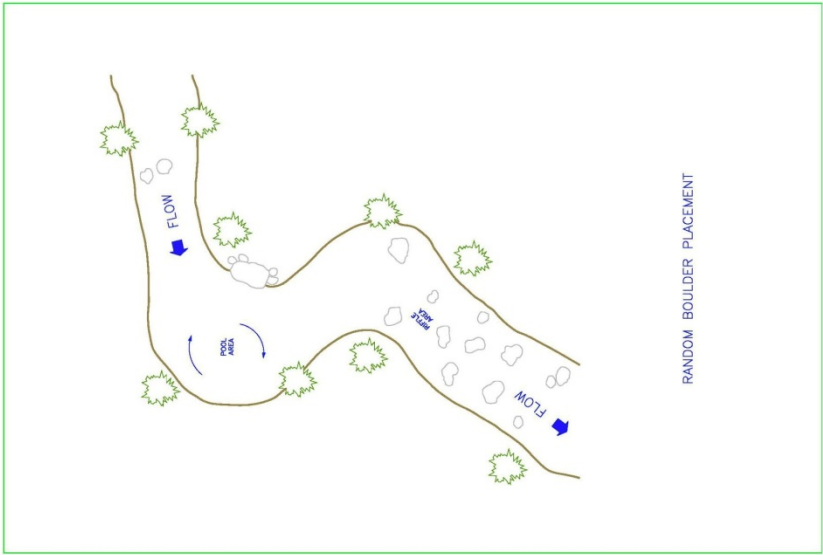
ENHANCED RIFFLE DETAIL
