CHANNEL-FORMING DISCHARGE ON THE DOLORES RIVER AND YAMPA RIVER, COLORADO

STATE OF COLORADO - DIVISION OF WILDLIFE

Gigi A. Richard, Ph.D. and Richard M. Anderson

Technical Publication No. 44
COLORADO DIVISION OF WILDLIFE

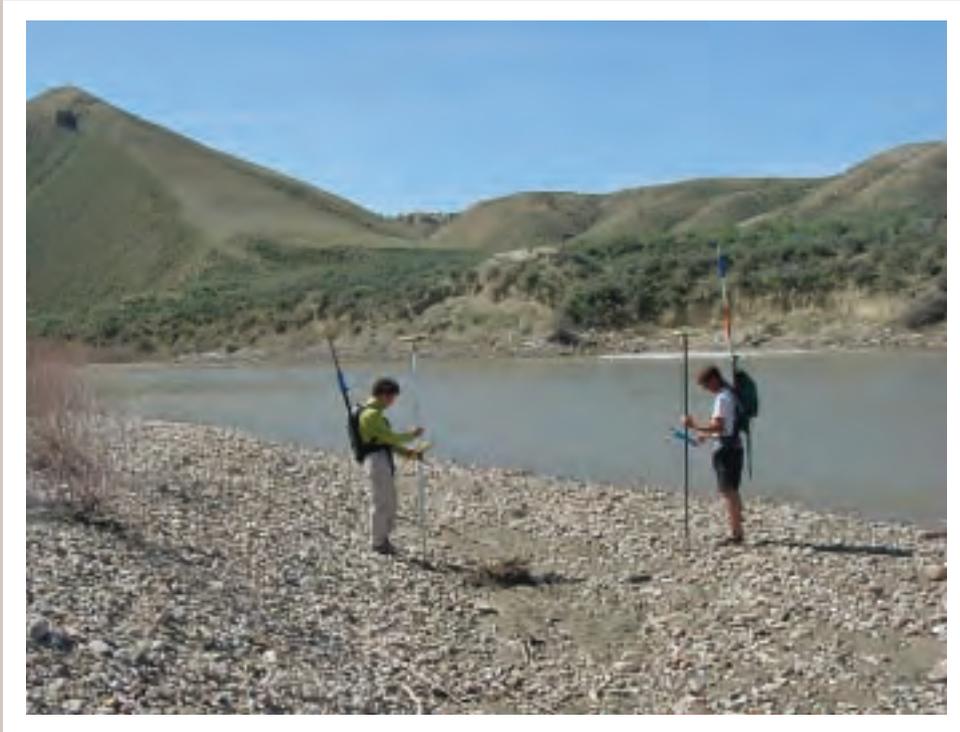
COVER PHOTO

Point-bar surface on Lily Park Reach, Yampa River, CO

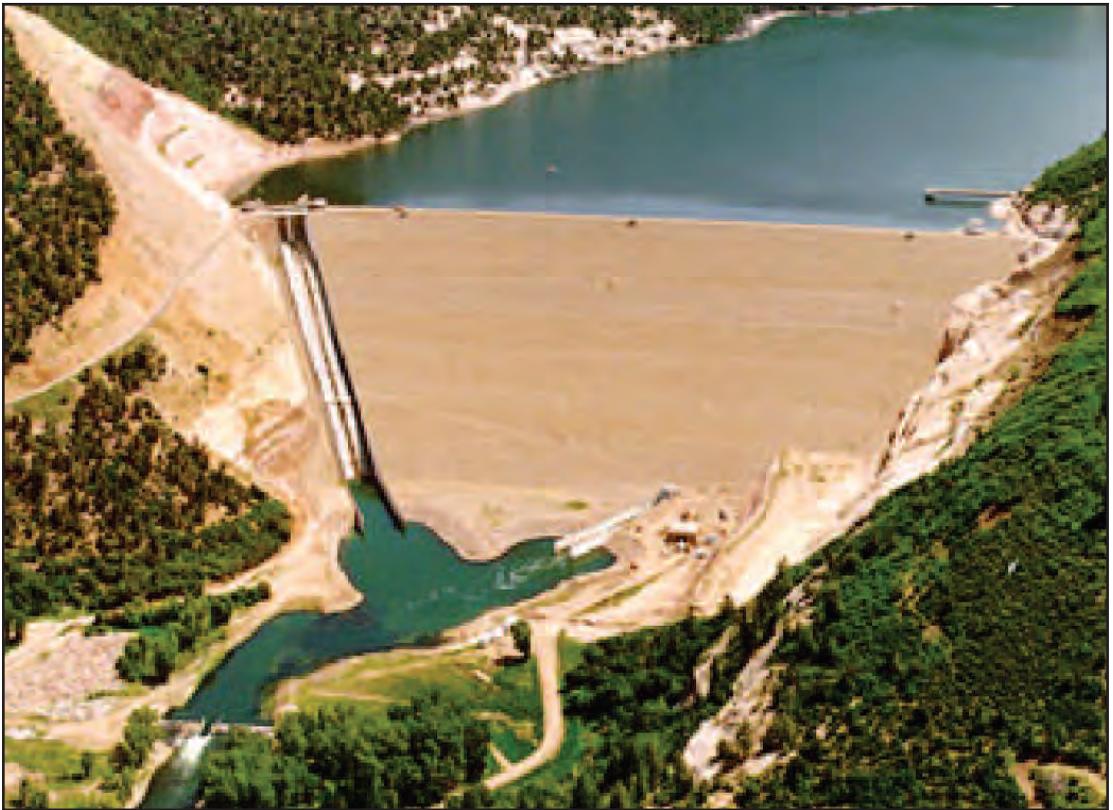
FIGURE 3. McPhee Dam and Reservoir (from US Bureau of Reclamation, Western Colorado Area Office)

Dolores river water has been diverted and used for irrigation since early settlement of the San Juan river valley. In 1968 the Dolores Project was authorized and included approval for McPhee dam (Figure 3), which was completed in 1984. McPhee Dam stores water from the Dolores River for irrigation, municipal and industrial use, recreation, fish and wildlife, flood control and production of hydroelectric power (USBR, 2006). With a storage capacity of 470 million cubic meters (381,195 acre-feet), McPhee Dam has substantially altered the flow regime of the Dolores

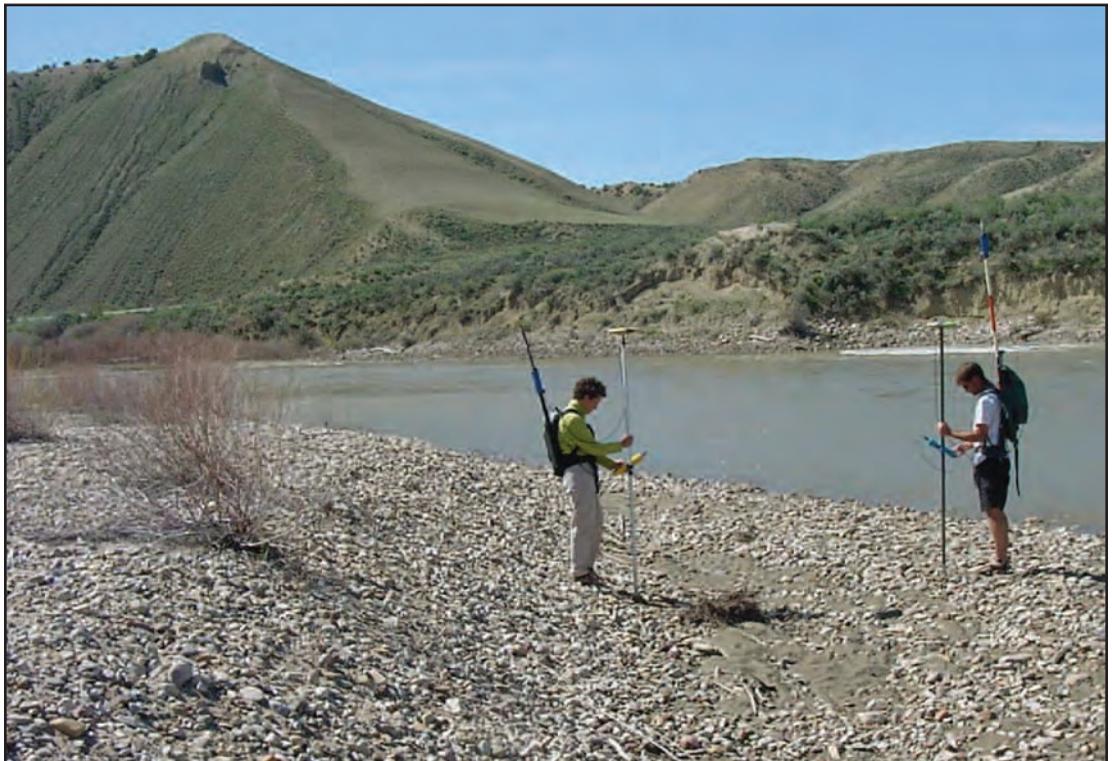
FIGURE 9. Point-bar surface on Lily Park Reach, Yampa River, CO

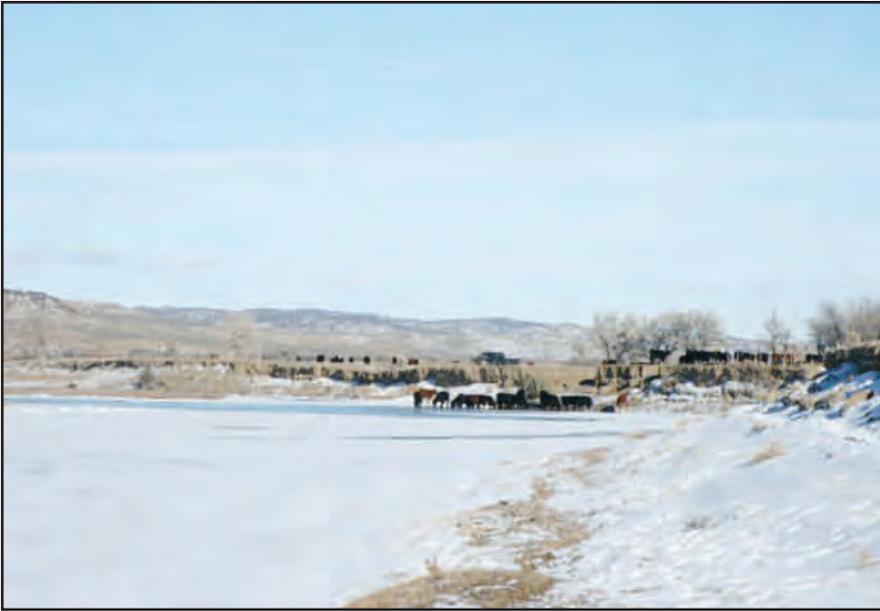
FIGURE 12. Grazing along the left bank of the Sevens Reach, Yampa River, CO. Note steepness of banks and evidence of slumping.

The Sevens Reach (Figure 10) has a milder slope, 0.0005, (Figure 11) than the Lily Park reach and also flows through irrigated and grazed land (Figure 12). The right bank rises steeply to a bluff for a majority of the reach (Figure 13). Floodplain surfaces are small and discontinuous. The left bank is near vertical for a majority of the reach. We noted evidence of recent bank erosion along the left bank of the reach, for example in Figure 14 you can see a fence post that is falling into the river. In addition some survey pins were lost to erosion between their installation in the early 1990's and our visit in 2002. The bed material of the Sevens reach is smaller than the Lily Park reach (Figure 15) and the sinuosity is 1.26.

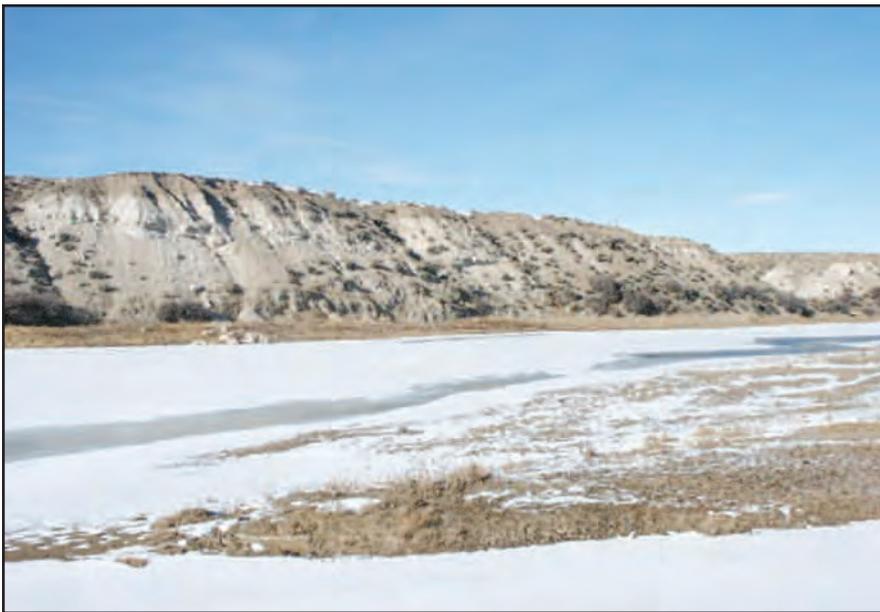
FIGURE 13. Upstream view of bluff along right bank of the Sevens Reach, Yampa River, CO.

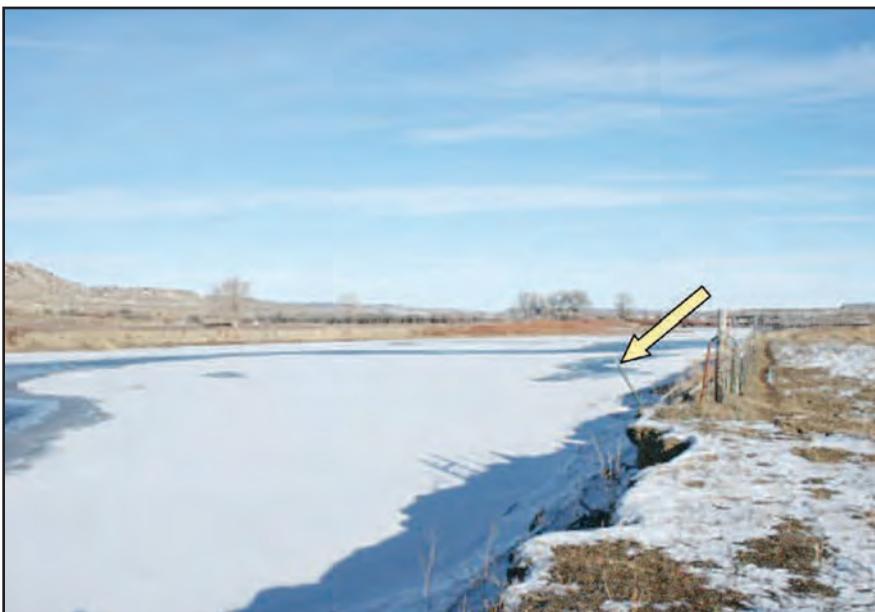
FIGURE 14. View of Sevens reach looking upstream from left bank. Note fence post falling into the river from erosion of the left bank.

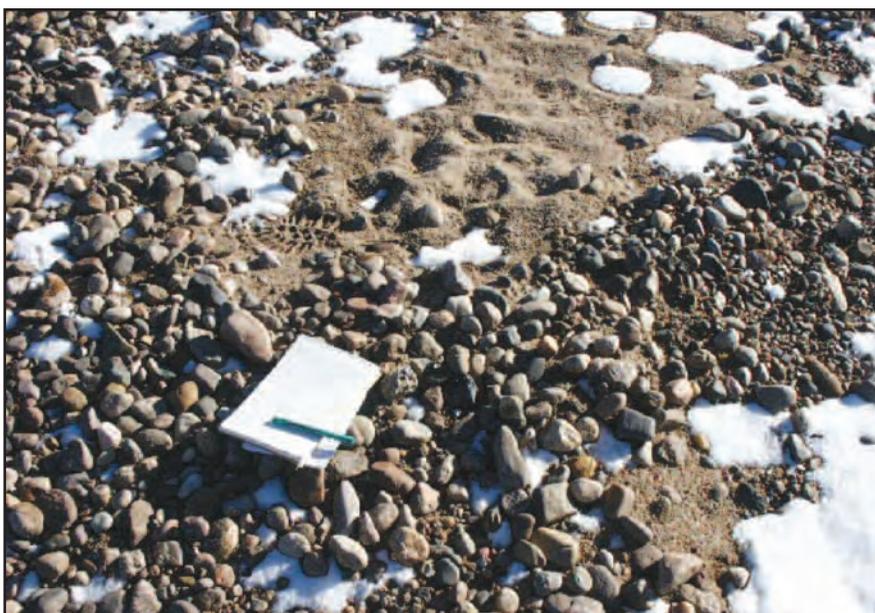
FIGURE 15. Typical bar material at Sevens Reach, Yampa River, CO.

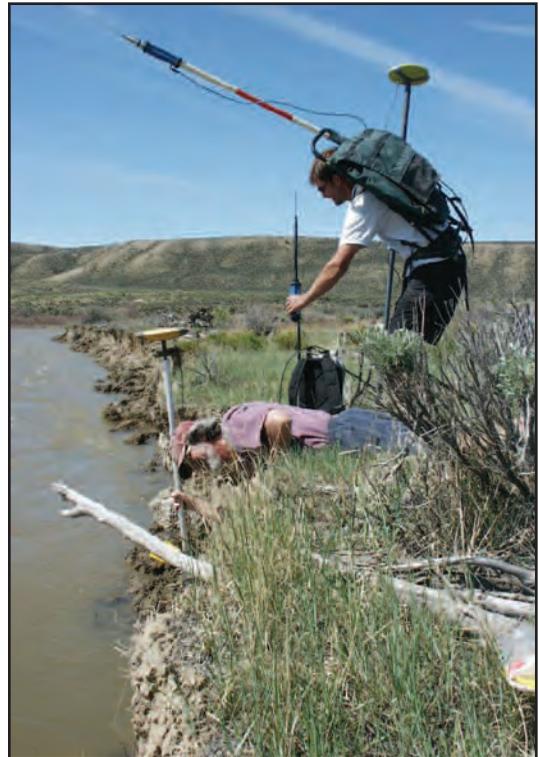
FIGURE 29. Surveying water line at 9,730 cfs at Lily Park Reach, Yampa River, CO (5/13/03)
