**STREAM HABITAT INVESTIGATIONS AND ASSISTANCE
PROJECT SUMMARY**

2021 Progress Report

Colorado Parks & Wildlife

Upper Arkansas River Habitat Restoration Project, Arkansas River

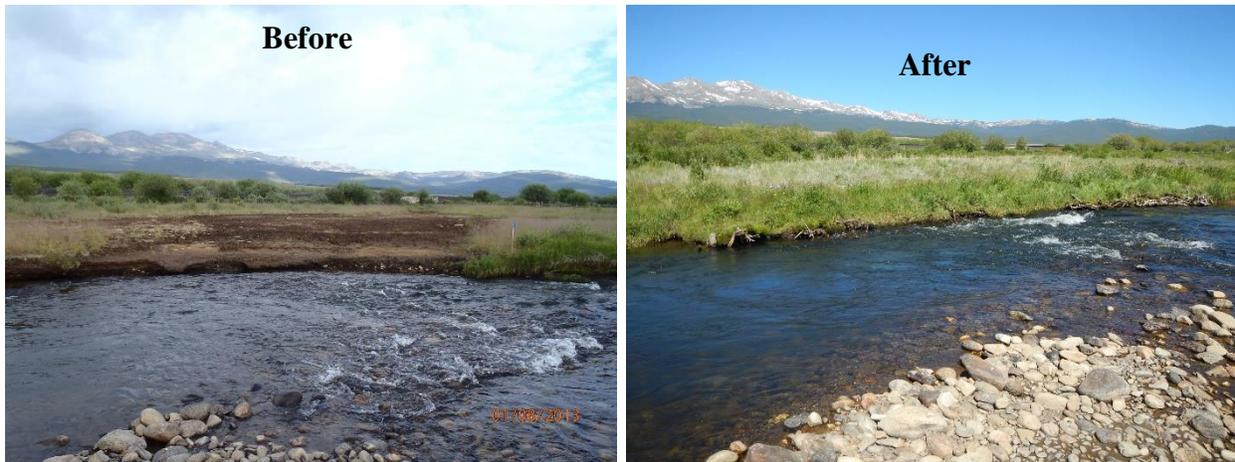
Figure 1. Before and after photos of wood toe treatment and fluvial tailings remediation.

Progress towards project goals for primary monitoring targets was summarized in Table 1 and brief descriptions of monitoring results for fish populations, benthic macroinvertebrates, riparian vegetation, habitat quality, and instream habitat structures were provided below. Select before and after photos were presented in Figures 1-3.

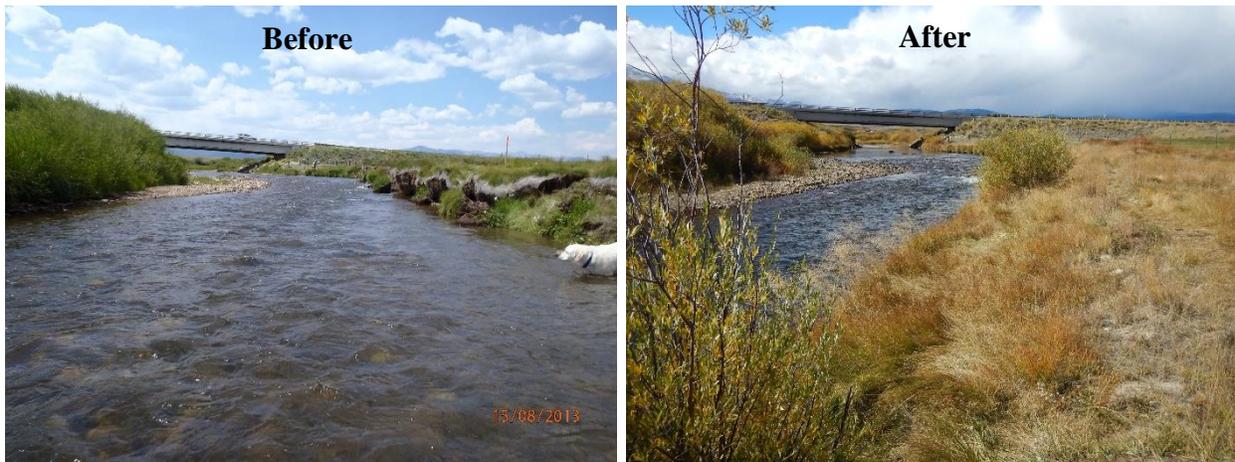
Figure 2. Before and after photos of an eroding bank that was stabilized with a riparian bench.

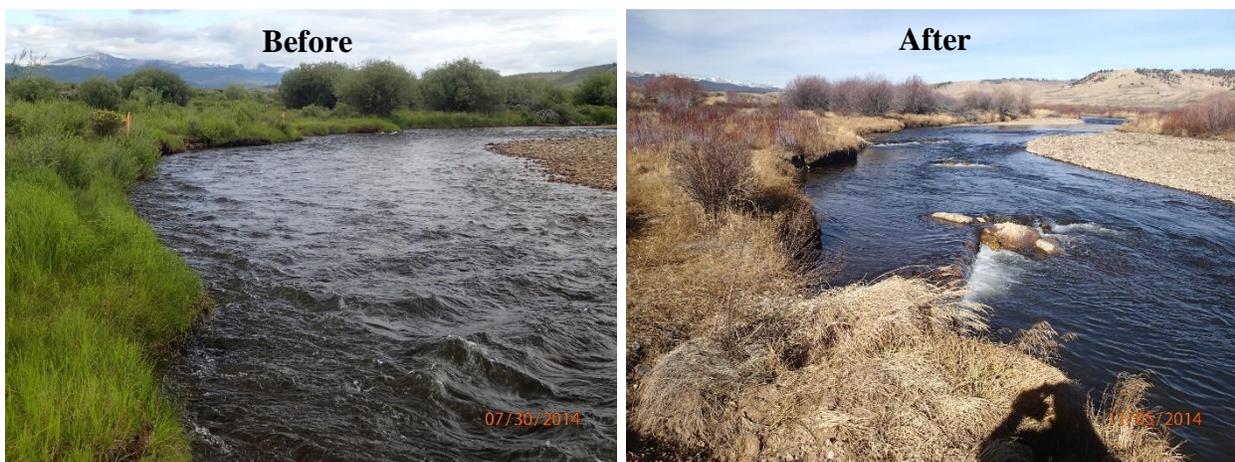
Figure 3. Before and after photos showing log vanes, habitat boulders, and channel narrowing.
